BREARLEY HOUSE PRESERVATION PLAN

SEPTEMBER 2023

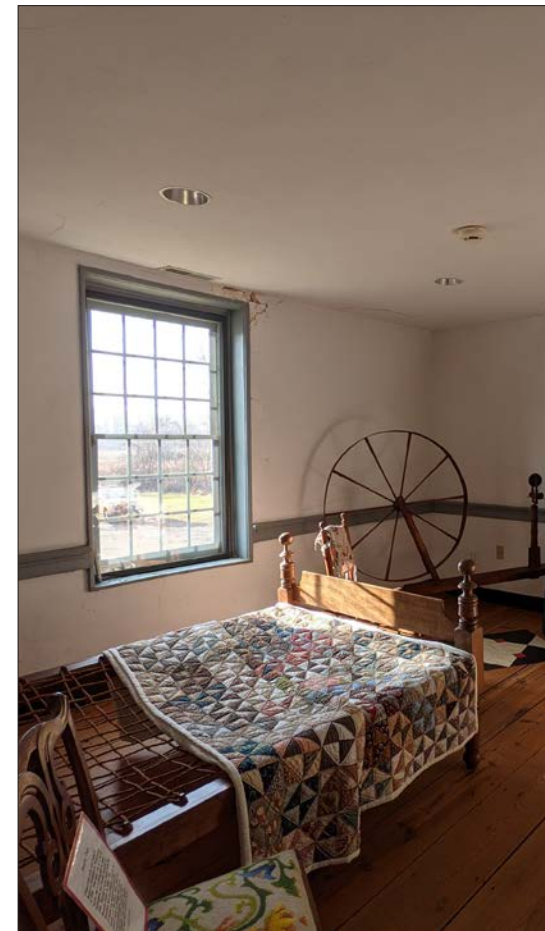
3-1: Southwest Chamber (202) with south-facing window.

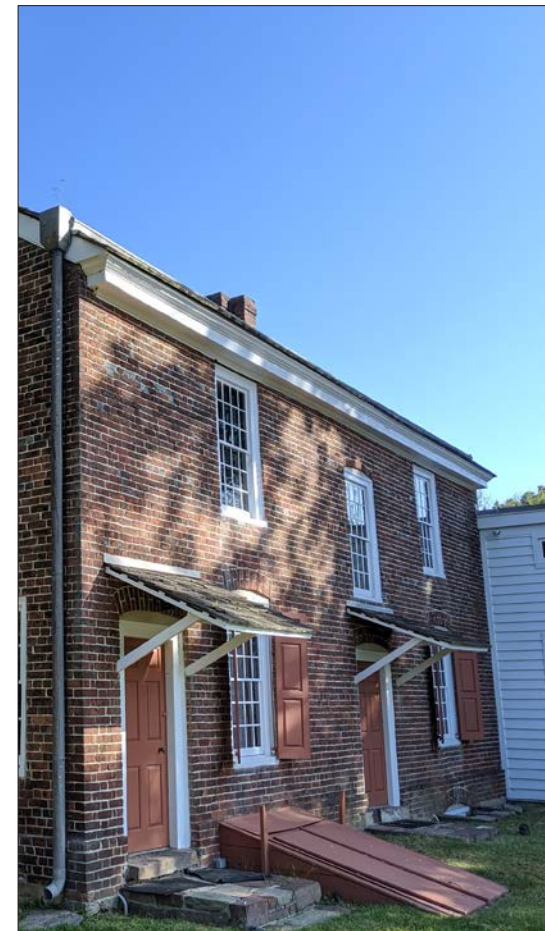
5-1: South end of the Brearley House.

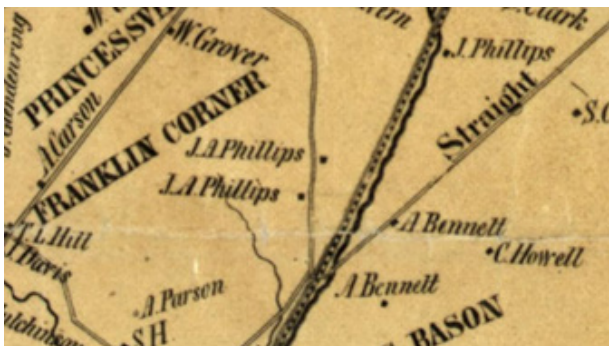
Figure 4: The Brearley House, standing to the east side of Meadow Road, is incorrectly identified as J.A. Phillips. Straight Run Turnpike, to the east, becomes the present-day Route 1.

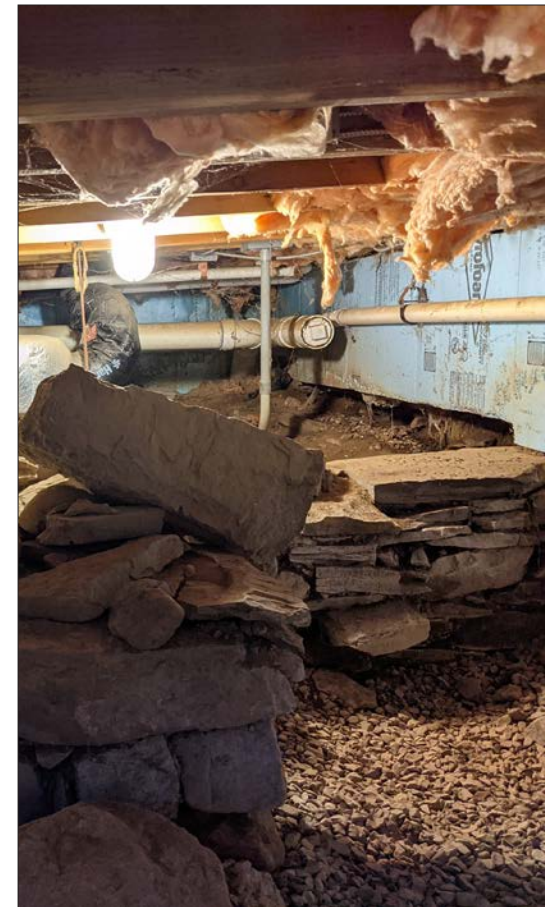
23-1: Stone wall underneath the addition.

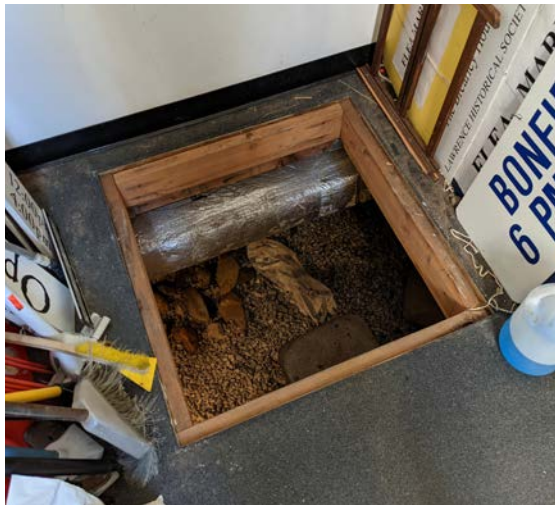
24-1: The crawl space under the addition is an area of previous archaeological investigation.

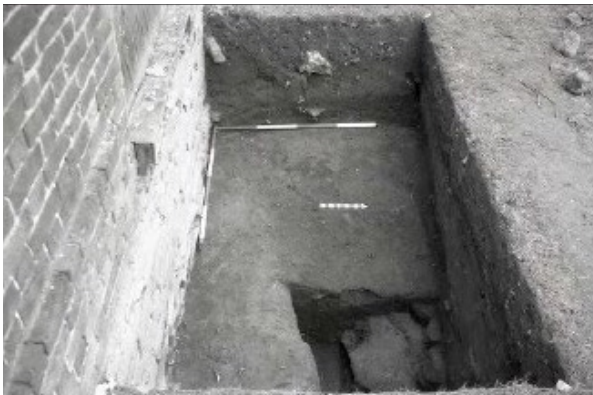
Figure A-2. The southern part of the cellar-hole of the c.1700 house on the north side of the 1761 brick house, as excavated in 1999. The view faces west. The north foundation of the 1761 house is on the left. The small north arrow/photo scale lies on the unexcavated dark soil filling the cellar hole. At the bottom right the dark soil has been partially removed, defining the southern side of the cellar-hole. A mass of clay loam and cobbles lies within the cellar-hole fill. See Figure A-1 for location. Source: Burrow and Butchko 2016, Plate 3.8.

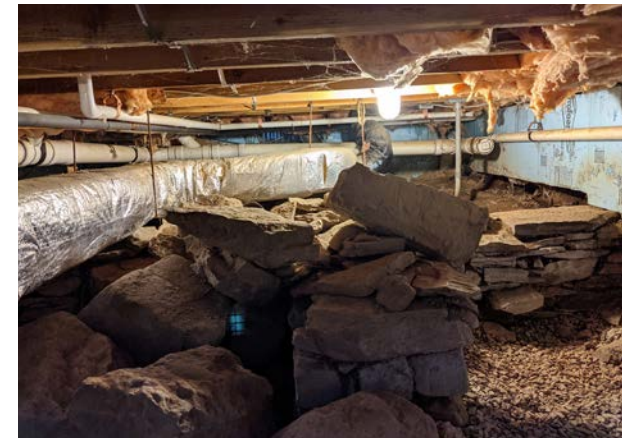
27-1 The 1999 archaeological examinations discovered a basemented structure and stone foundation which may date to before 1722.

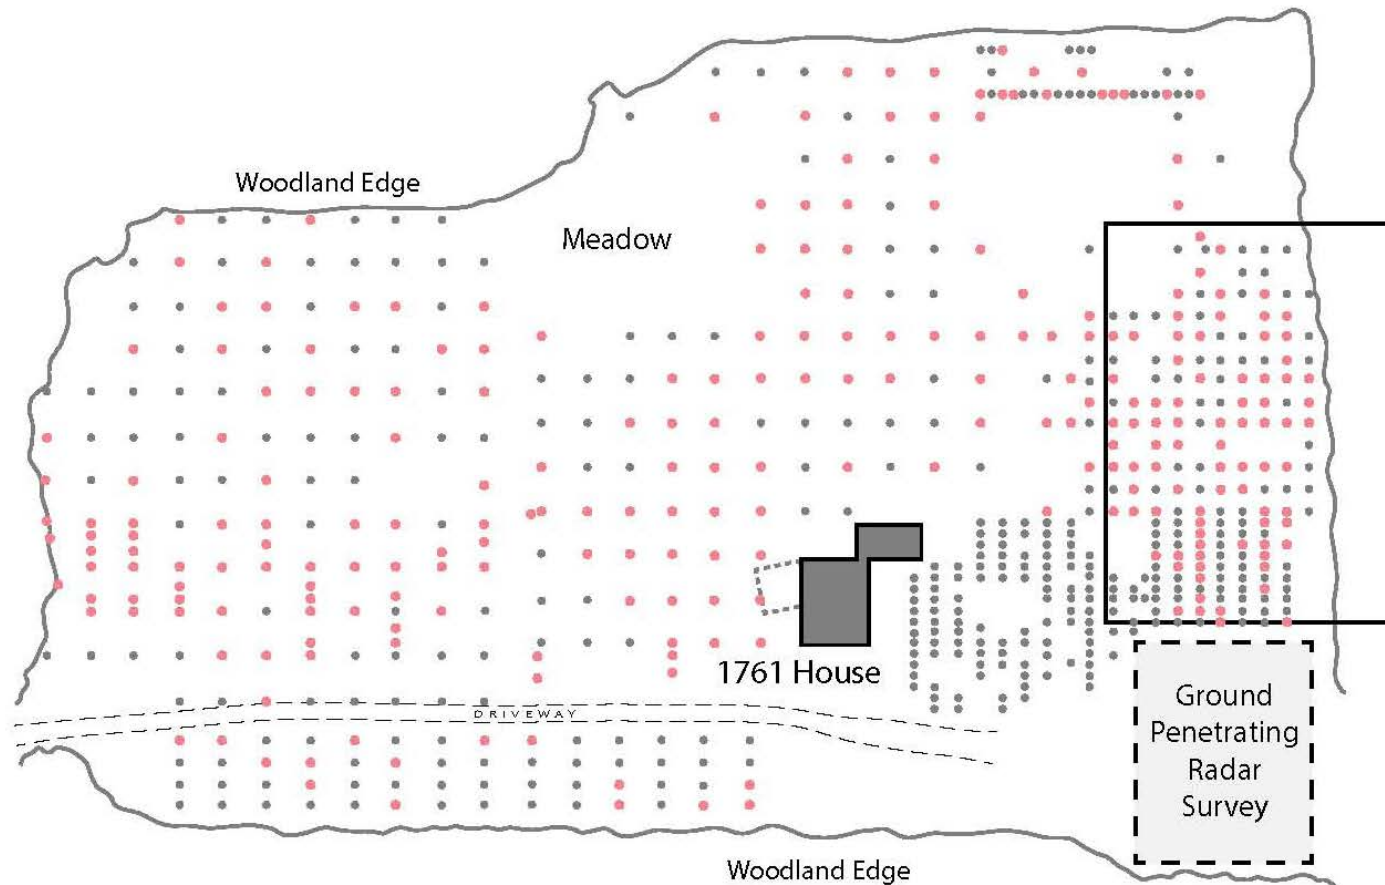
- Shovel Test with Prehistoric Material
- Negative Shovel Test

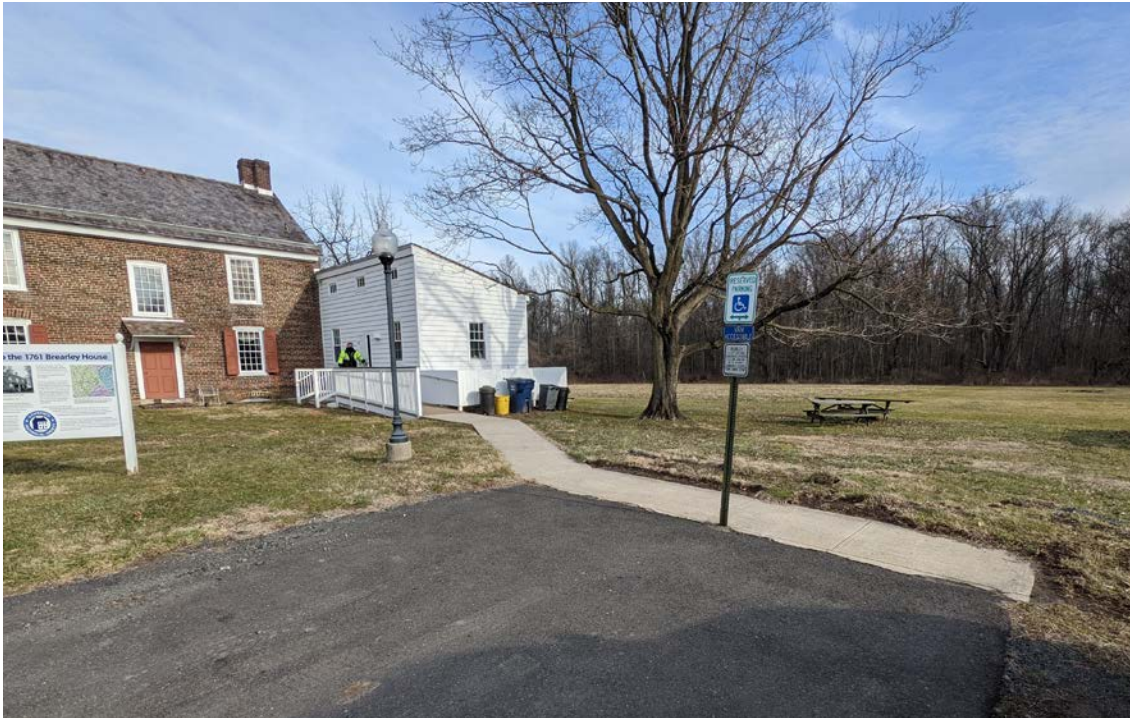
33-1: Apart from the parking lot, which is partially paved with a sidewalk leading to the visitor's entrance, the Brearley House is surrounded by meadow.

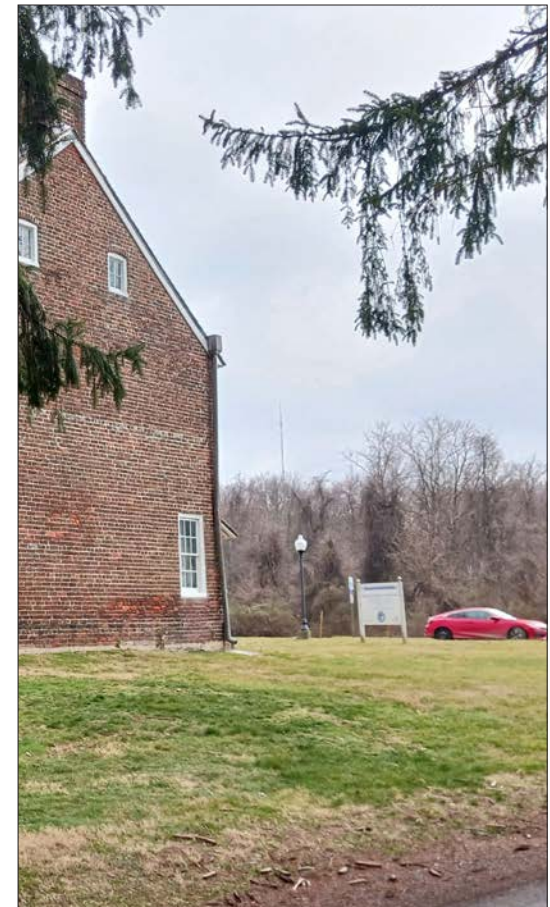
33-2: View of parking lot from Meadow Road along East side of the Brearley House, facing South.

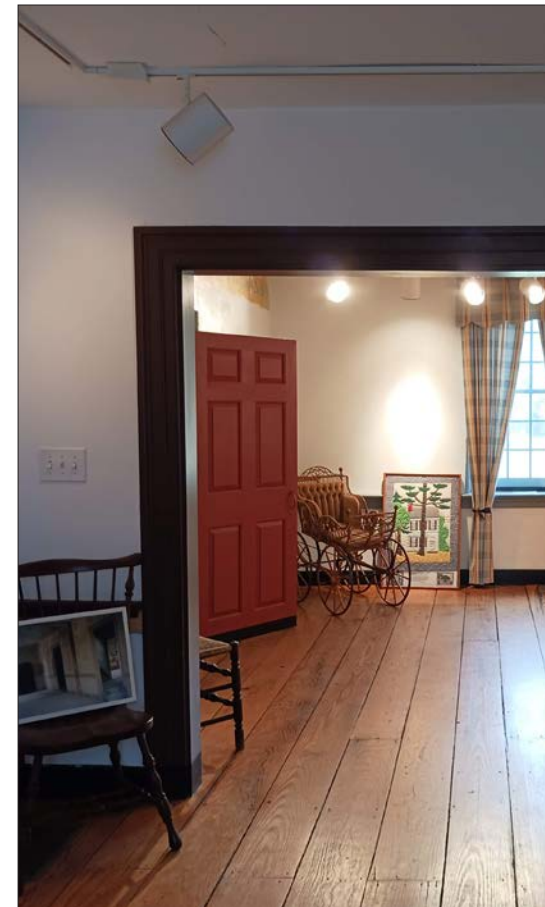
35-1: Looking North into Northeast Parlor (Room 101) from Southeast Parlor (Room 102)

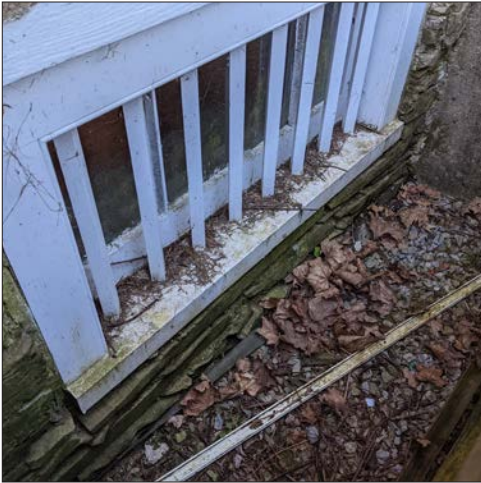
39-1: The window wells are clear of vegetation, and should continue to regularly be cleared of leaves and debris. Moss is growing on various surfaces.

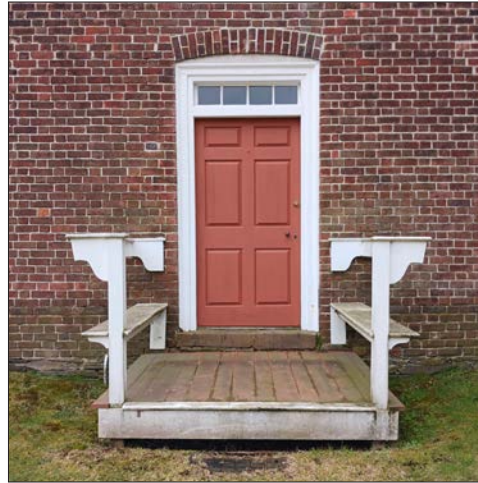
39-2: Porch has become dirty over time, porch and benches are in stable condition.

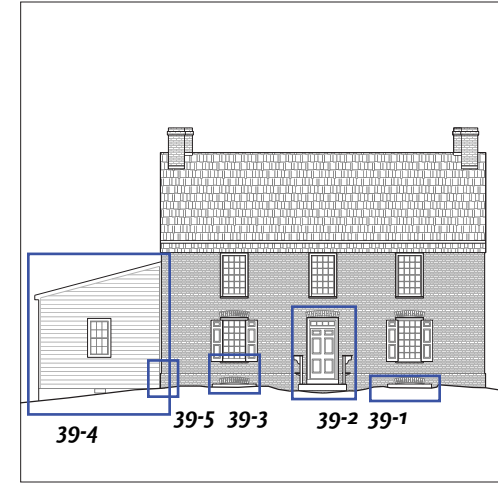
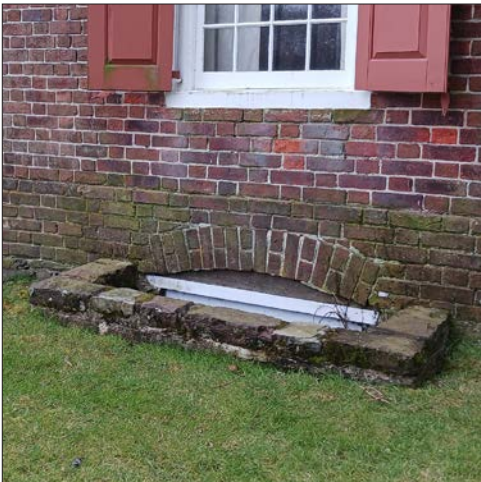
39-3: Plants should be removed from window wells and any leaks should be repaired to avoid water infiltration into the basement.

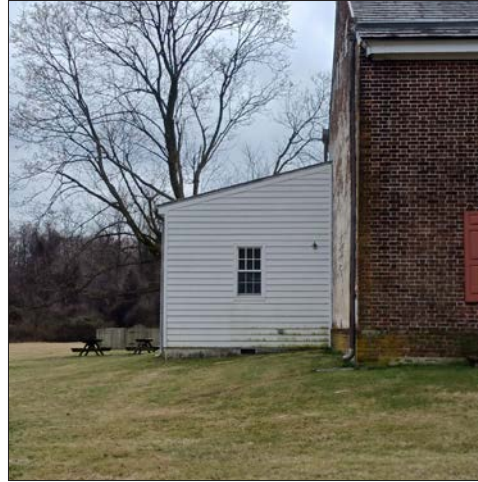
39-4: The 1990s addition is in good condition though moss is growing on the vertical surfaces.

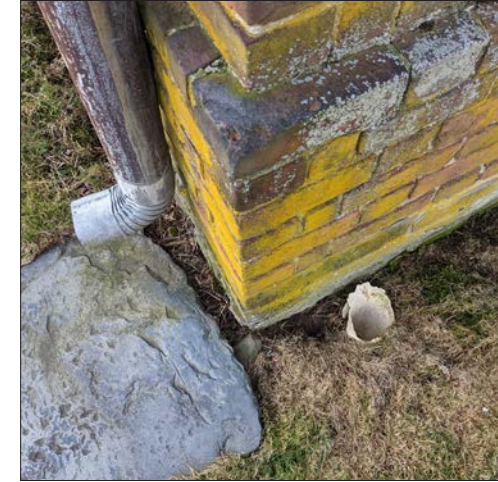
39-5: Vegetation growing on water table and side of wall. PVC pipe should be removed if it is not performing a useful service.

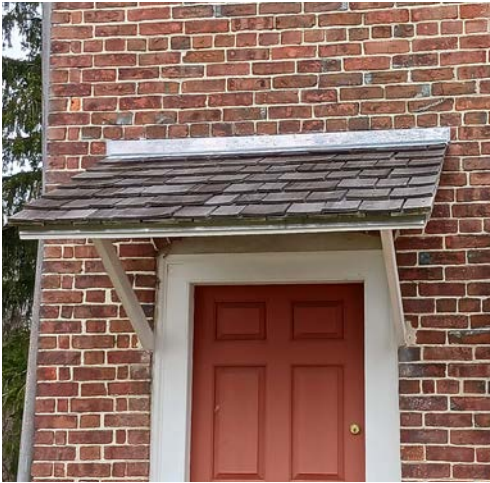
46-1: Shed roofs over doors at South elevation.

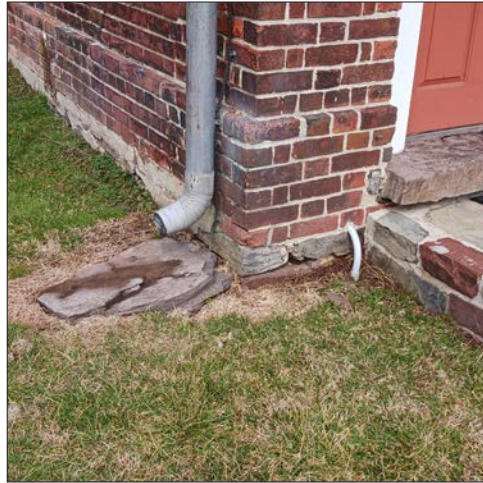
46-2: Existing downspout and foundation

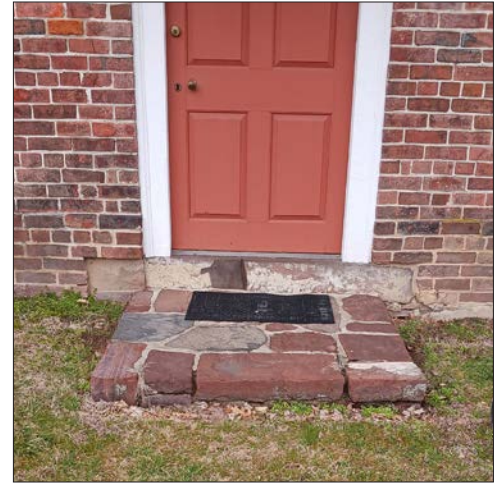
46-3: Stone step to door accessing museum.

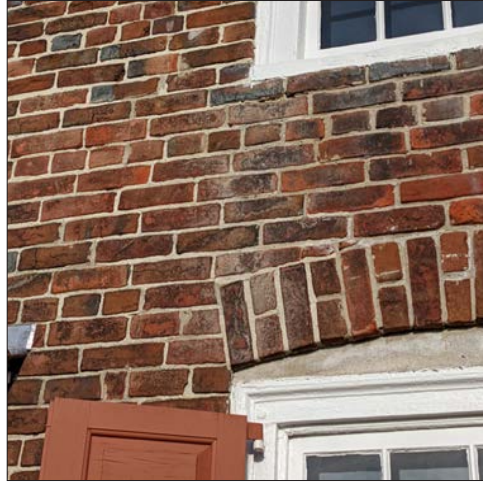
46-5: Mortar and brick condition at South elevation.

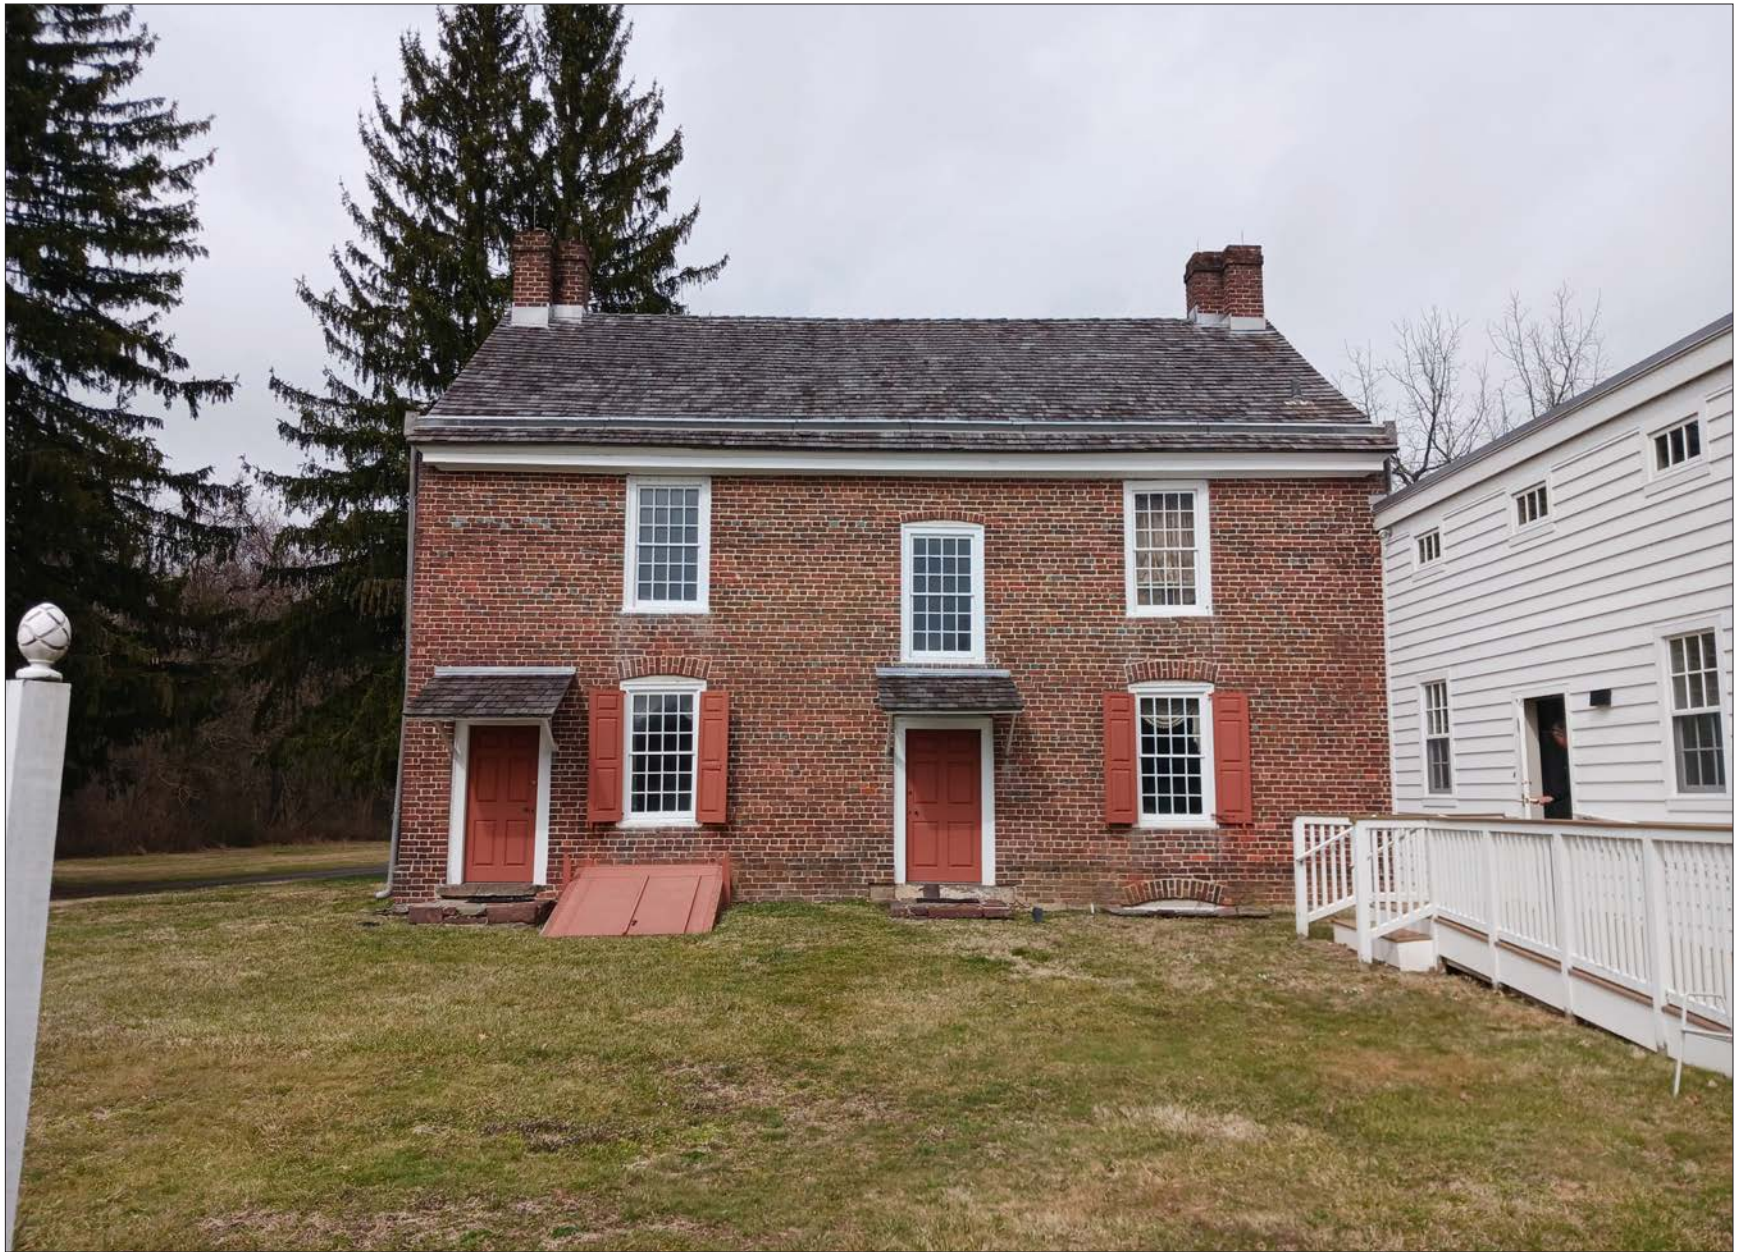
47-1: The south elevation of the Brearley House is the nearest to the parking lot, and the house is accessed through the addition.

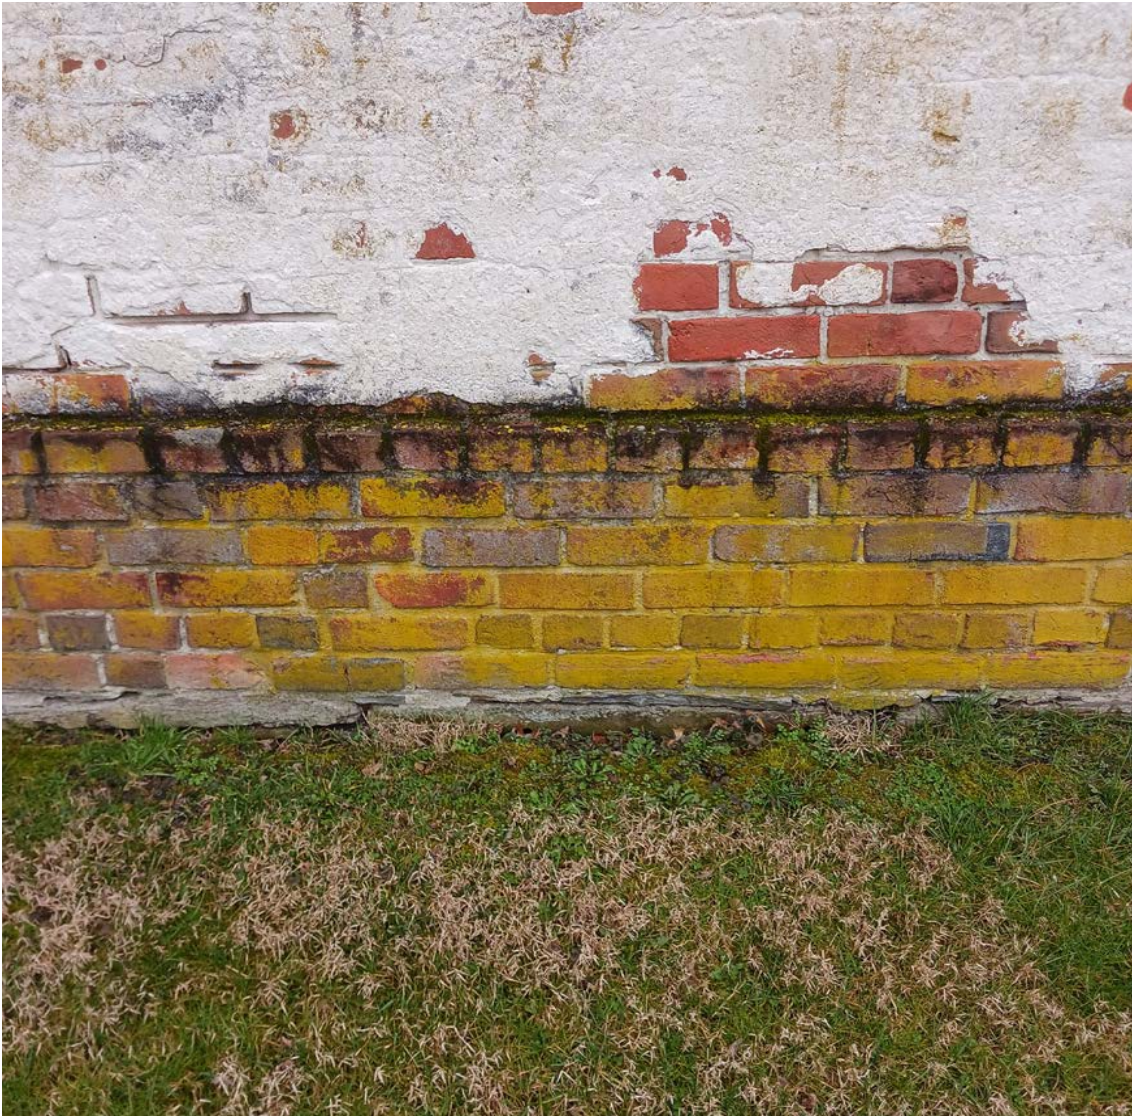
50-1: Stucco coating on brick is deteriorating; some bricks are spalling.

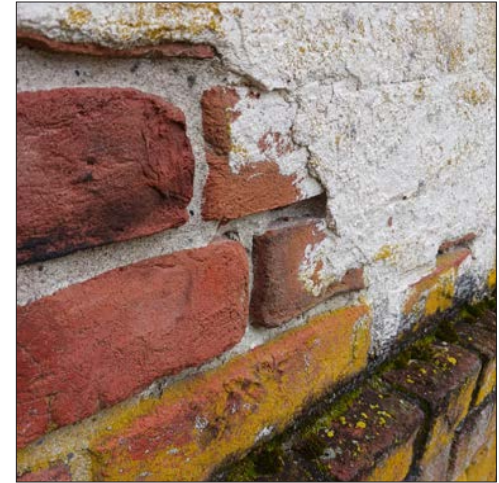
50-2: Spalling and damaged bricks, coating should be cleaned and examined further.

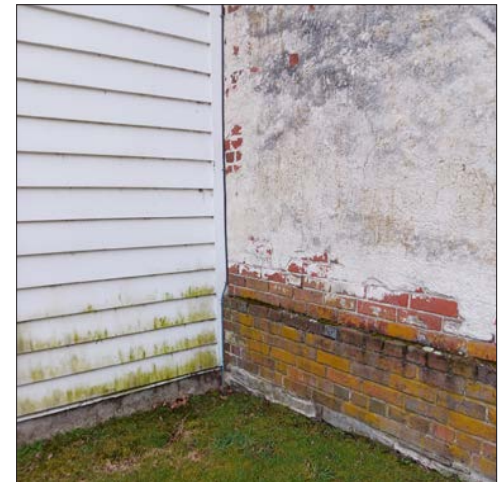
50-3: Coating on brick is deteriorating; some bricks are spalling.

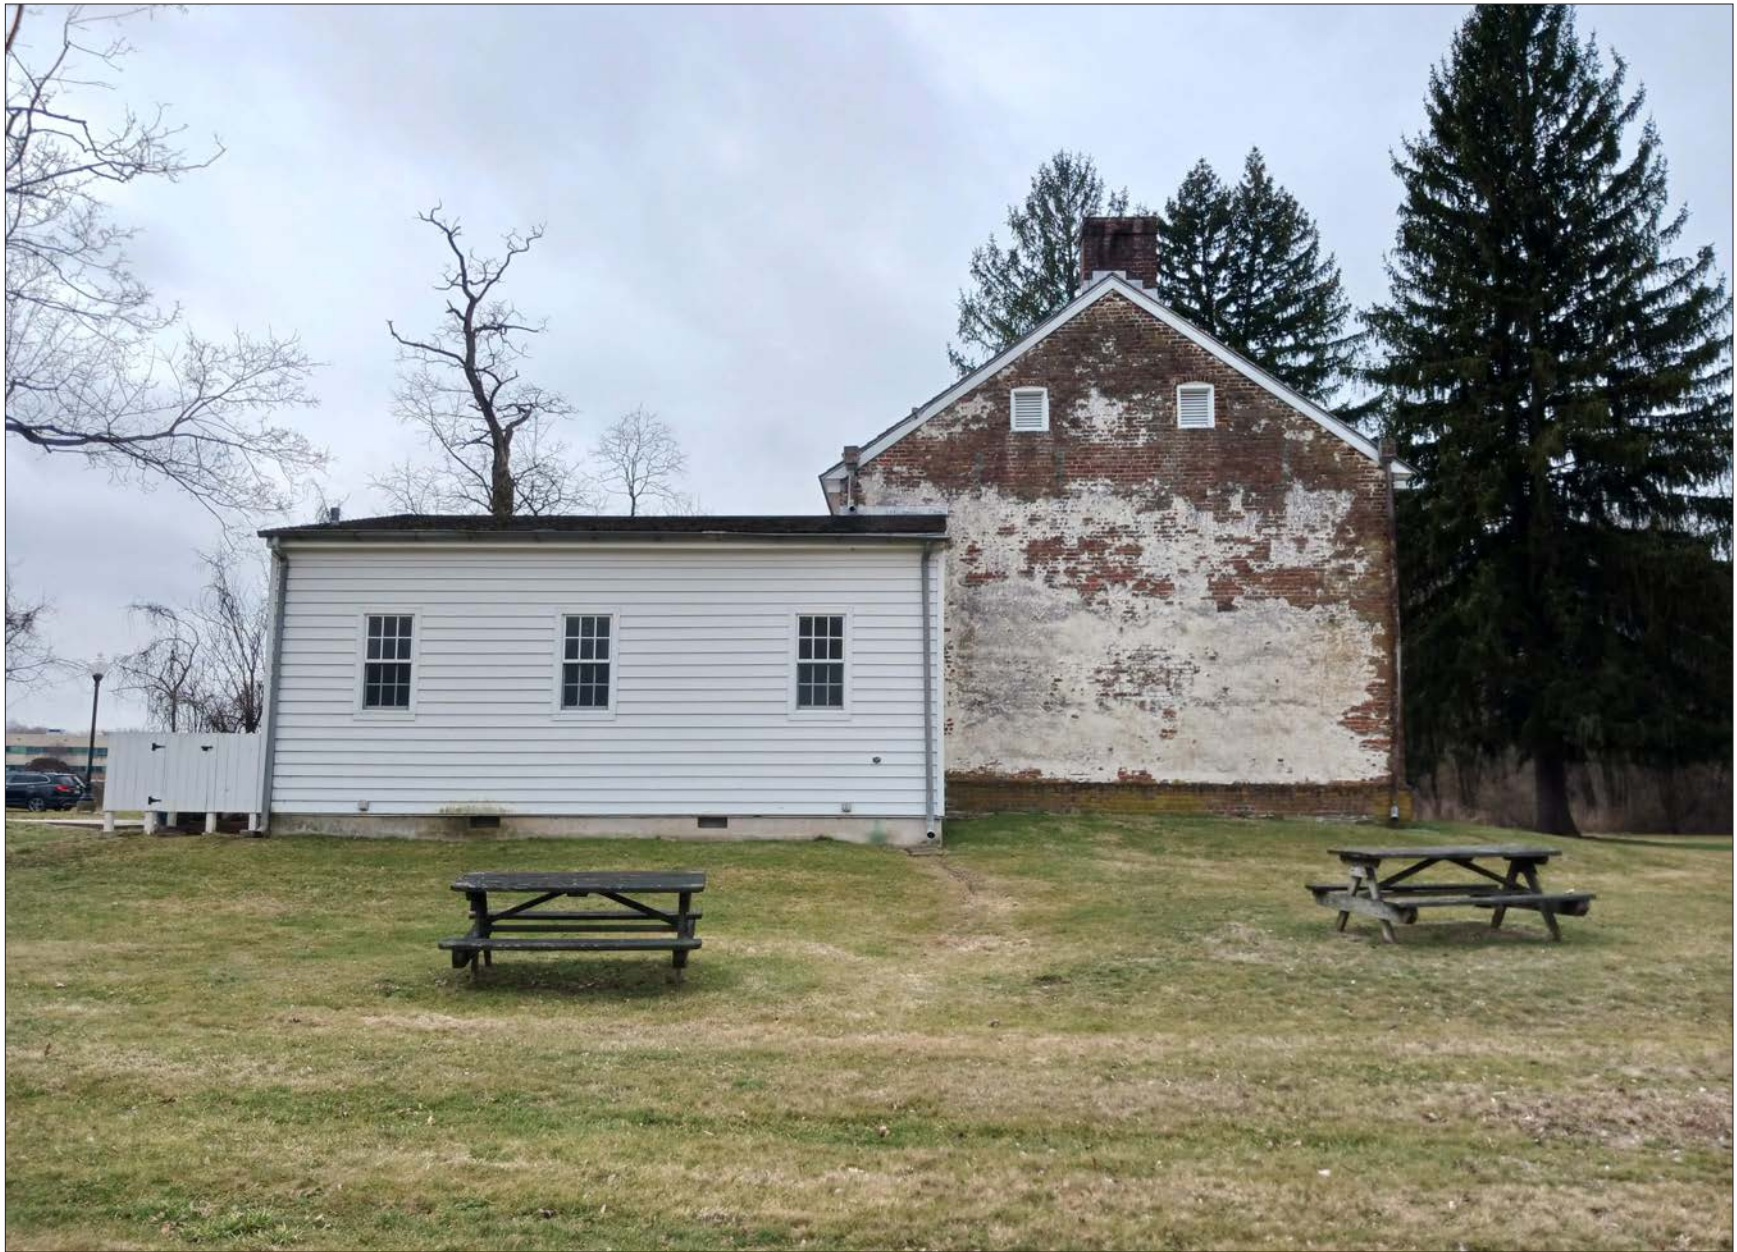
51-1: East elevation of the Brearley House; note the "1761" in vitrified brick below the louvered openings.

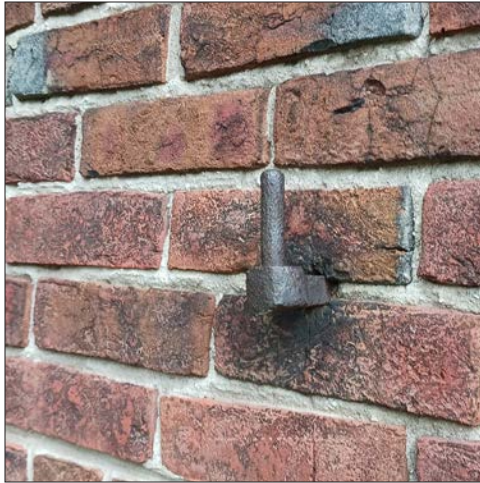
54-1: Miscellaneous metal object embedded in wall; location not associated with window opening or doorway. Function unknown, corrosion could cause damage to mortar and brick face.

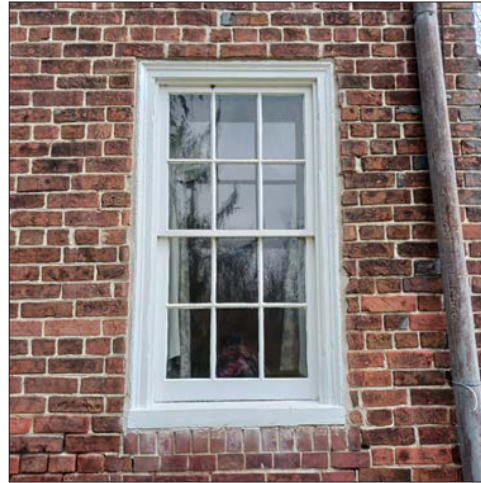
54-2: Efflorescence at window and some spalling bricks around window. Note areas of mortar loss at lower left of image.

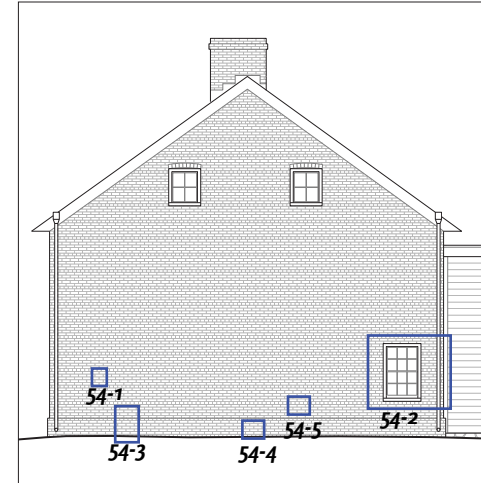
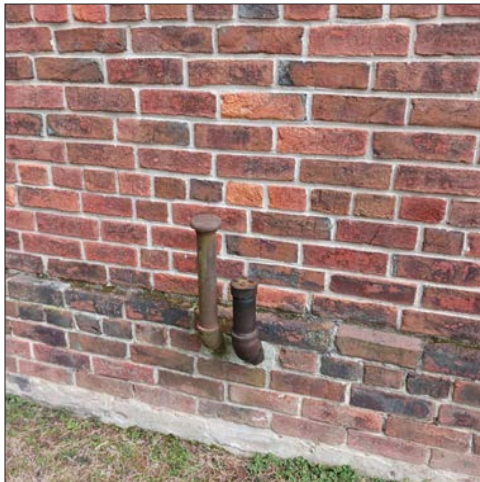
54-3: Pipes protruding from wall. Bricks in wall are spalling and cracked.

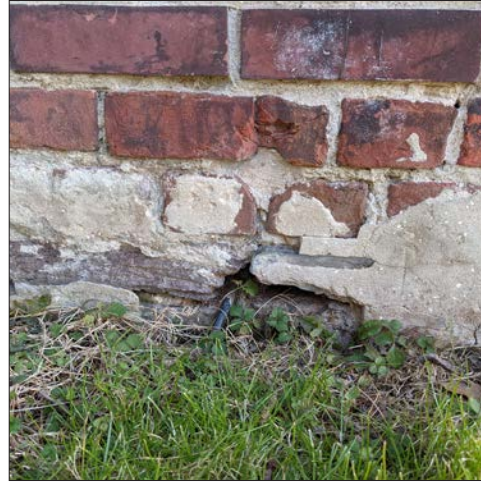
54-4: Gap at base of exterior masonry wall. Stucco coating has been damaged.

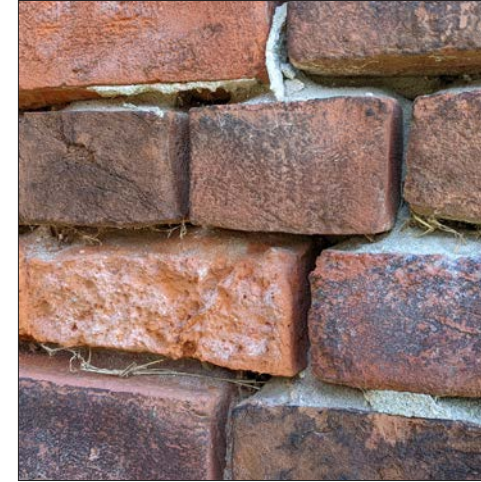
54-5: Mortar and brick detail. Some bricks are spalling and mortar is deteriorating.

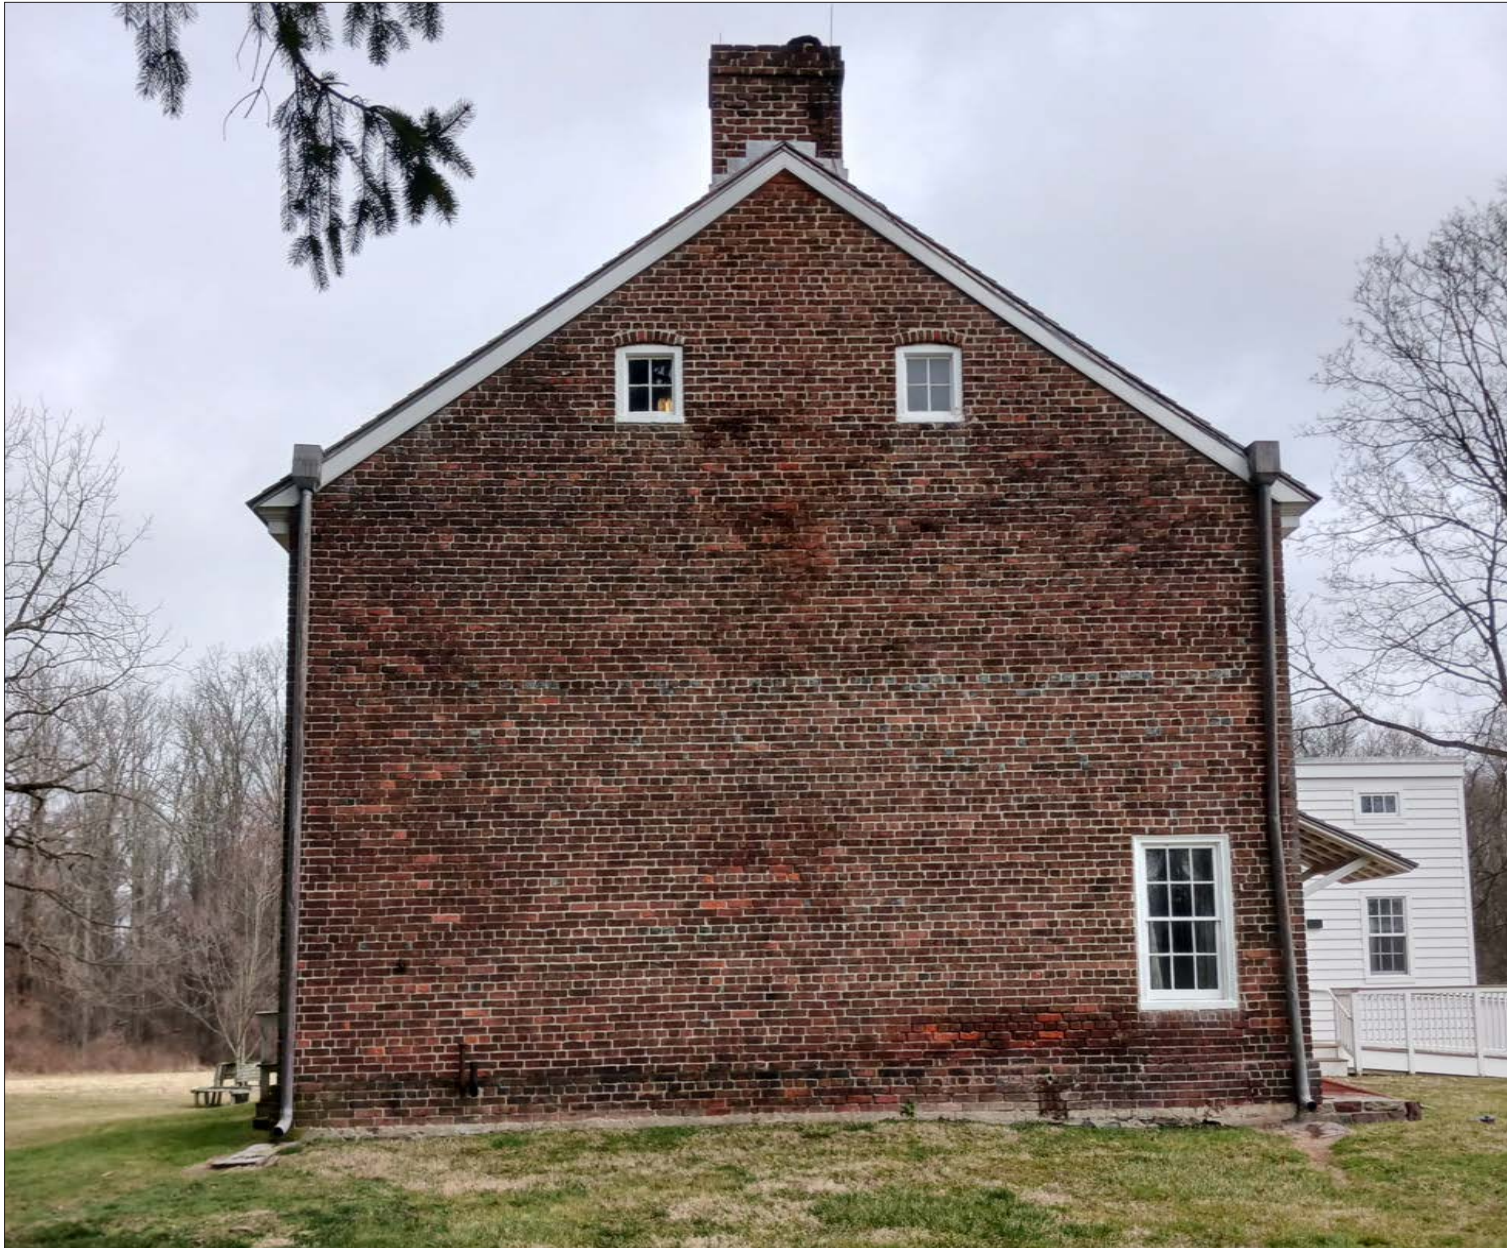
55-1: West elevation of the house.

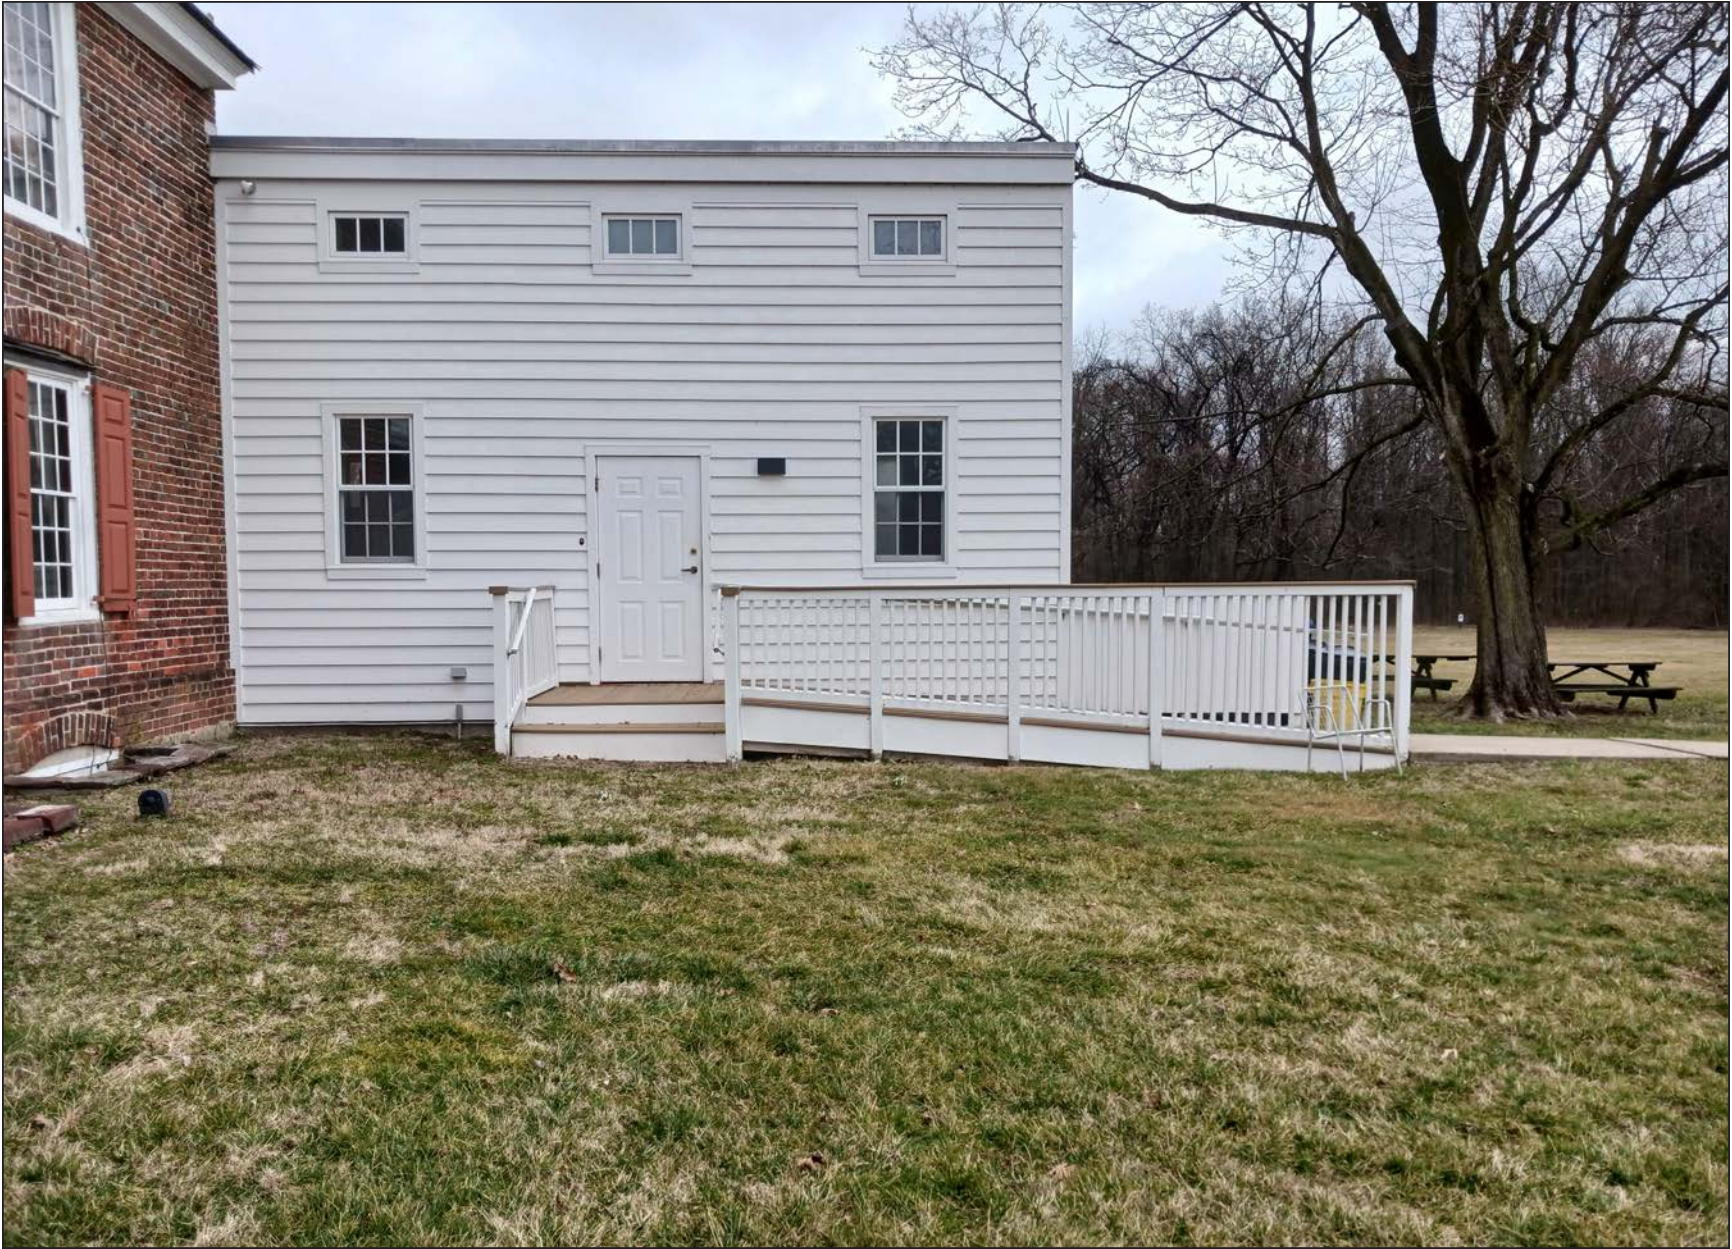
57-1: West elevation of addition showing accessible ramp and steps.

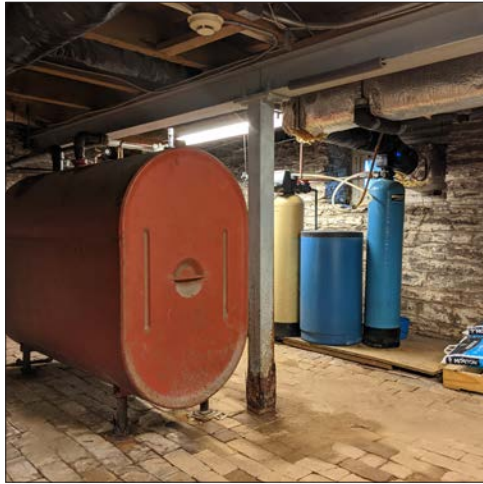
59-1: Existing oil heating unit and water system.

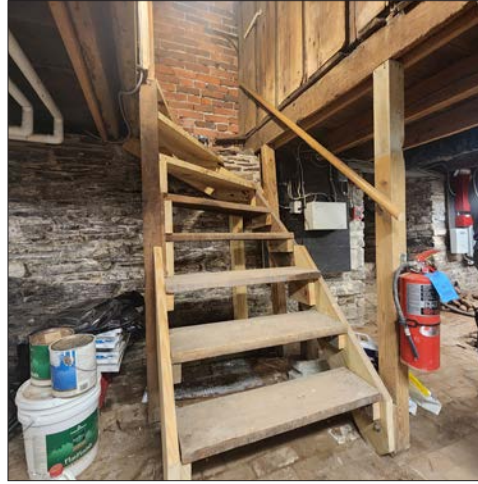
59-5: Steps from basement to first floor. Treads and stringers appear to be recently replaced.

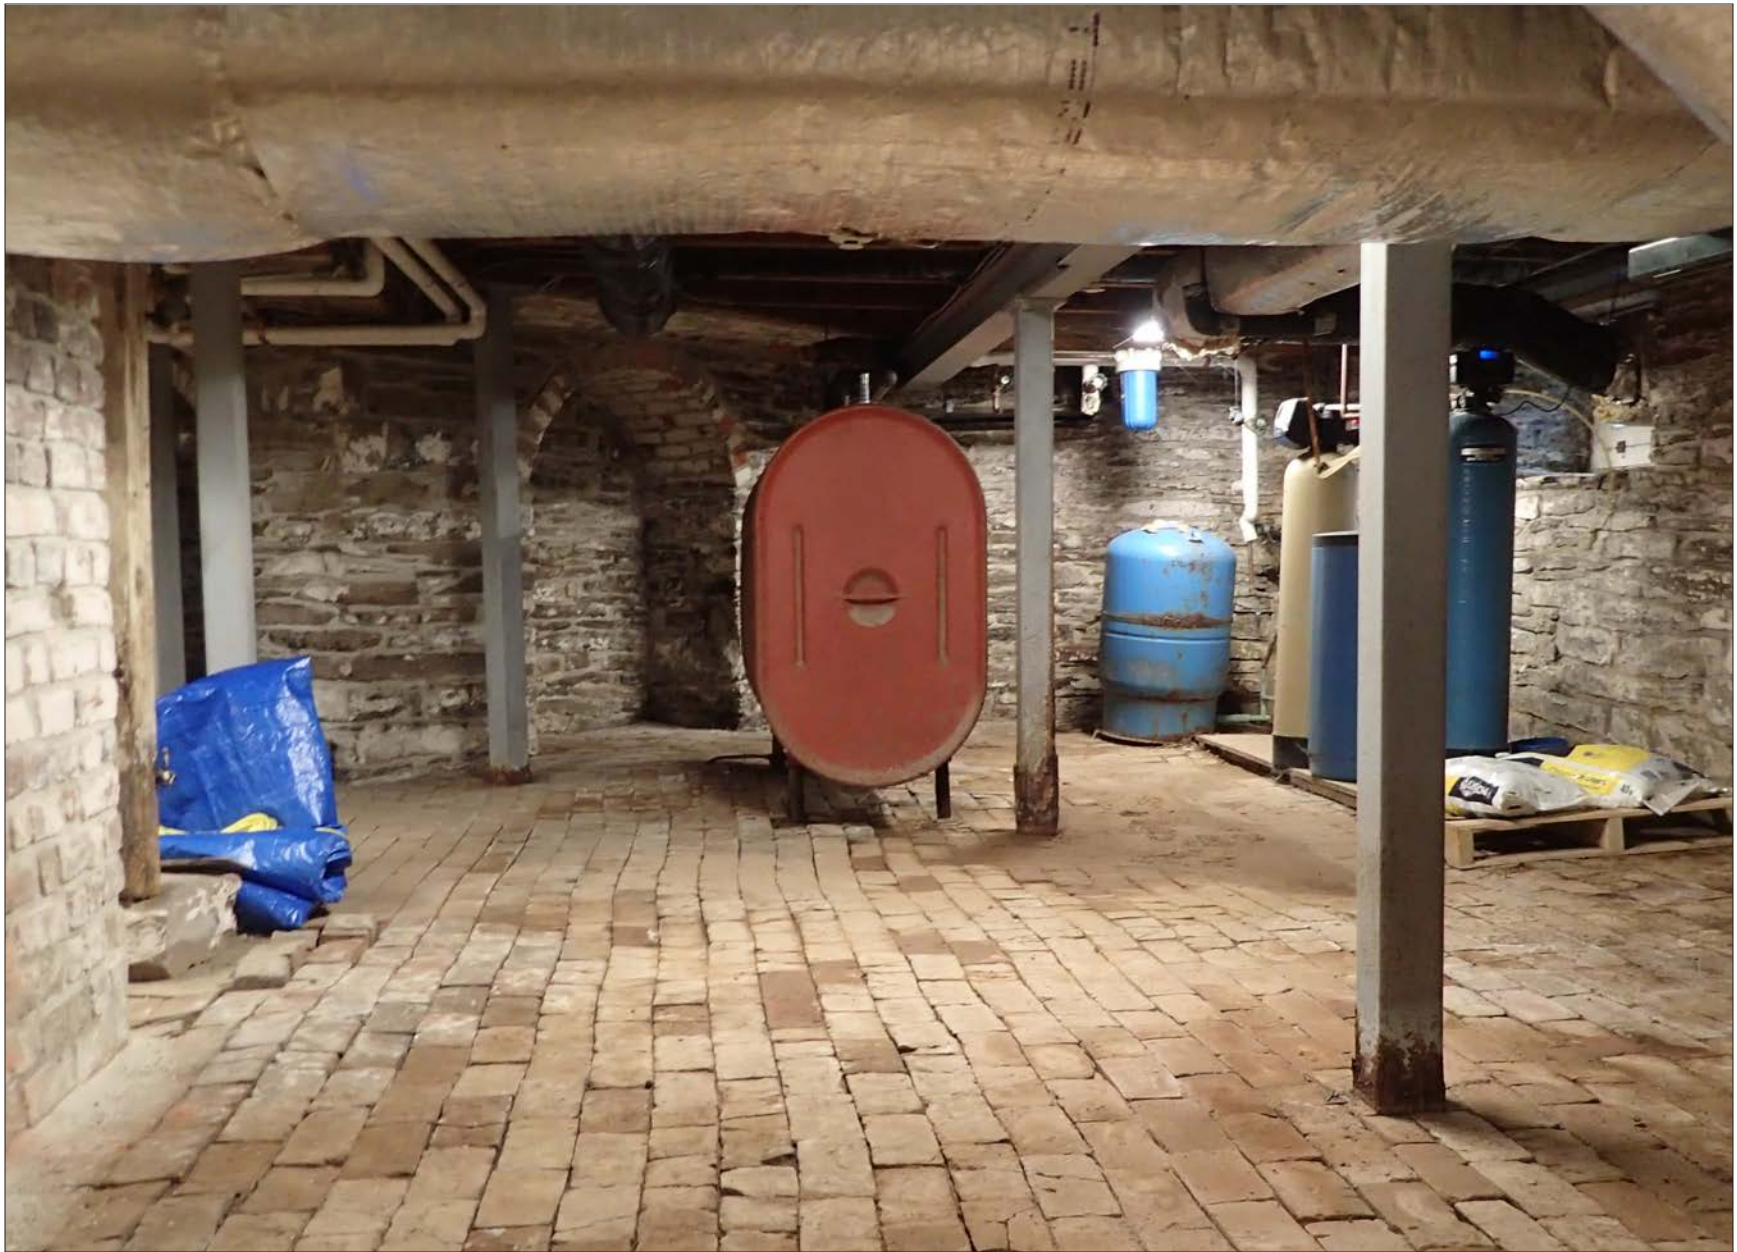
60-1: Building systems equipment, including oil heating and well water systems.
