BREARLEY HOUSE PRESERVATION PLAN

SEPTEMBER 2023

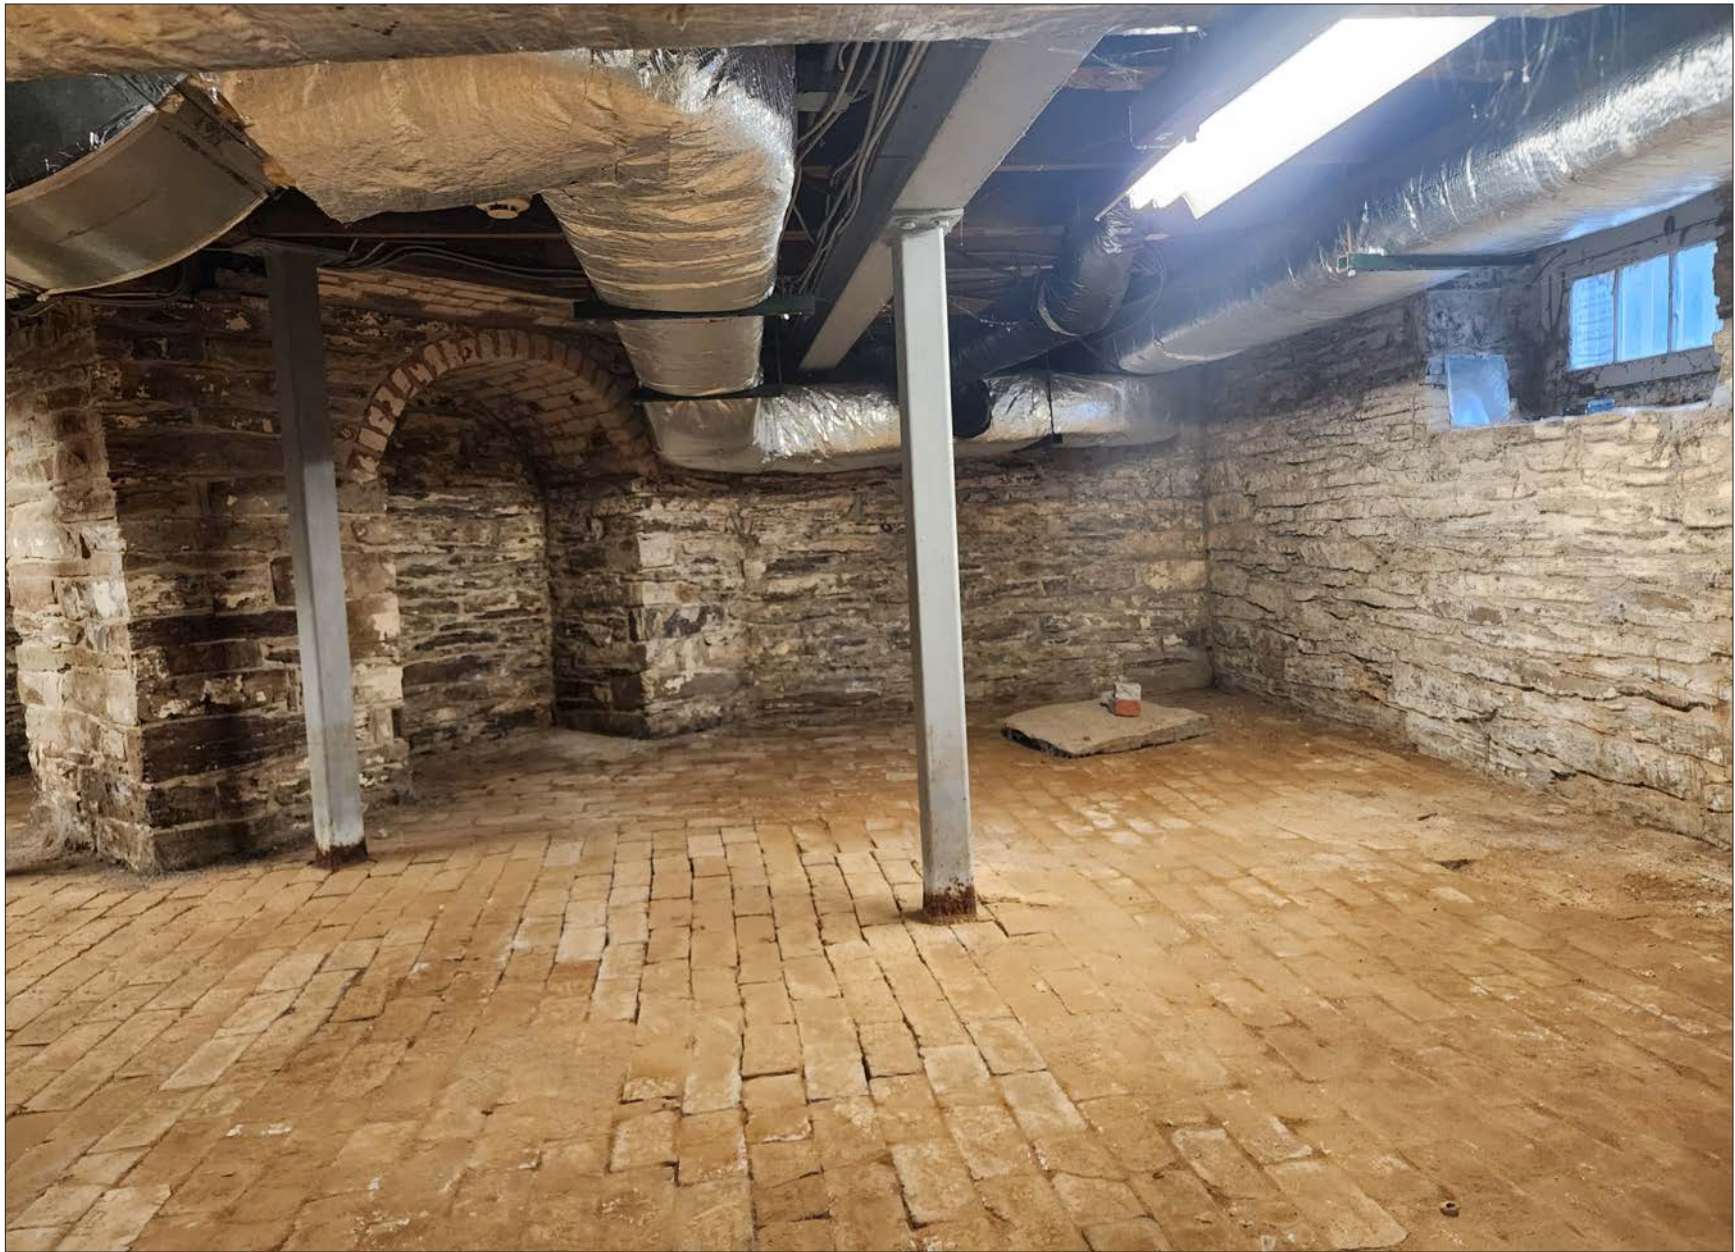
61-1: Existing view of rubble masonry walls and contemporary interventions including steel supports and mechanical ductwork. Flooring is generally dry with sporadic locations and periods of water infiltration.

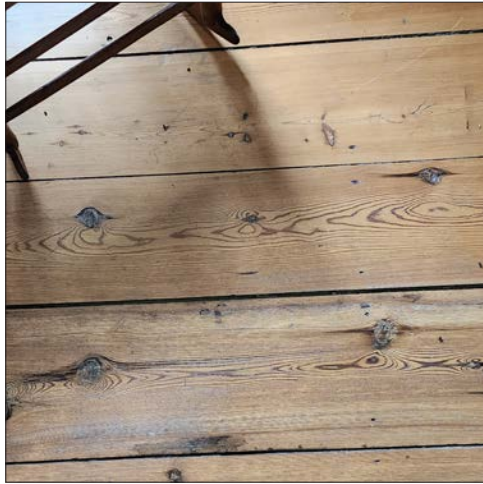
64-1: Original wood flooring exists throughout the house and should continue to be maintained.

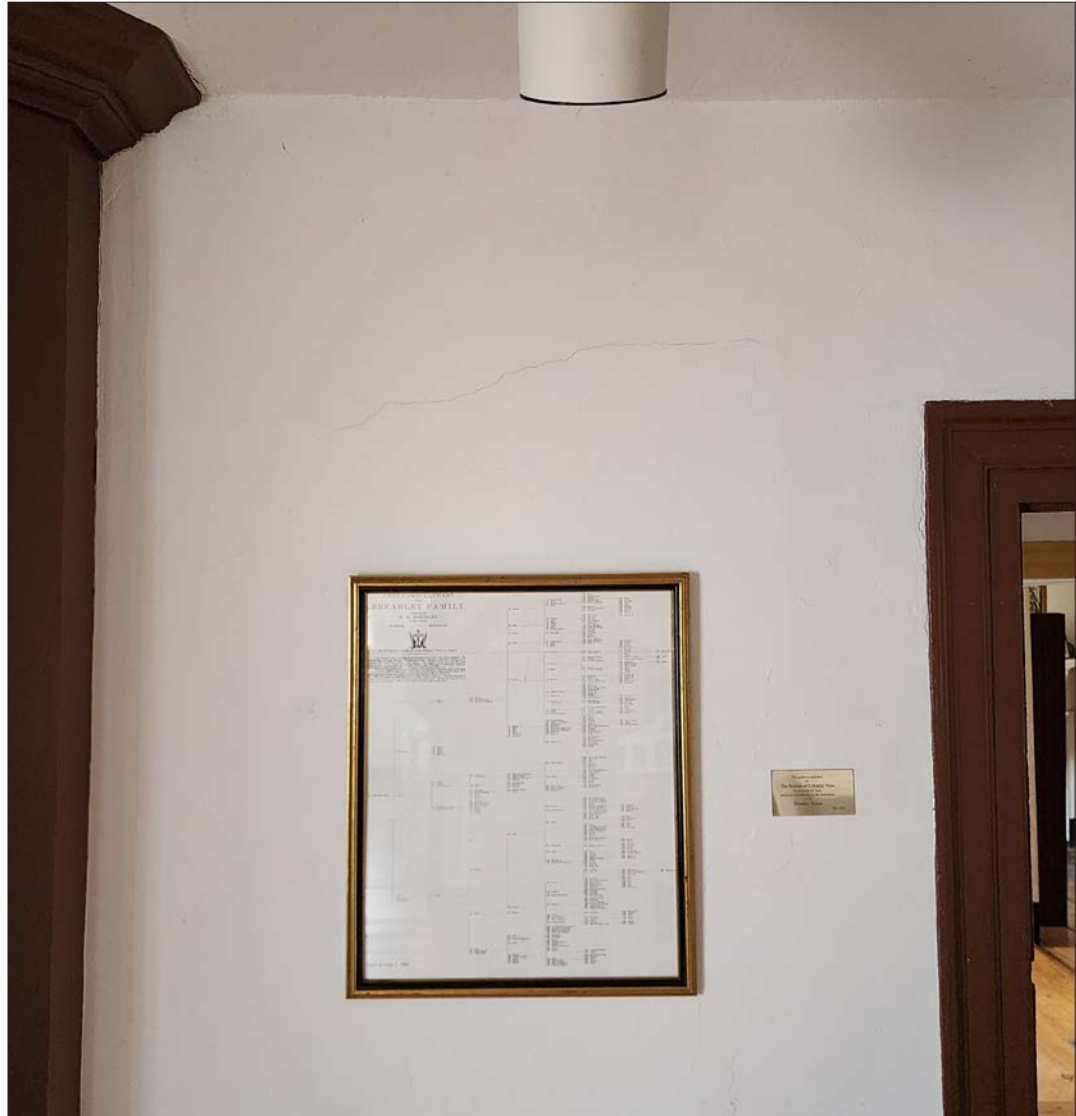
64-3: Plaster at walls is cracking and needs to be repaired.

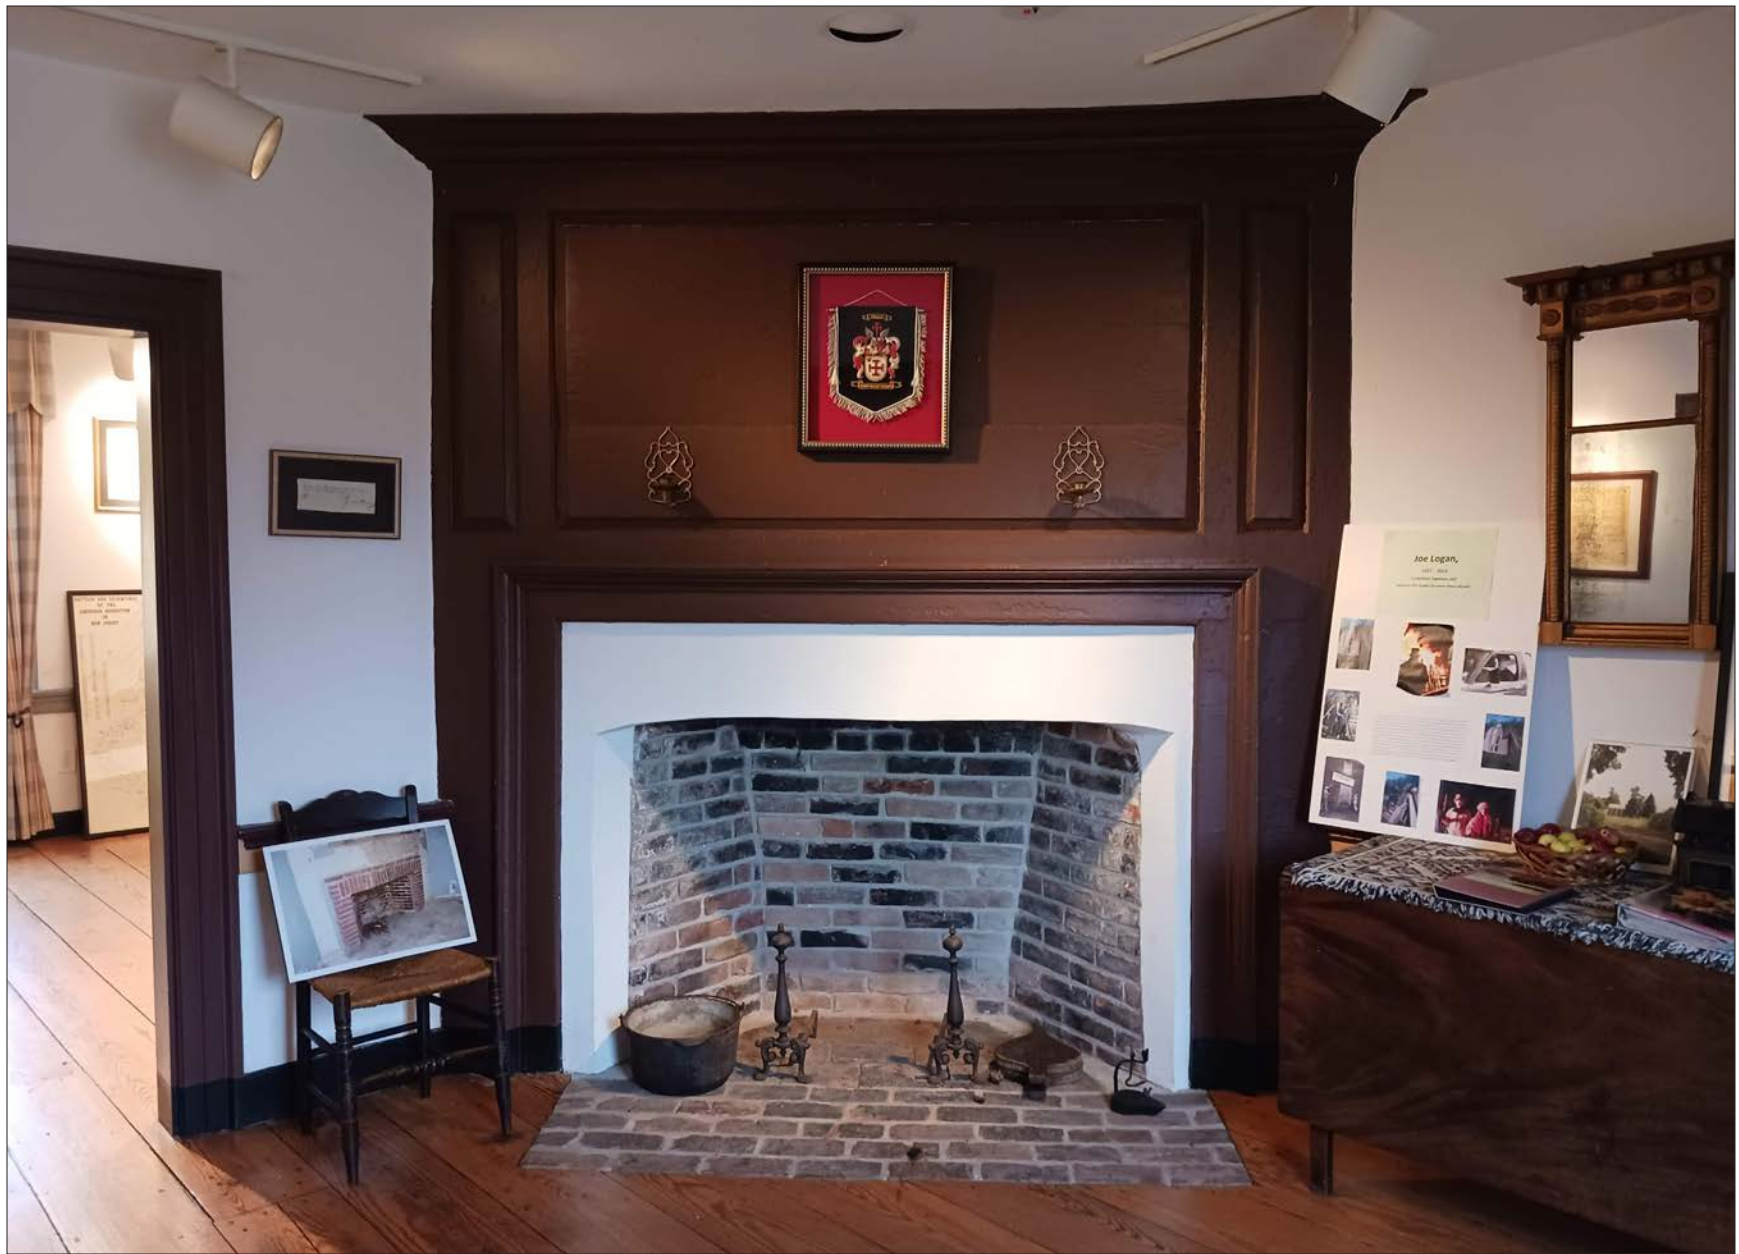
65-1: The original wood paneling should continue to be maintained.

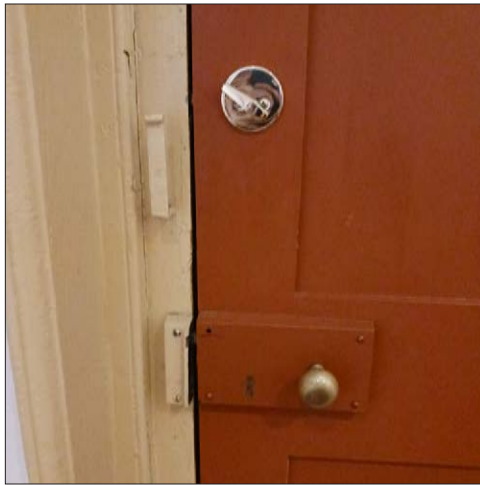
68-1: Modern door hardware.

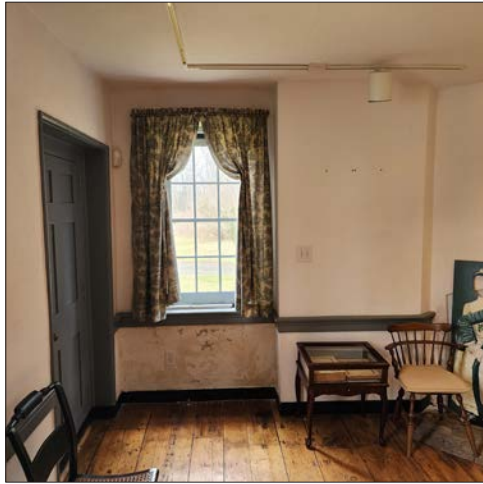
73-1: Significant damage to plaster below windows. Proper investigation needs to occur to mitigate water infiltration.

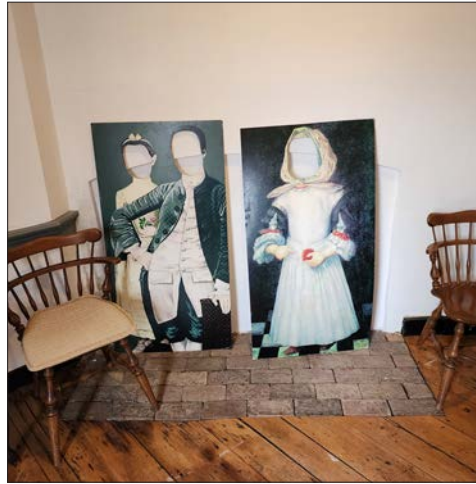
73-2: Fireplace has been covered over and the hearth remains exposed.

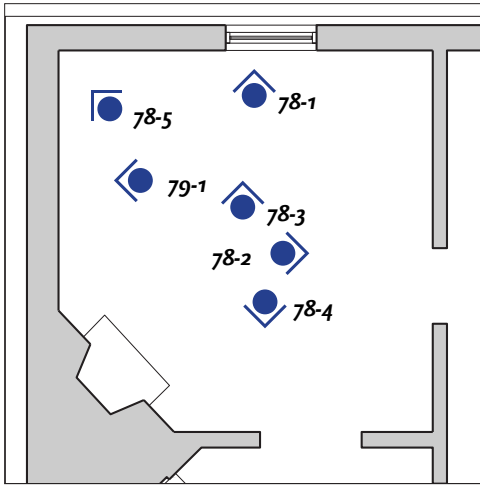
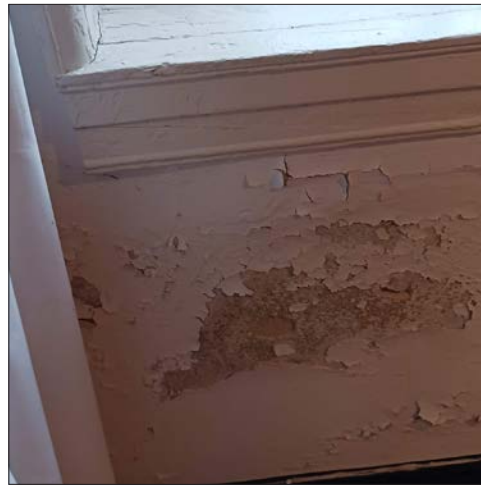
78-1: Peeling of plaster and paint below window.

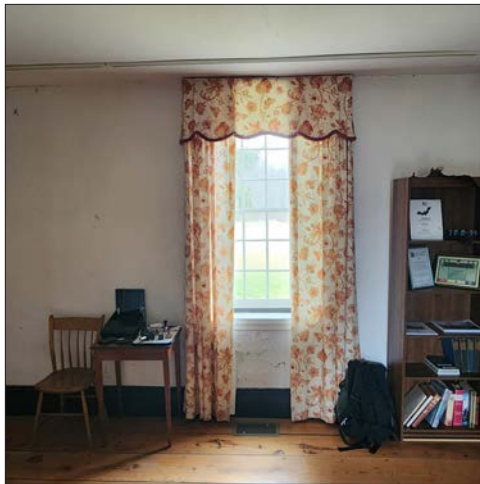
78-3: Significant damage to plaster under windows

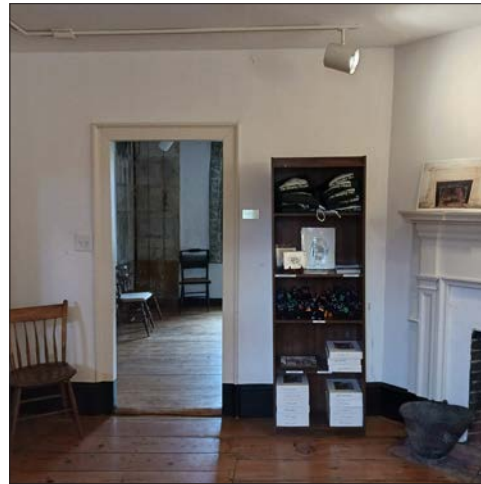
78-4: Cracked paint and plaster around door frame

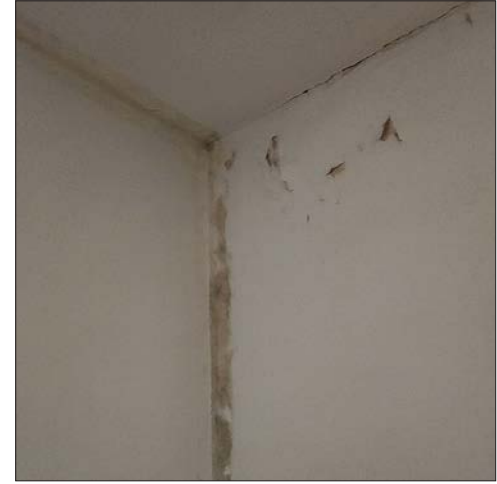
78-5: Peeling paint at corners of wall and ceiling; strip along wall edge removed to show previous paint finishes.

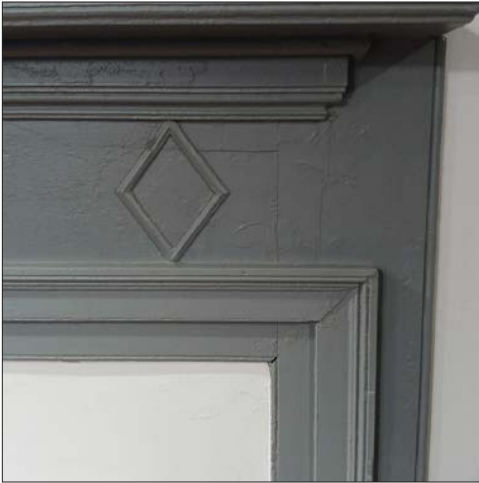
82-1: Detail of mantle woodwork.

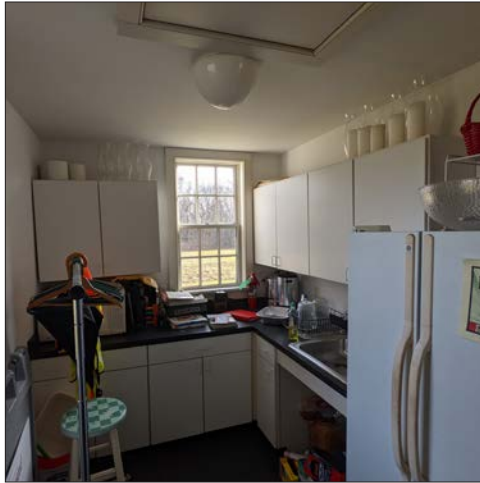
85-1: Kitchenette; linoleum flooring and contemporary cabinets and fixtures.

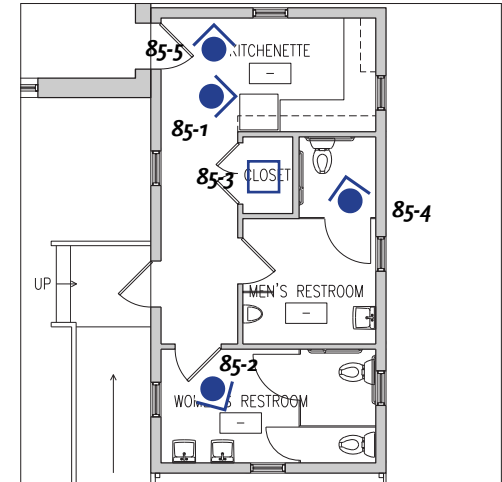
Brearley House - Second Floor Stair Hall (200)

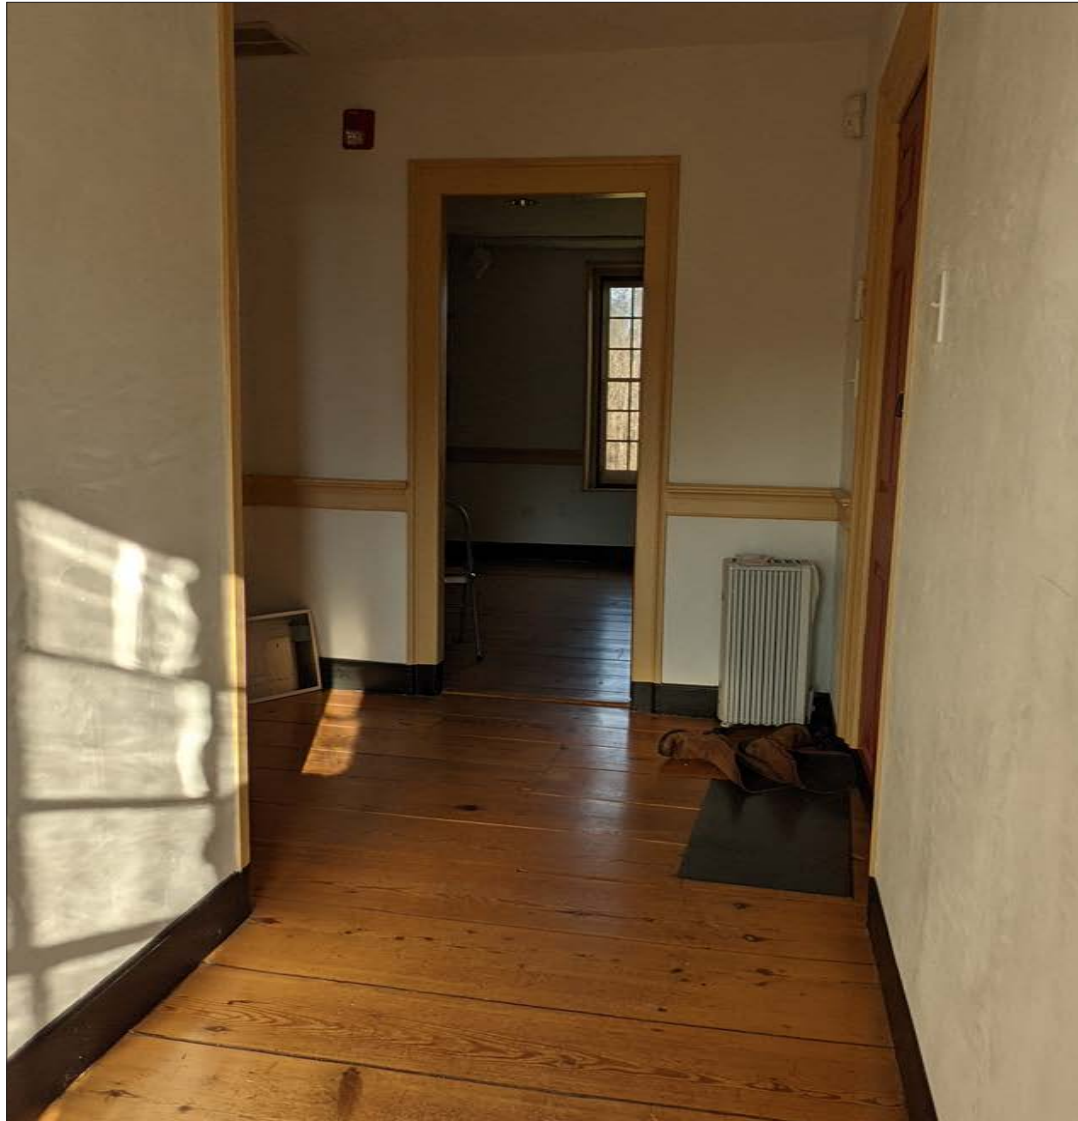
87-1: Overview of the second floor landing looking towards interior.

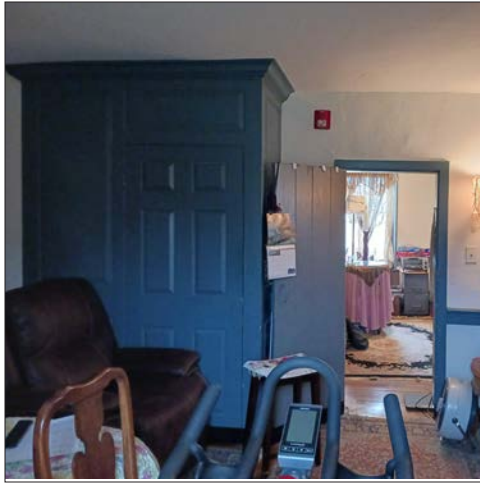
91-1: Door to bathroom from tenant kitchen.

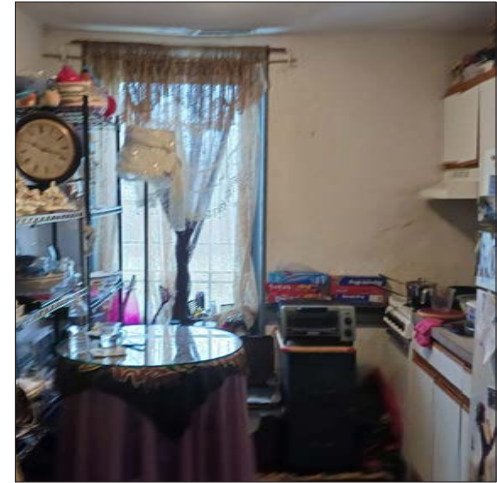
91-3: Existing conditions of the window and plaster at the tenant kitchen.

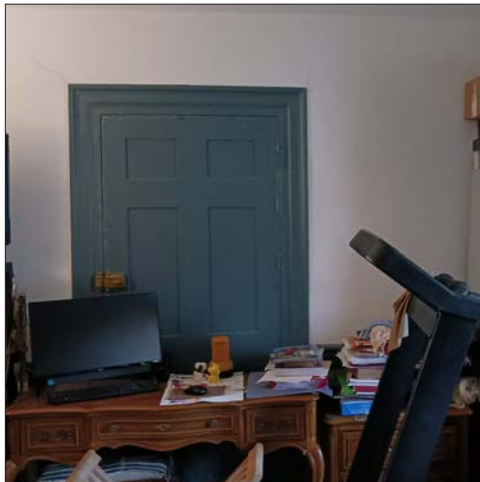
91-4: Locked door between caretaker apartment (205) and Northwest Chamber (203).

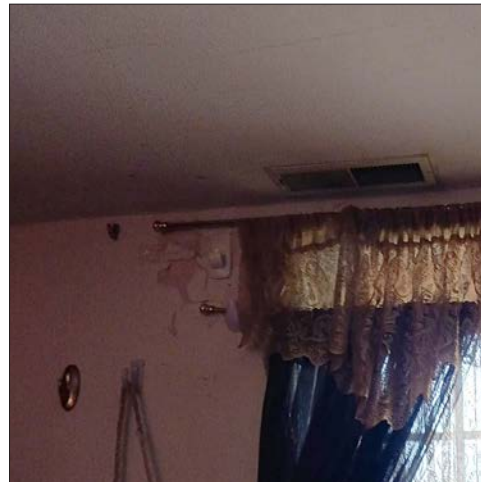
91-5: Failing plaster around window indicates possible water infiltration.

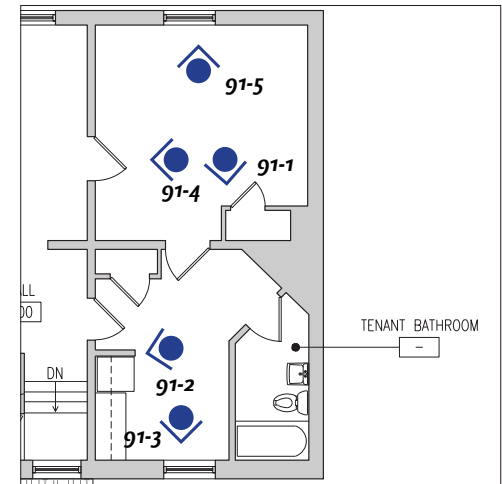
Brearley House - Southwest Chamber (202)

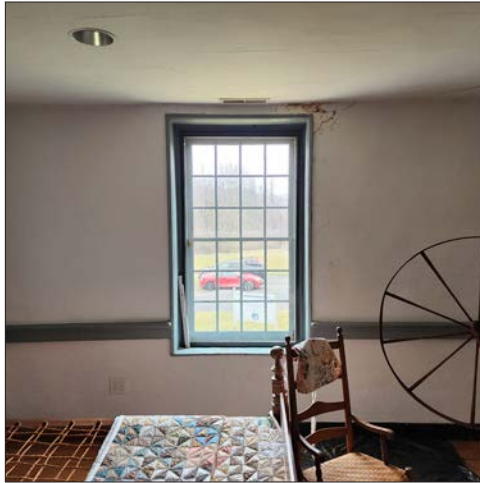
94-1: Cracked plaster ceiling and walls.

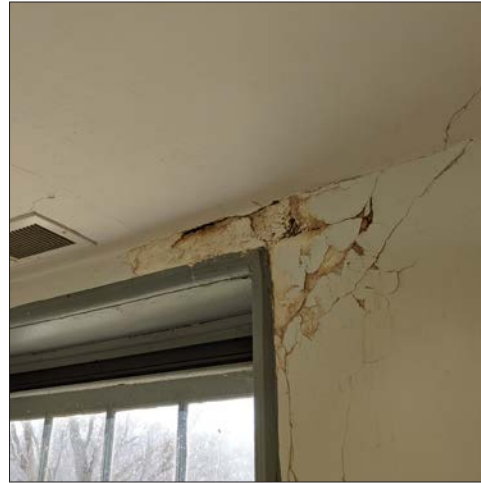
94-2: Cracked and peeling plaster around window head and ceiling.

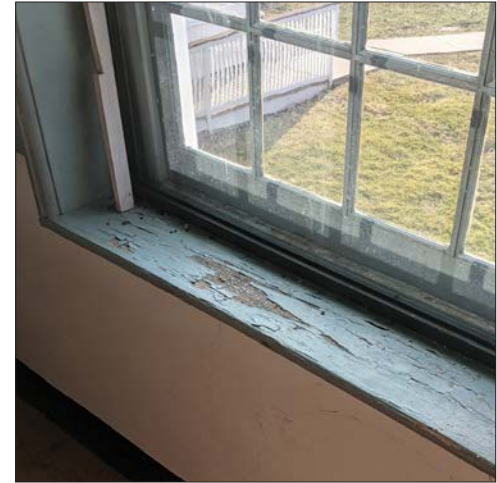
94-3: Paint peeling at window sill.

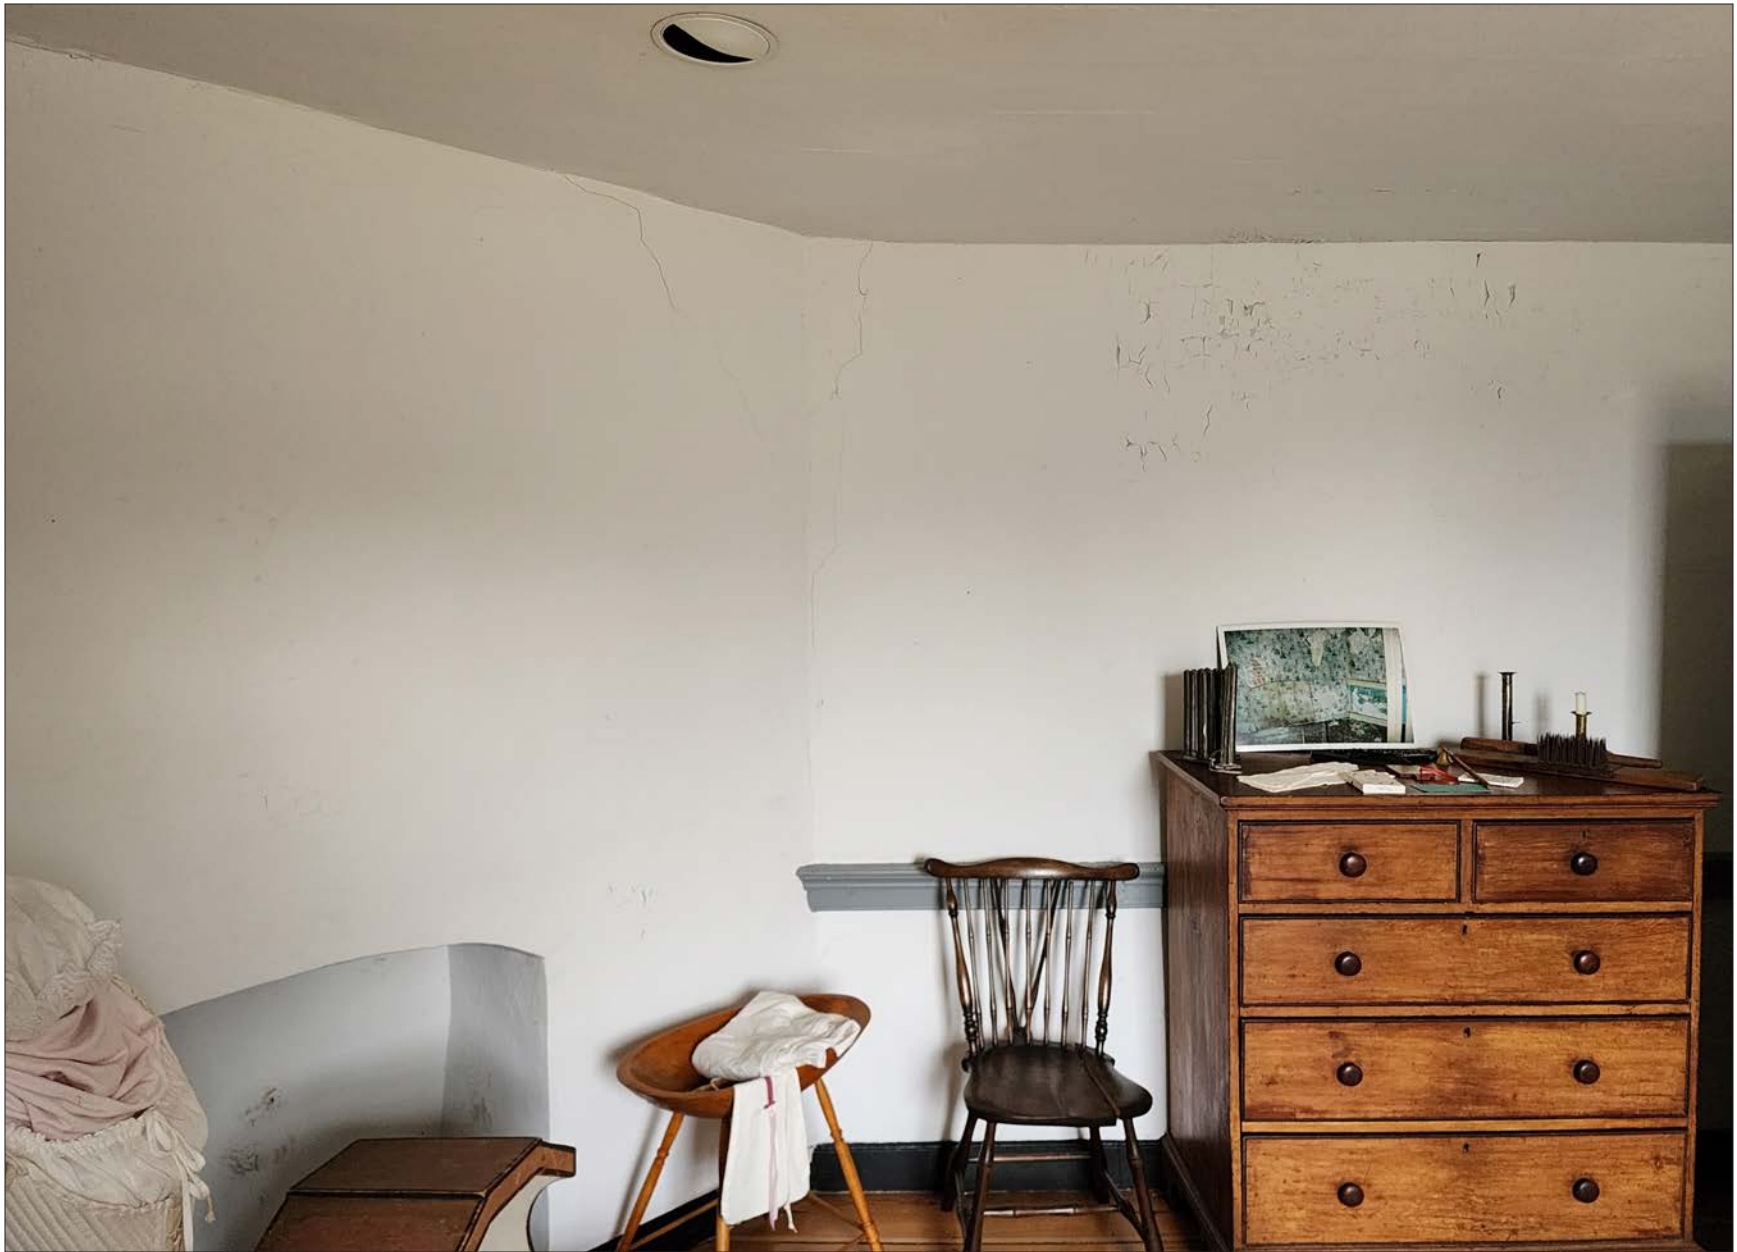
95-1: Plaster cracking above wall. Image placed on period furniture shows room prior to 1999 work.

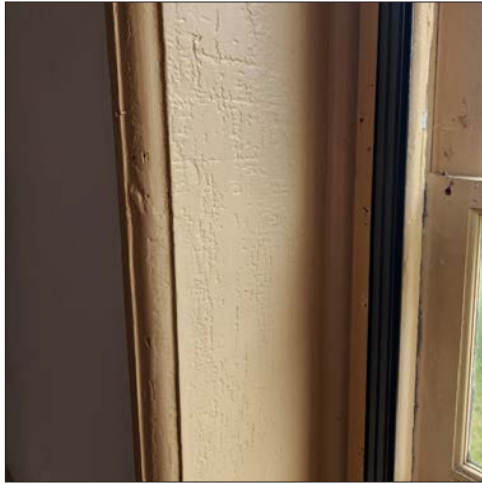
98-1: Scratches and damage to window frame

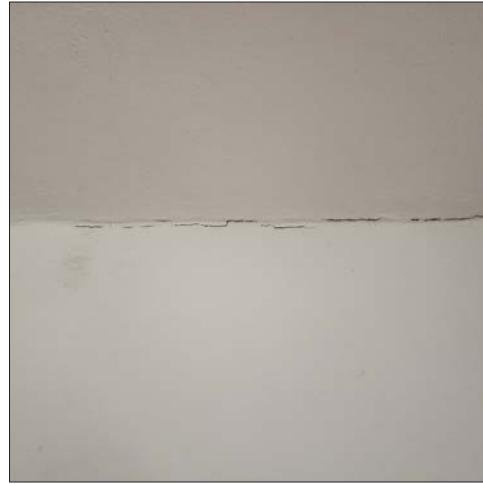
98-2: Cracked plaster at meeting of ceiling and wall

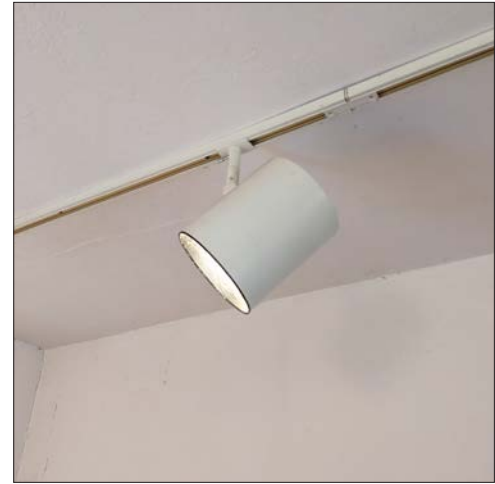
98-3: Track lighting dates to 1999.

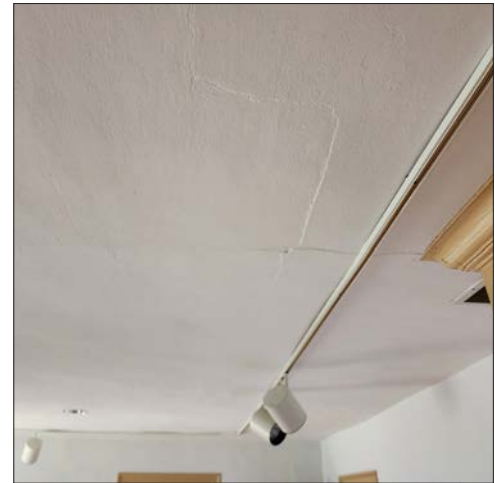
98-5: Cracks in ceiling plaster.

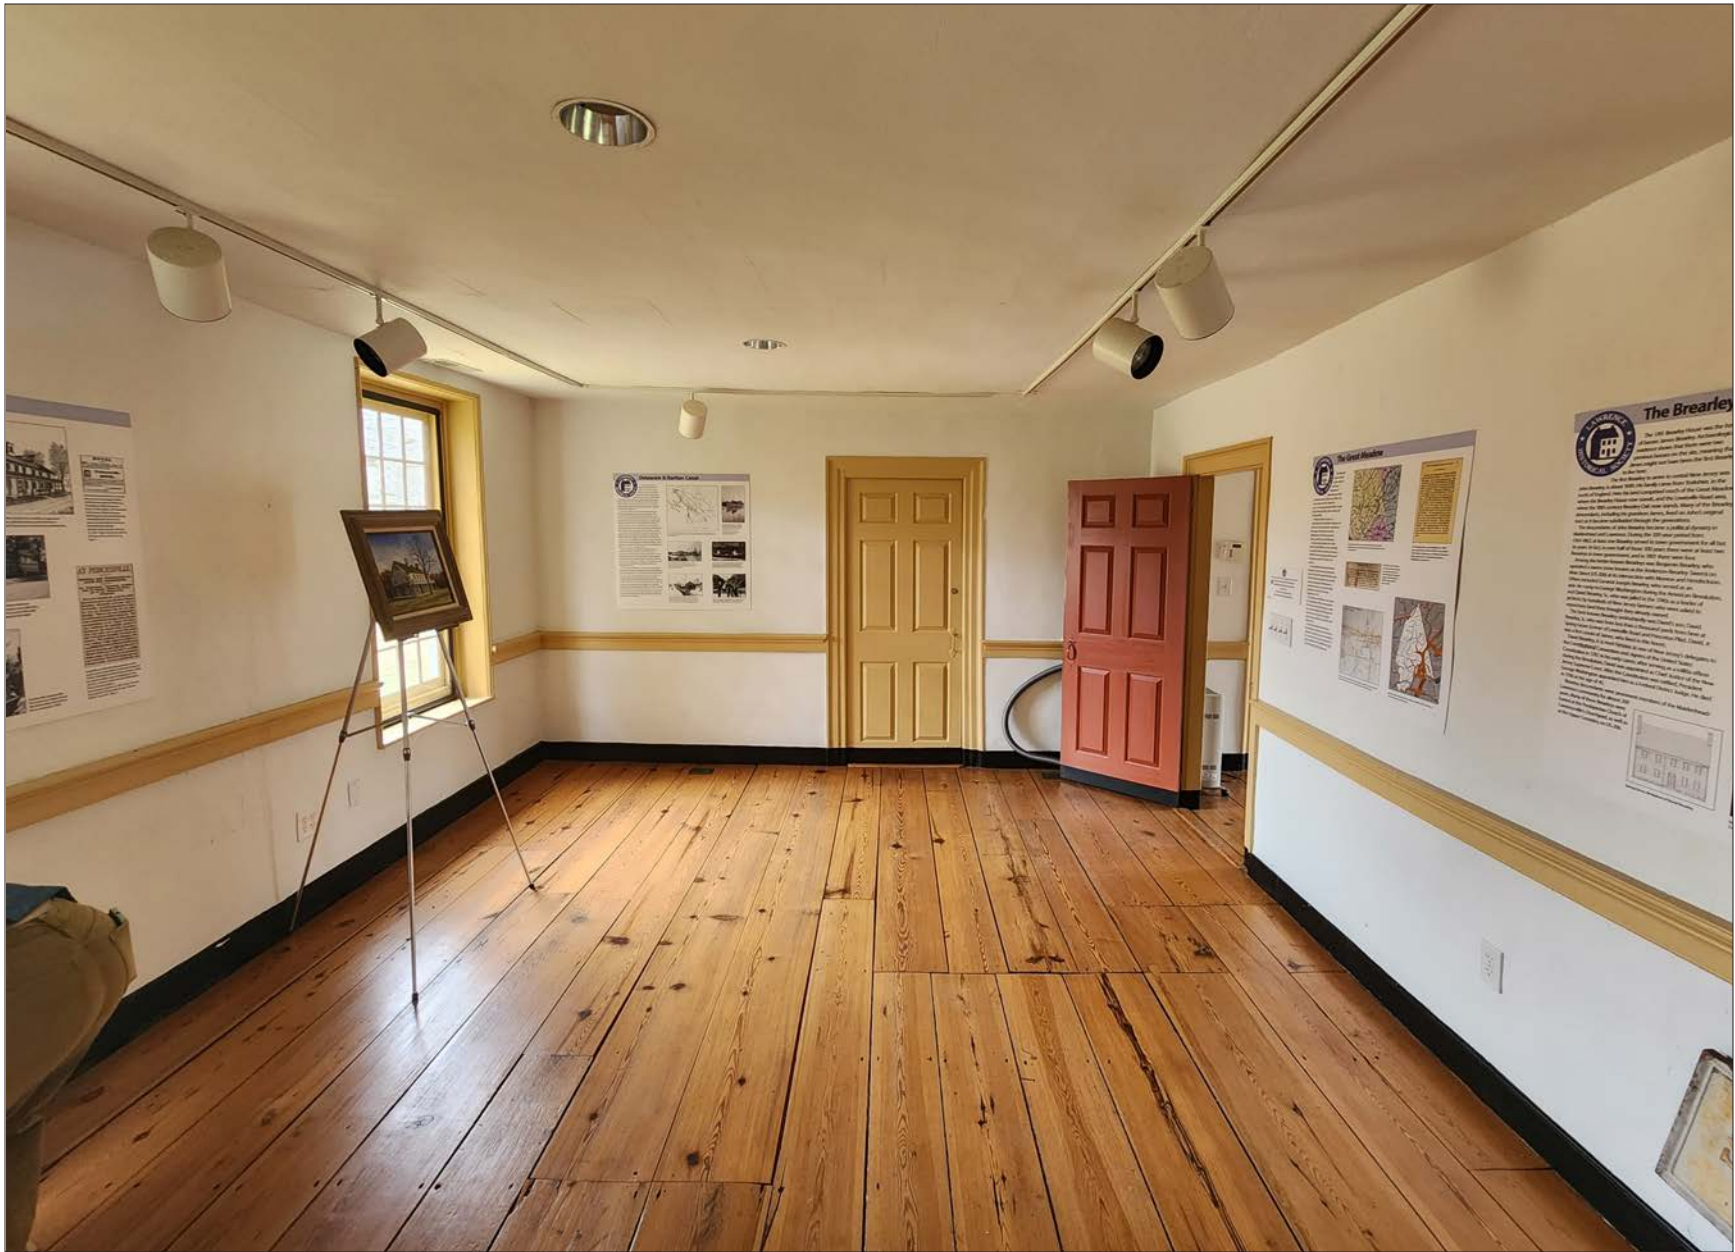
99-1: Original floorboards, closets, and frame are original and should be maintained.

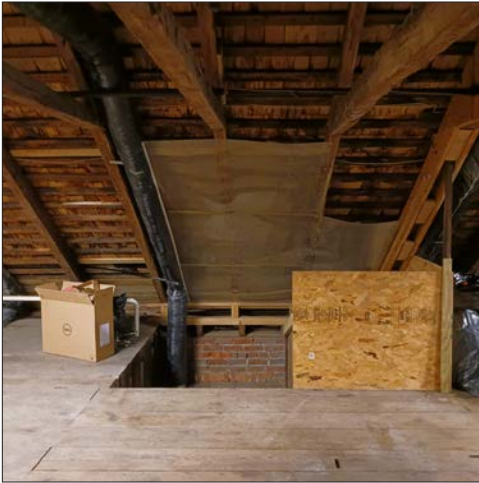
101-1: Stairway to second floor. Plastic sheeting has been installed to the roof joists.

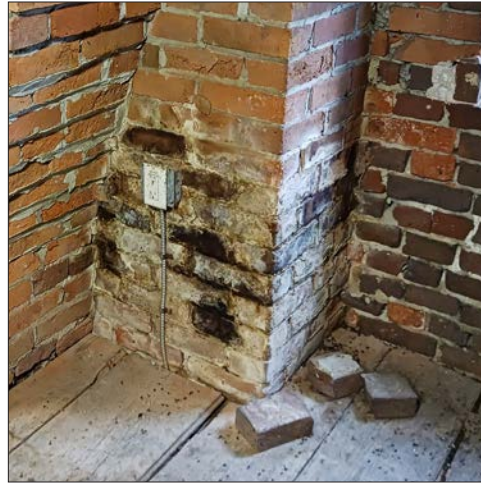
101-2: Efflorescence and damaged bricks in the chimney as seen at the attic level.

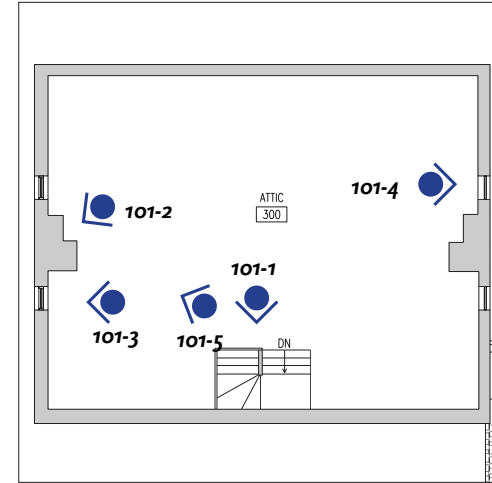
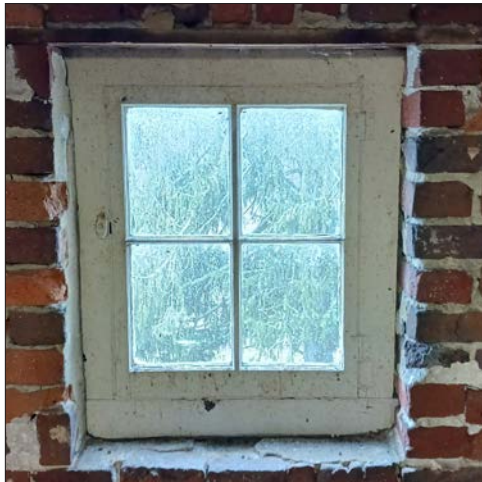
101-3: Typical attic casement window.

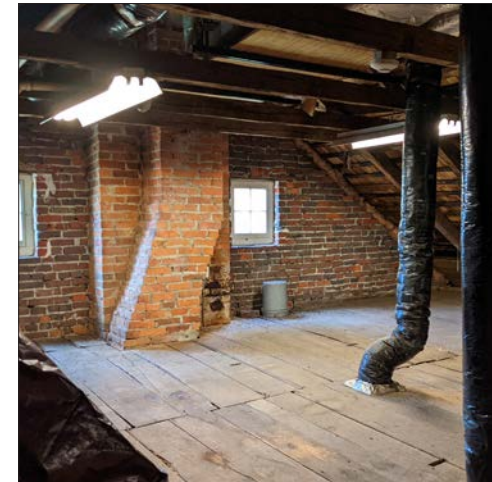
101-5: View of gable end and chimney showing spalling of bricks.

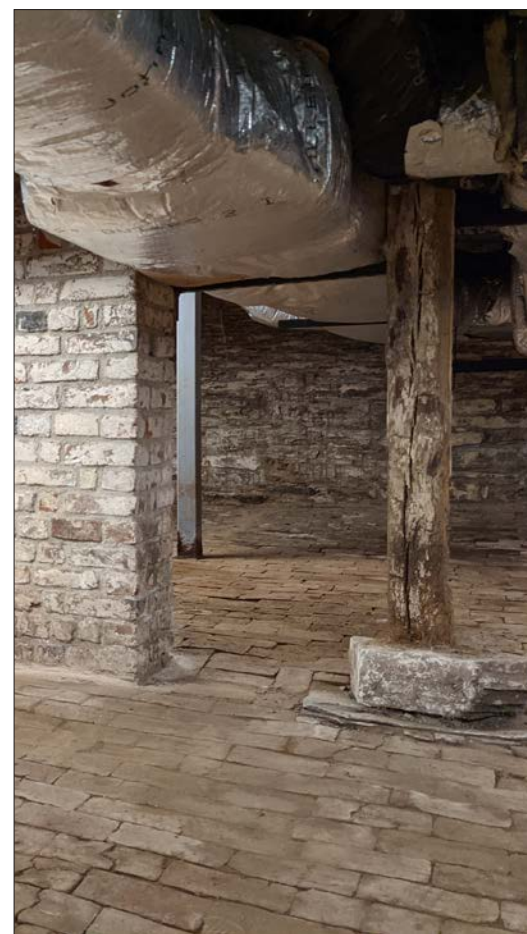
103-1: View of basement showing wood, brick, and steel structural columns.

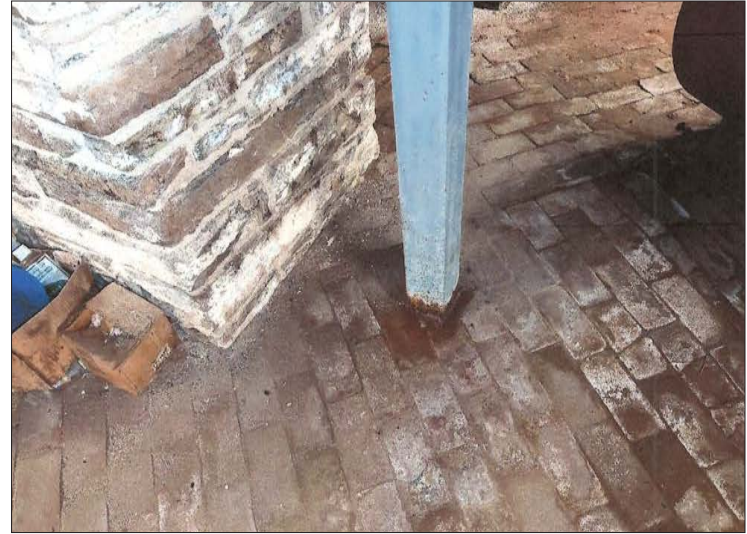
104-2: The only structural defect identified was the rusting at the base of the new steel columns in the basement.

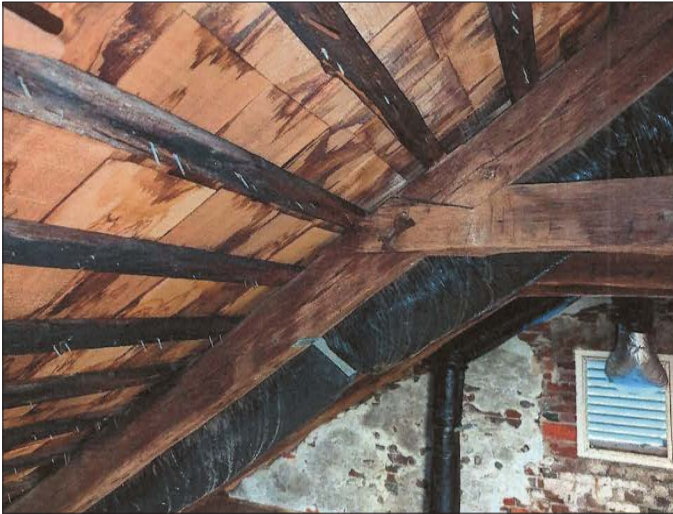
104-3: The roof framing is in good condition and is adequately supporting anticipated gravity and lateral loading conditions.

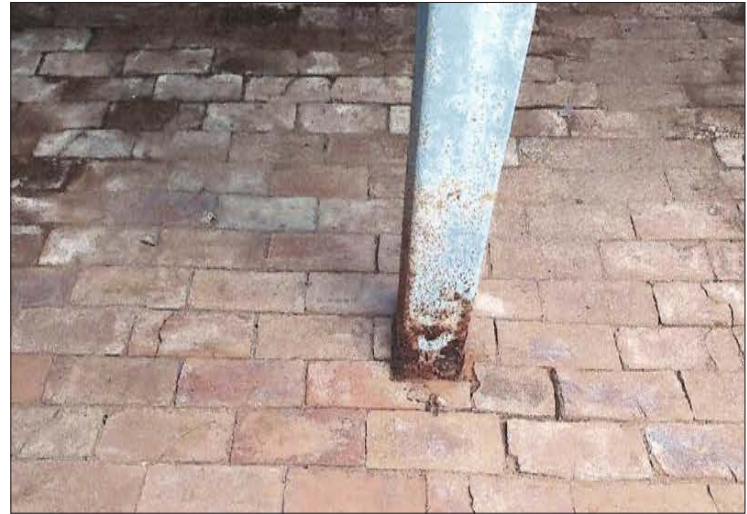
104-4: The only structural defect identified was the rusting at the base of the new steel columns in the basement.

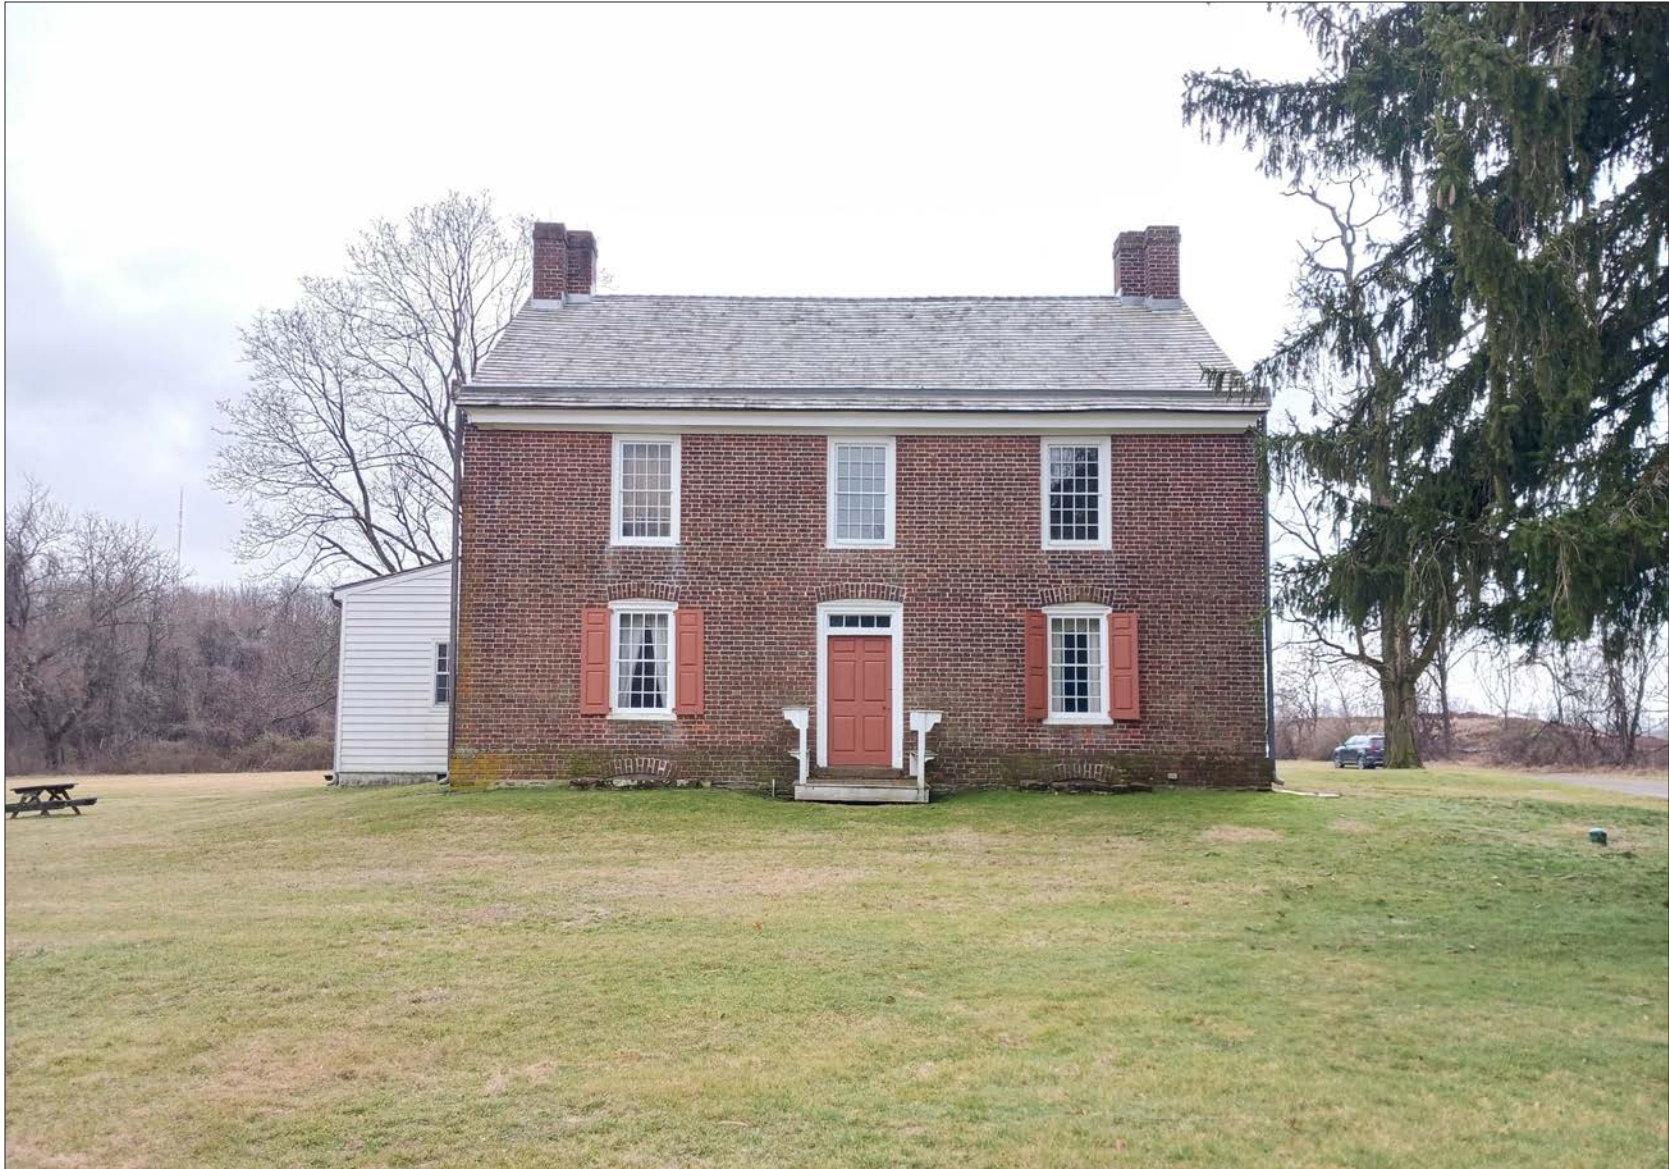
105-1: The building is a multi-wythe brick masonry wall bearing structure,

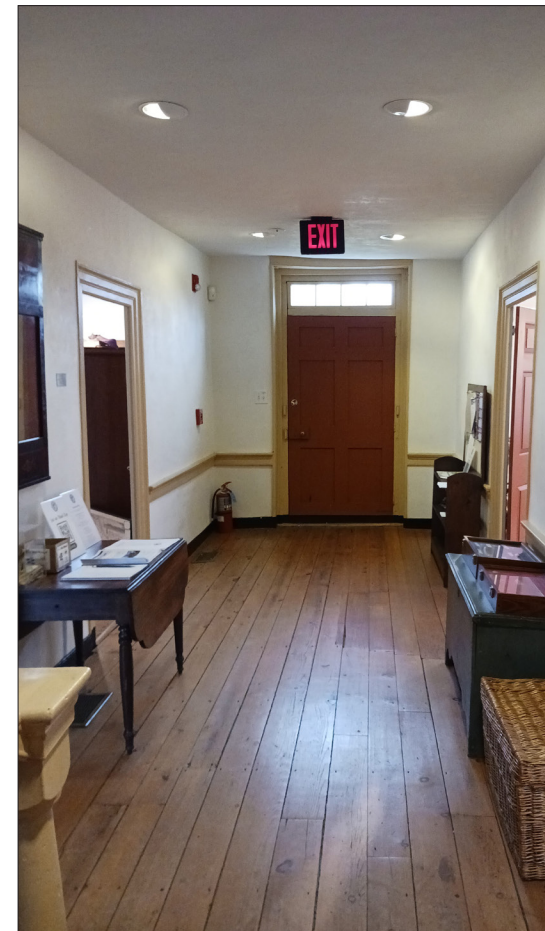
107-1: Center Hall (Room 100) facing North.

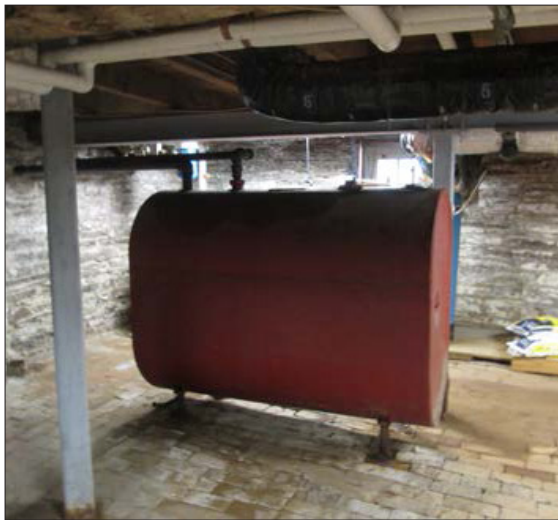
108-2: Fuel oil storage system

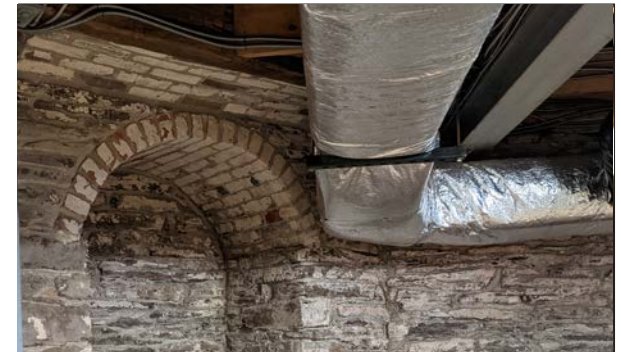
109-1: First floor fan coil and distribution ducts
