BREARLEY HOUSE PRESERVATION PLAN

SEPTEMBER 2023

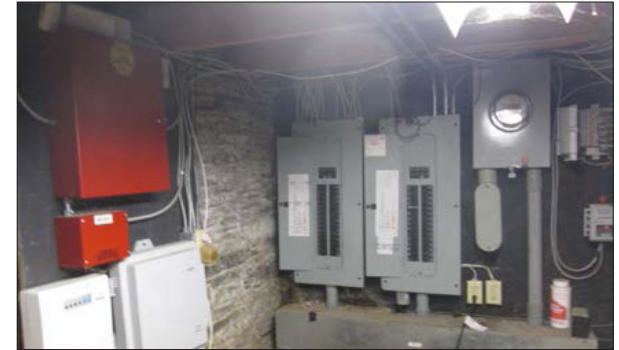
111-1: Circuit breakers

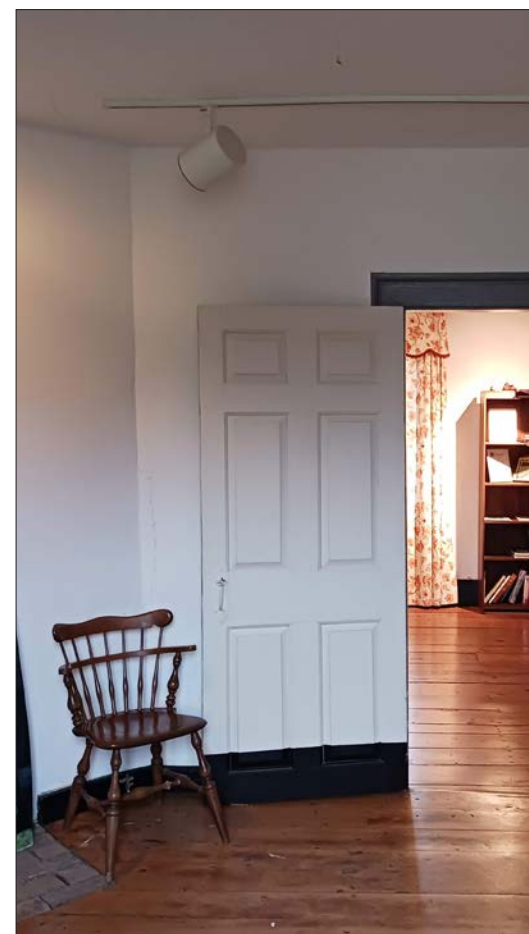
113-1: North-facing view from Southwest Parlor (Room 103) into Northwest Parlor (Room 104).

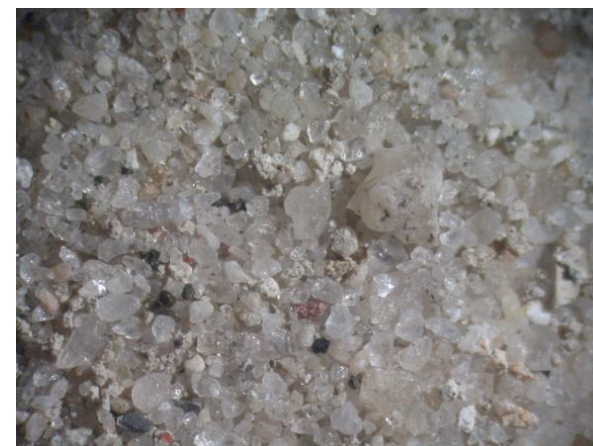
115-1: Sample 1, photomicrograph of extracted sands at 10x magnification in reflected light.

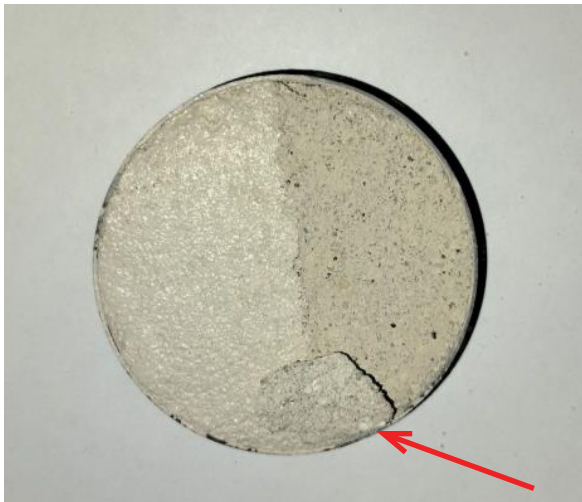
116-1: Sample 1, brick mortar (arrow, chip at bottom of disc) and replication (left half struck, and right half prepared to resemble effect of aging/weathering.

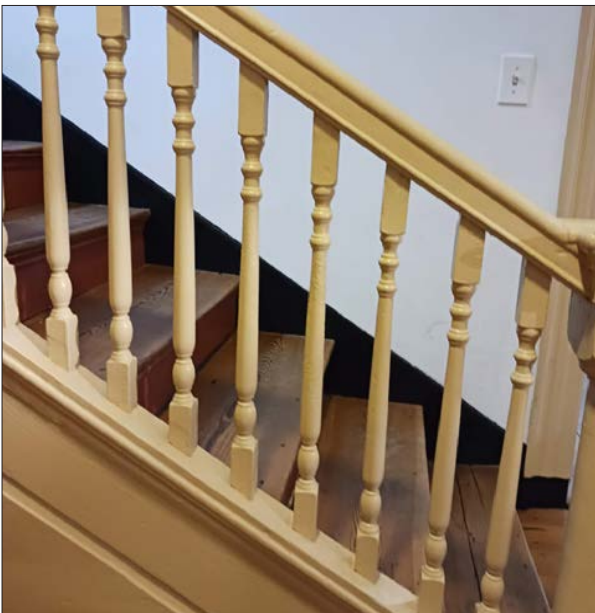
136-2: Stair balustrade

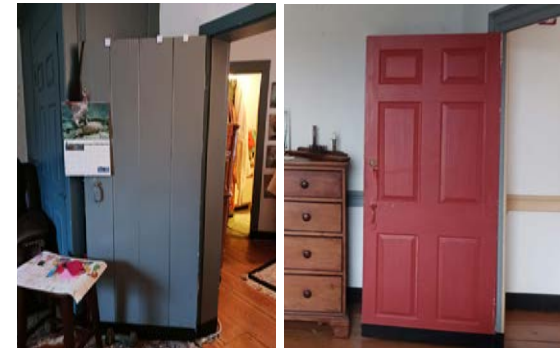
137-1, 137-2: Second floor doors

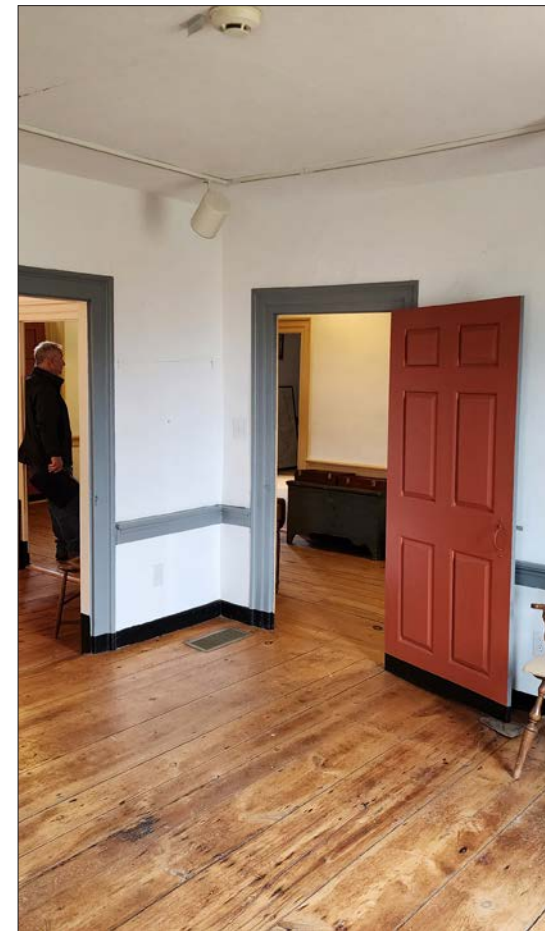
141-1: View from Southwest Parlor (Room 103) to Northwest Parlor (Room 104) and Center Hall (Room 100)

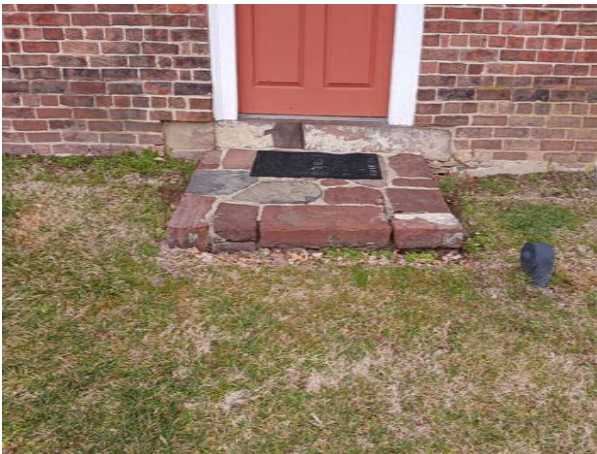
142-2: Stone steps into the south side of the Brearley House.

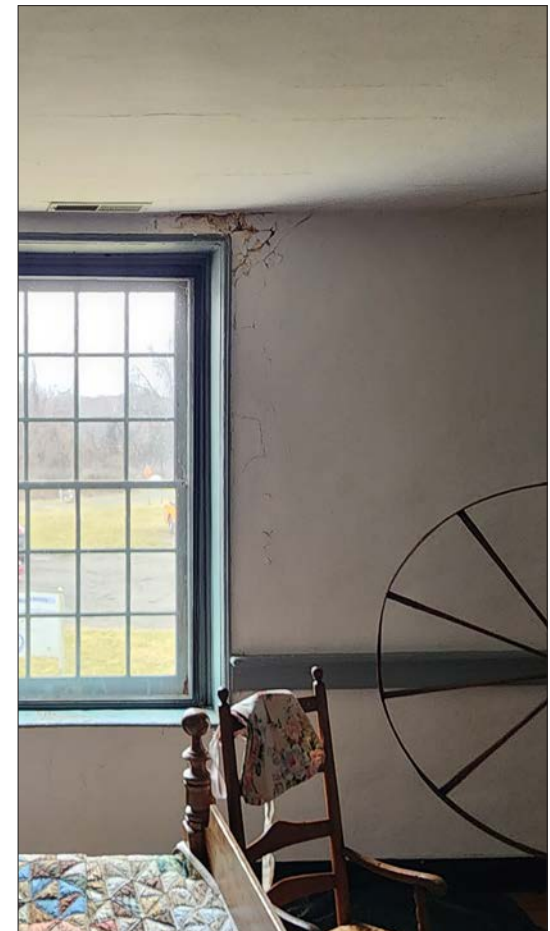
147-1: Southerly view from Southwest Chamber (Room 202) overlooking parking lot.

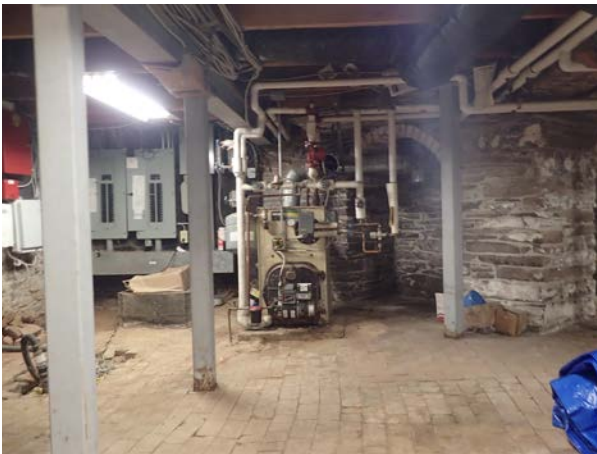
148-2: Address columns at basement level to prevent further corrosion

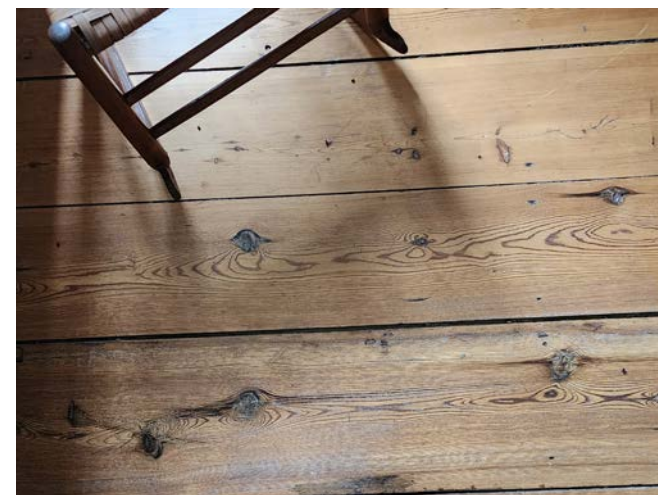
149-1: Maintain wood flooring

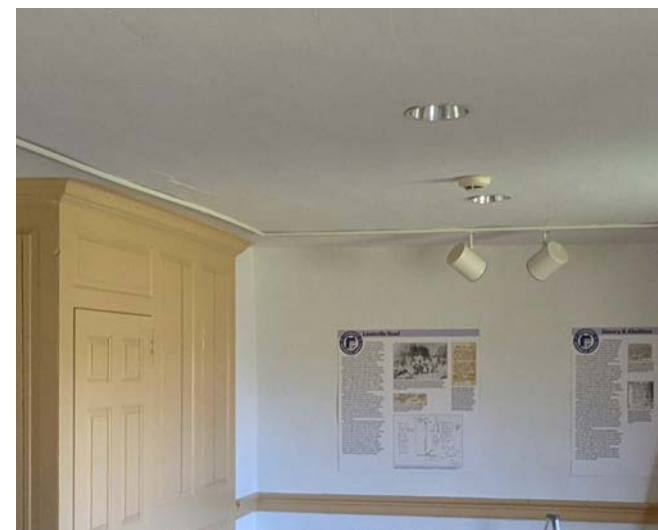
149-2: Replace lighting fixtures

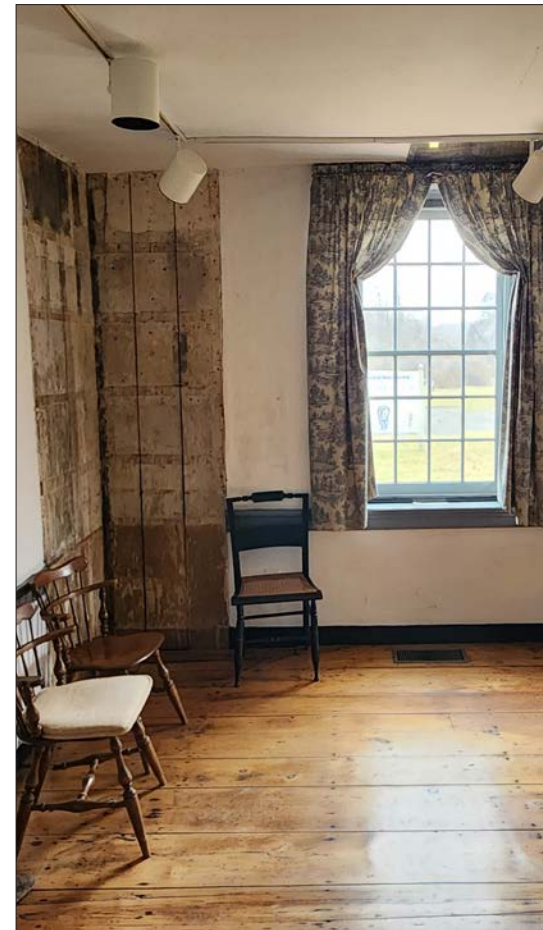
151-1: Southerly view from Southwest Parlor (Room 103) to parking lot.

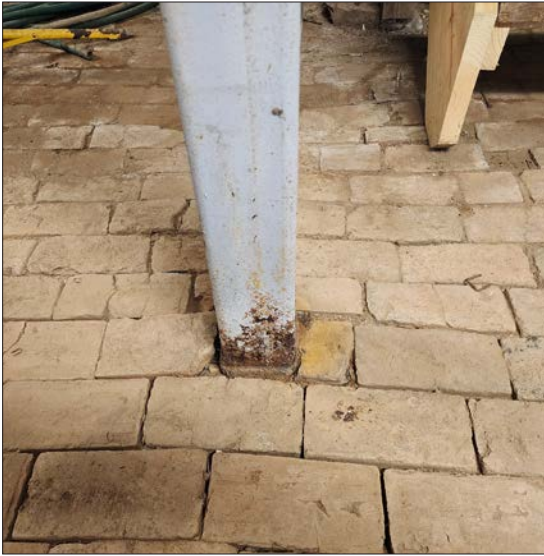
152-1: Corroded steel columns

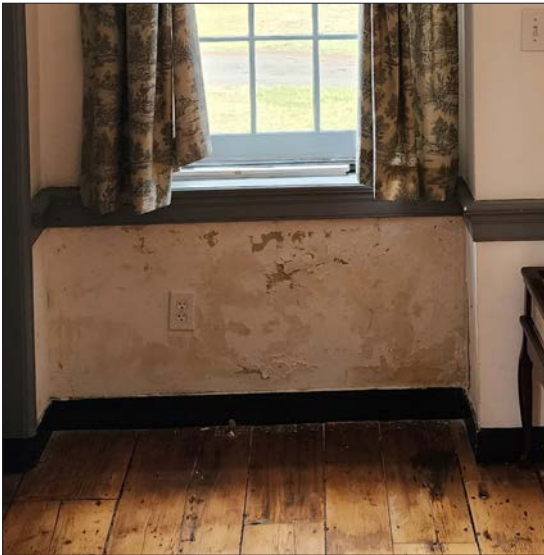
152-2: Damaged plaster

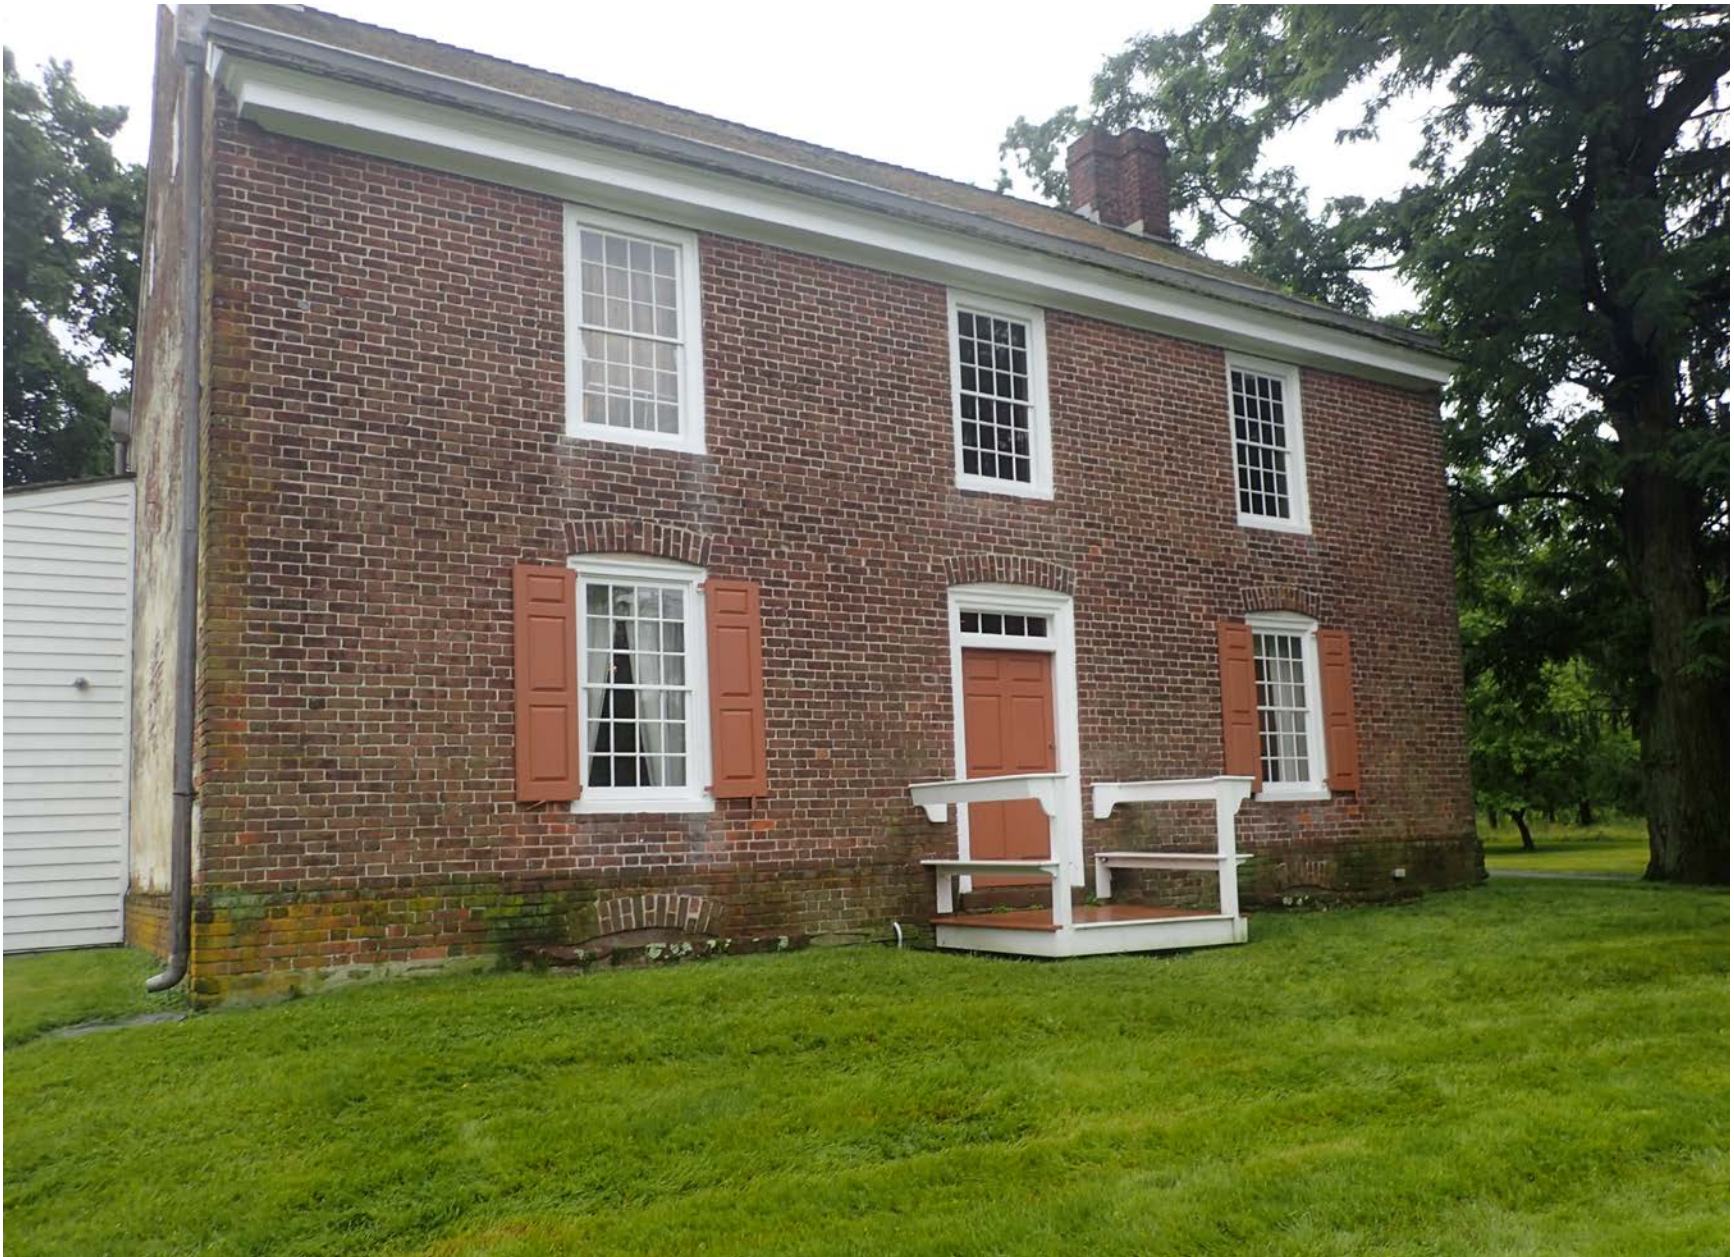
153-1: Immediate recommendations include cleaning of mortar and bricks, repointing mortar, and patching masonry.

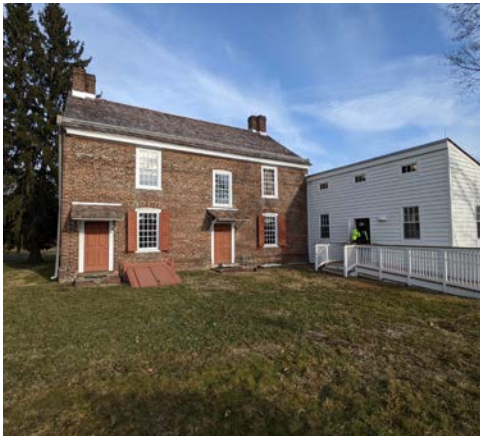
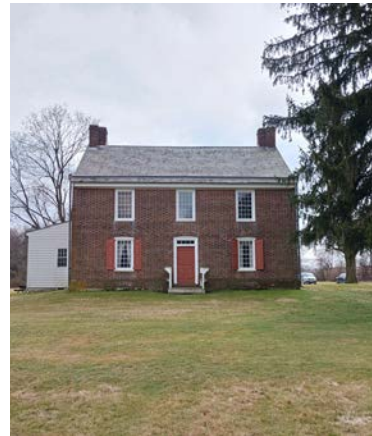
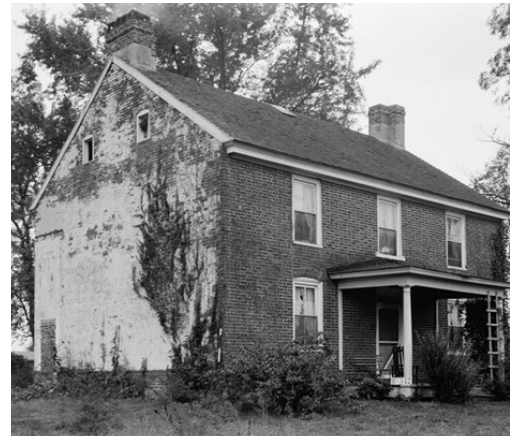
BREARLEY HOUSE PRESERVATION PLAN

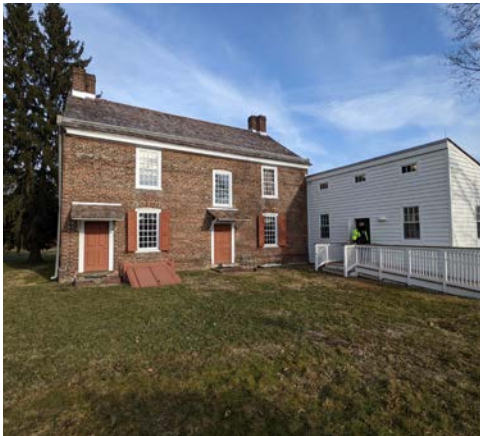
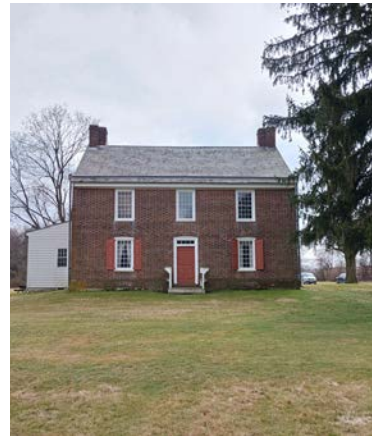
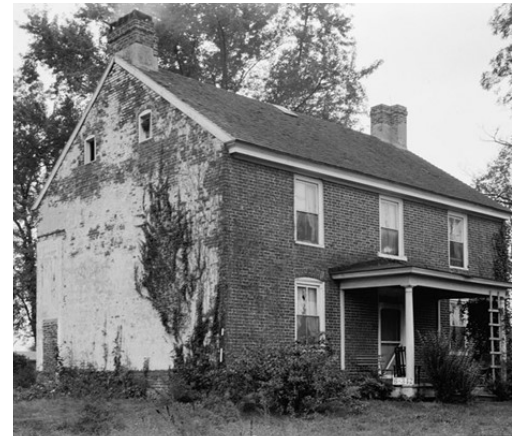
Hazard and Vulnerability Assessment

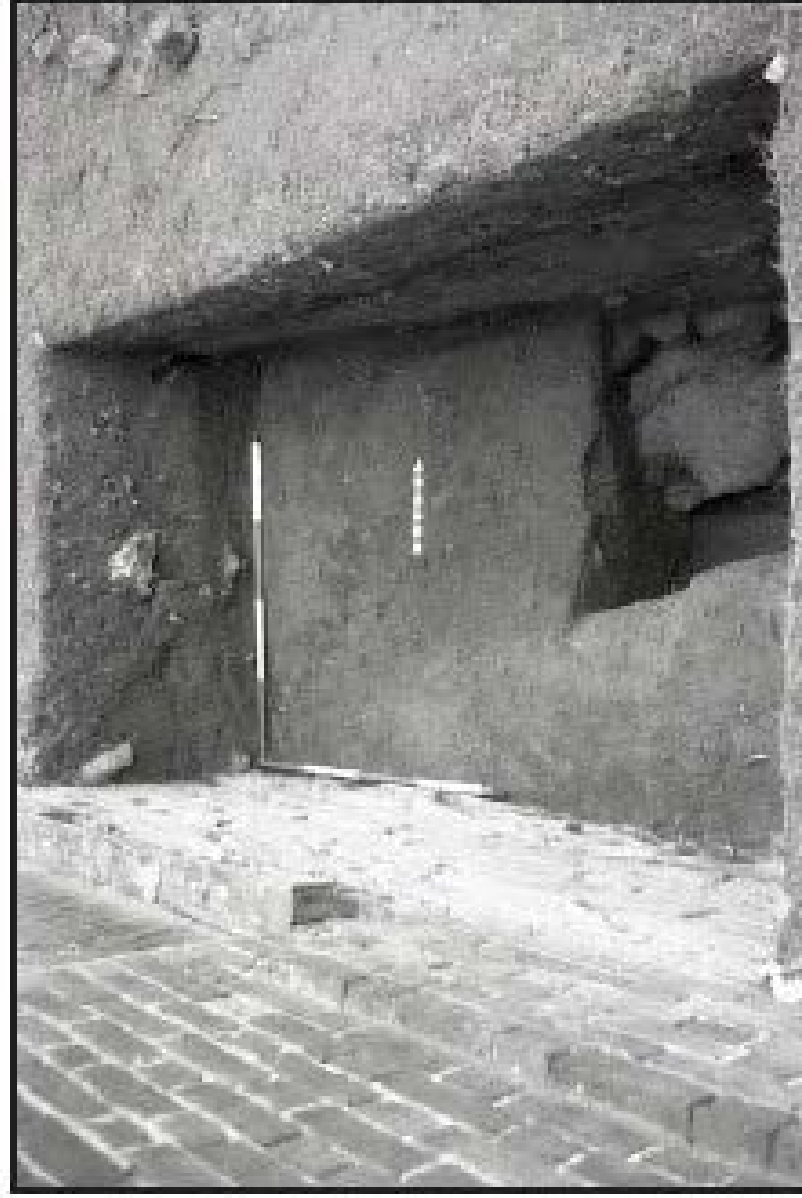
Figure A-2. The southern part of the cellar-hole of the c.1700 house on the north side of the 1761 brick house, as excavated in 1999. The view faces west. The north foundation of the 1761 house is on the left. The small north arrow/photo scale lies on the unexcavated dark soil filling the cellar hole. At the bottom right the dark soil has been partially removed, defining the southern side of the cellar-hole. A mass of clay loam and cobbles lies within the cellar-hole fill. See Figure A-1 for location. Source: Burrow and Butchko 2016, Plate 3.8.

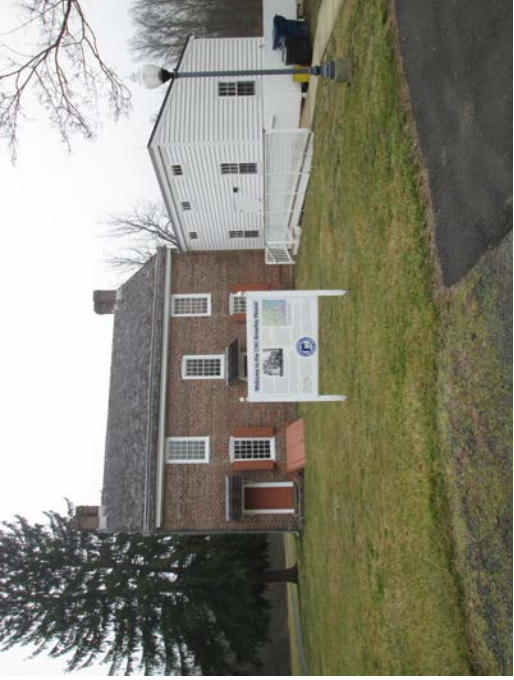
100 MEADOW ROAD
LAWRENCEVILLE, NEW JERSEY 08648

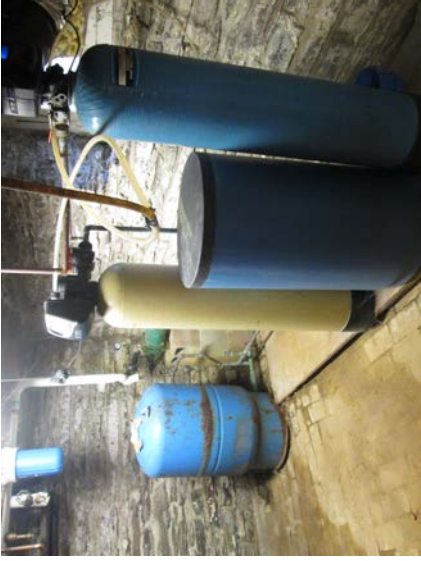
There is an Ademco Vista-100 fire alarm and security system control panel located in the basement (Photo 8, red panel), with full coverage smoke/heat detectors and motion sensors throughout the building, and central station monitoring. Given the historic nature of the structure, coupled with its combustible construction and lack of a sprinkler system, this was a wise decision.

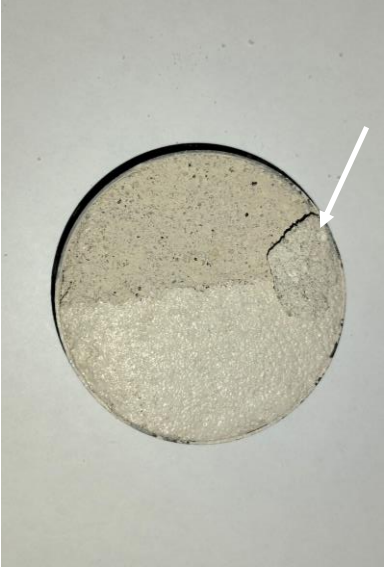
Sample 1, brick mortar (arrow, chip at bottom of disc) and replication (left half struck, and right half prepared to resemble effect of aging / weathering).
