**LAWRENCE TOWNSHIP, MERCER COUNTY, NEW JERSEY**  
**ADDENDUM NO. 2 (ANSWERS TO QUESTIONS PRESENTED)**  
**REQUEST FOR PROPOSAL (RFP #LT-2026-01)**  
**LEASE OF LAWRENCE NEIGHBORHOOD CENTER**  
**TO A NON-PROFIT ORGANIZATION**

# LAWRENCE COMMUNITY CENTER CONDITIONS ASSESSMENT

295 EGGERT'S CROSSING ROAD

JANUARY 27, 2025

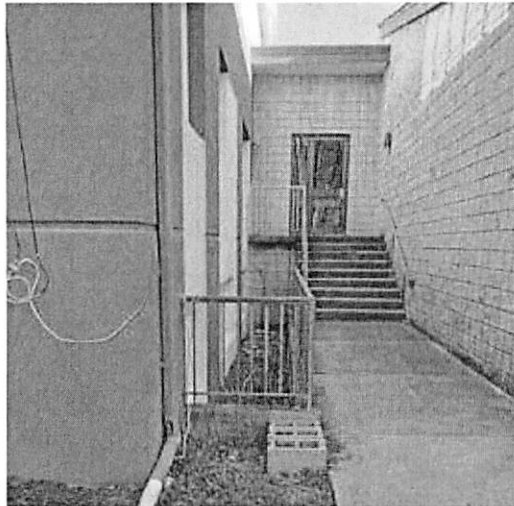
Egress at corridor between main building and gym

Existing egress stairs are missing handrail on one side of steps; guardrail is not 42" above floor.

Install code-compliant handrail and guardrails. Remove debris and leaves from areaway.

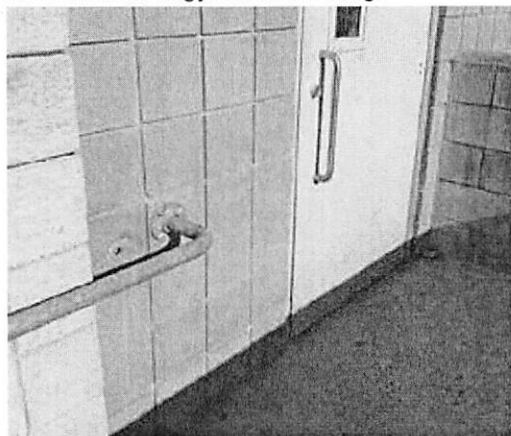
Holes in masonry from handrail support.

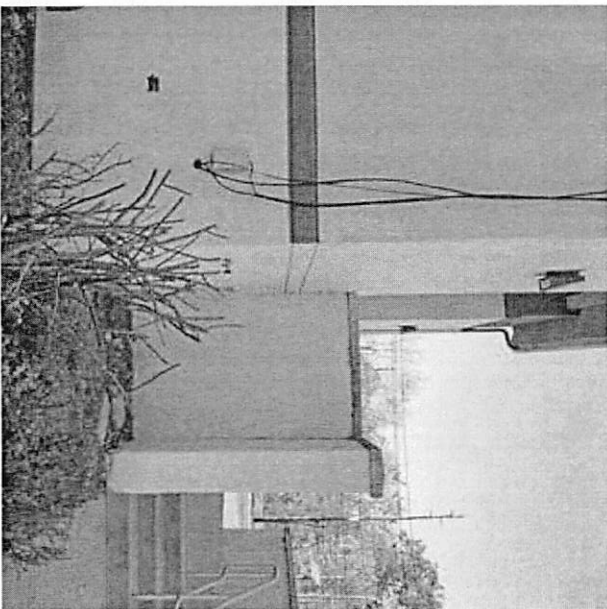
Loose wires and cables at east side of main entry.

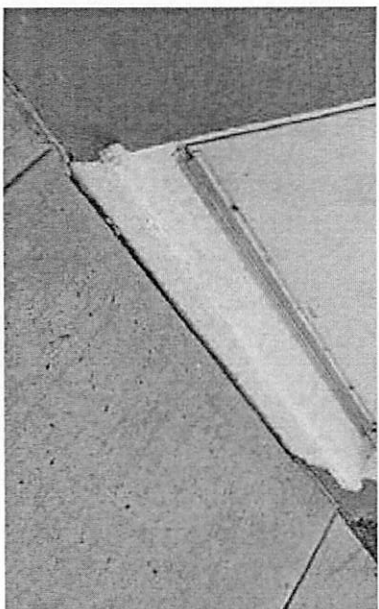
Step and threshold at egress Stair #2.

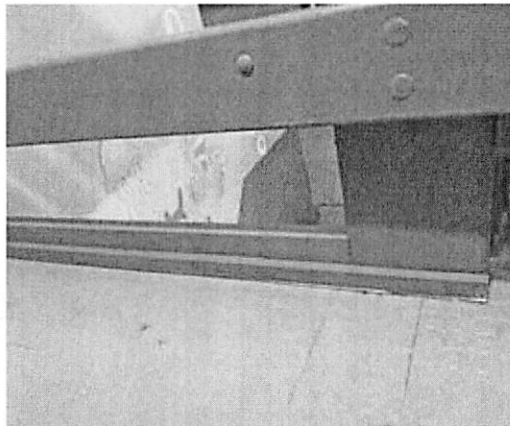
Gap at bottom of guard rail is greater than 4"

Install code-compliant handrails and guardrails

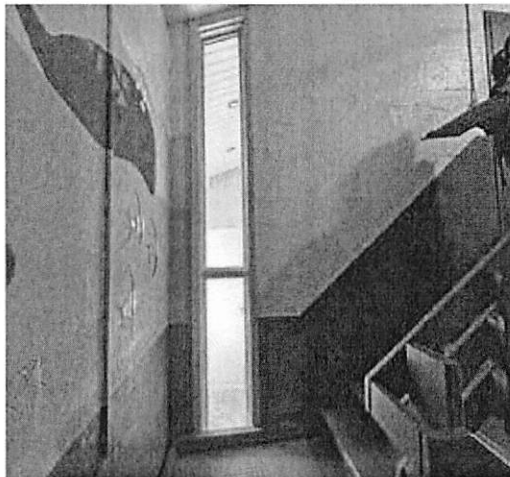
Window at stair #1

Window at stairs. No signs of water damage observed.

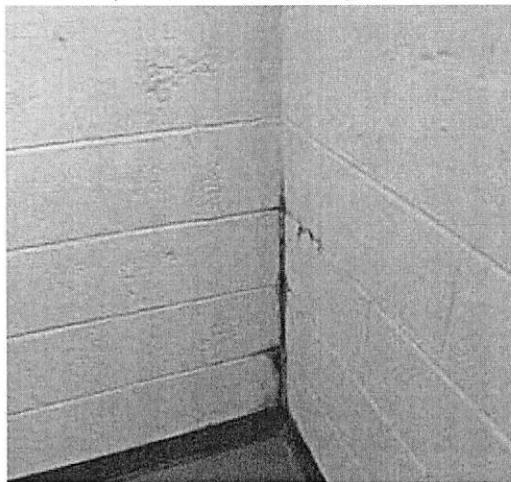
Efflorescence and mold at basement landing.

Efflorescence noted at basement level along with what appears to be mold and/or water damage.

Immediate: Remove efflorescence and dirt; clean

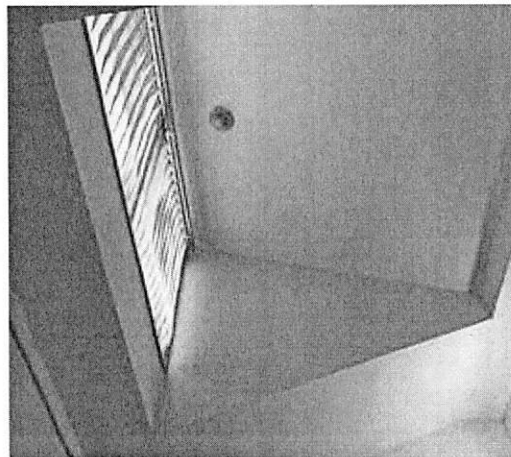
Clerestory window at top of stairwell

Clerestory window at top of stairs. No signs of water damage observed.

Clean window, replace shades

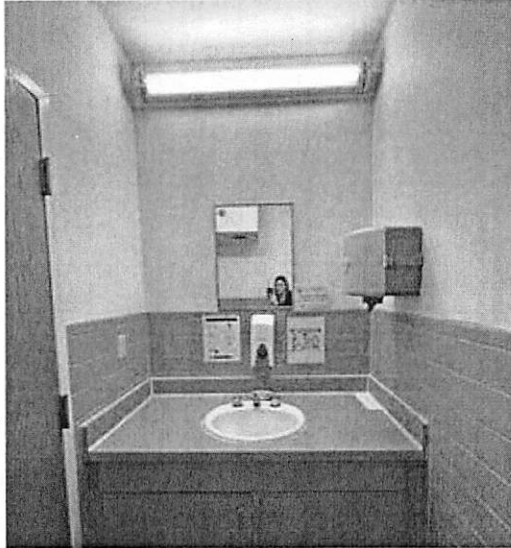
Women's Toilet: Sink cabinet, accessories, and exposed bulbs in lighting fixture.

Bathrooms are undersized; doors are 2'-0" wide, height of toilets is not code-compliant. Soap dispensers are located directly above faucets, which makes it difficult to use. Lighting is in need of an upgrade. Cabinets missing panels and door hinges damaged. Mirror appears to be more than 40" above the floor.

Renovate restrooms; create one single-user restroom with 3'-0" door and adjacent Janitor's Closet. Sinks to be wall-mounted or recessed in a cabinet that meets current code requirements. New toilets, grab bars, and code-compliant toilet accessories. Remove and replace floor and wall finishes.

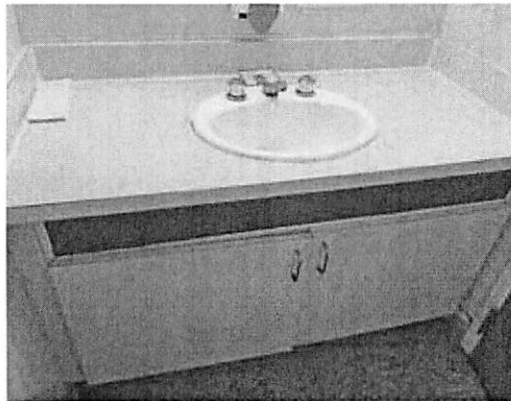
Men's toilet: Sink cabinet missing panel

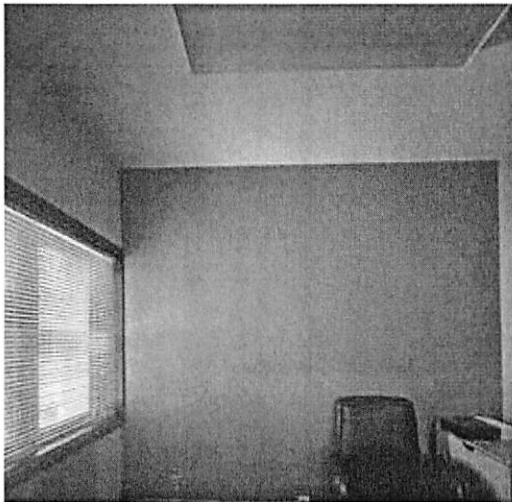
Window and ceiling-mounted light fixture

Finishes are worn and in need of replacement.

Replace floor, base, and repaint walls. Replace window shade. Install new ACT grid, ceiling, and lay-in light fixtures following installation of fire sprinkler system.

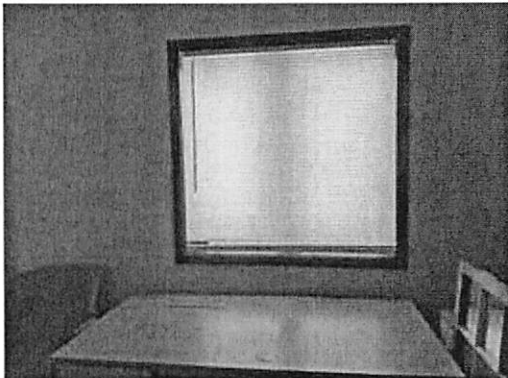
Office 106 - Existing window

Finishes are worn.

Replace finishes, window blinds, and repaint. Install new ceiling and light fixtures following installation of fire sprinkler system. Combine with Office 106 and Office 108 to create shared office.

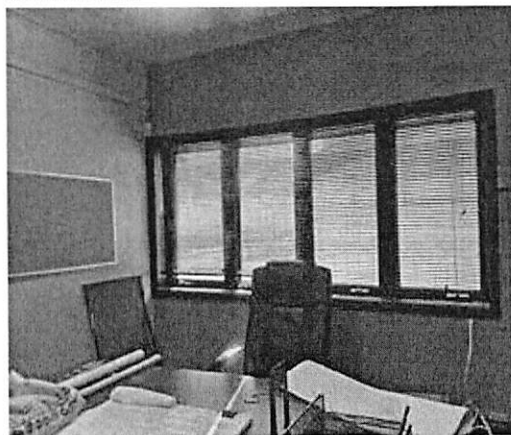
Finishes are worn. Remove existing finish and repaint.

Replace finishes, window blinds, and repaint. Remove closets to enlarge office. Install new ceiling and light fixtures following installation of fire sprinkler system.

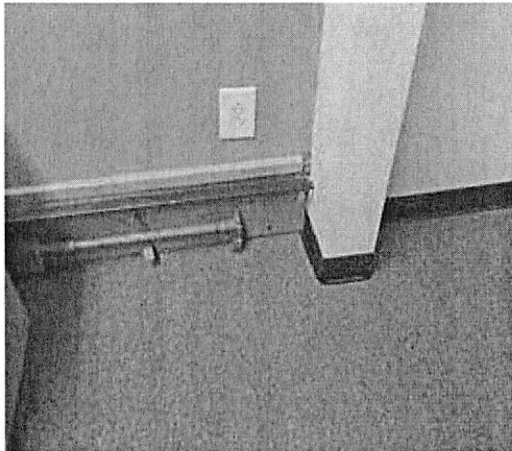
Exposed baseboard piping

Baseboard piping is exposed due to missing cover.

Replace baseboard covers.

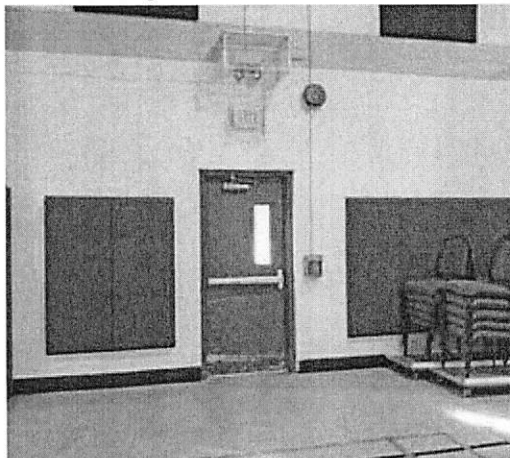
Egress door to ramp

Door finish is worn. Door is only existing means of accessible entry to building.

Replace door and threshold. Consider replacing hardware for egress only.

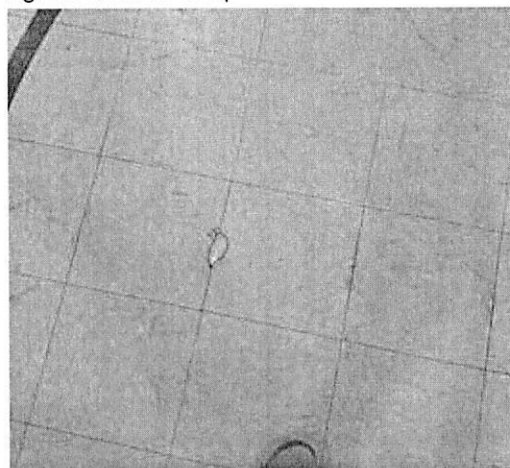
Damaged floor tiles

Floor is worn and tiles are breaking.

Replace flooring with sports flooring or VCT.

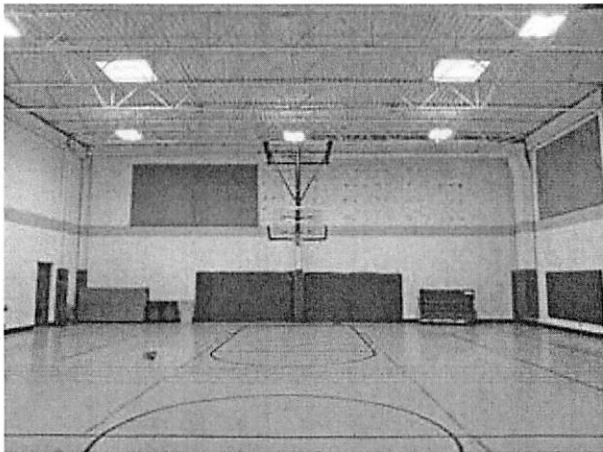
Missing acoustical padding at upper walls

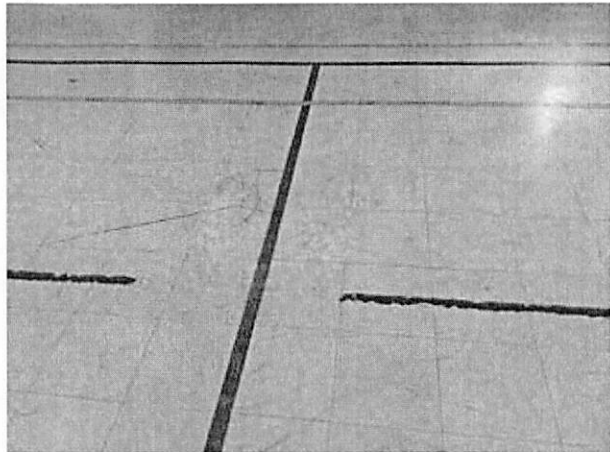
Damaged floor tiles and peeling tape

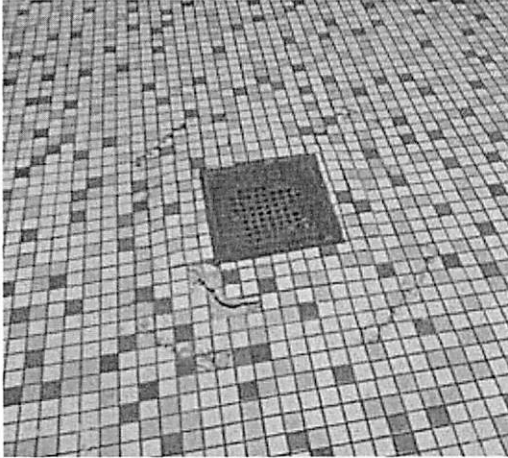
Cracked tile and floor raised around floor drain at men's restroom

Tiles around floor drain are cracked and floor is raised around floor drain.

Remove floor finish and reset floor drain prior to installation of new floor finish.

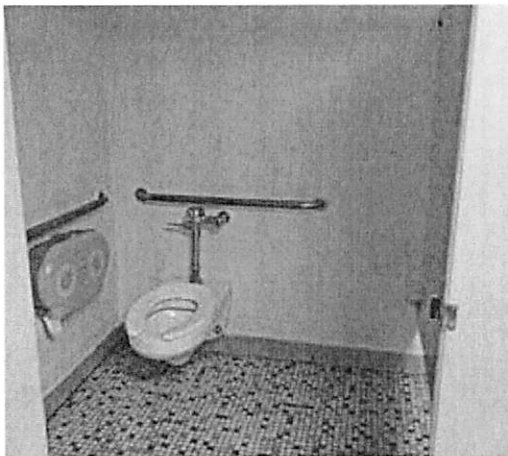
Accessible toilet stall

Vertical grab bar is missing, toilet seat is at 15", code requires height of toilet seat to be 17"-19" above finished floor. Floor tiles are worn.

Replace plumbing fixtures, floor, and floor base finishes. Repaint wall. Increase to three WCs at height compliant with code and required grab bars and accessories.

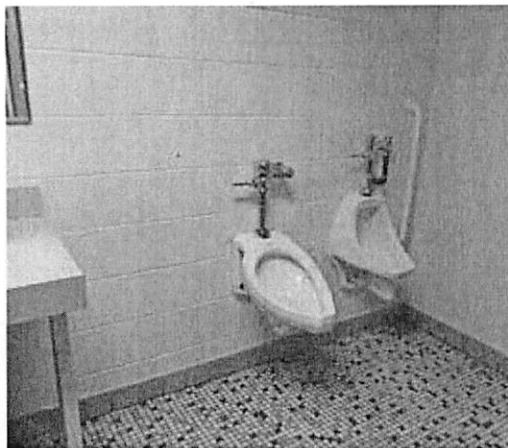
Existing urinals are in need of replacement.

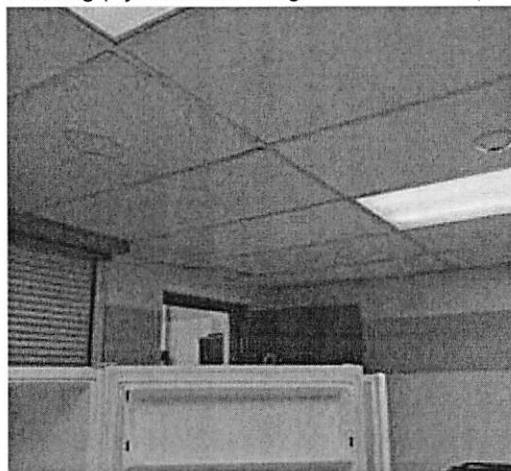
Water damage to ceiling

ACT ceiling is stained.

Replace ACT ceiling, and lighting with scrubbable ceiling tiles and energy-efficient lighting.

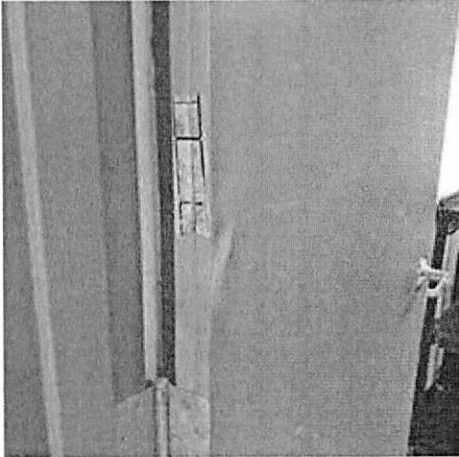
Door to kitchen is damaged

Door is damaged

Replace door and hardware.

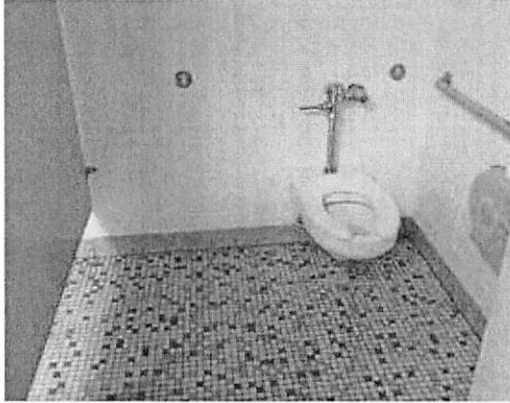
Accessible stall missing rear grab bar.  
Height of toilet seat is 15" AFF.

Vertical and rear grab bars are missing, toilet seat is at 15"; code requires height of toilet seat to be 17"-19" above finished floor. Floor tiles are worn.

Replace plumbing fixtures, floor, and floor base finishes. Repaint wall. Increase to three WCs.

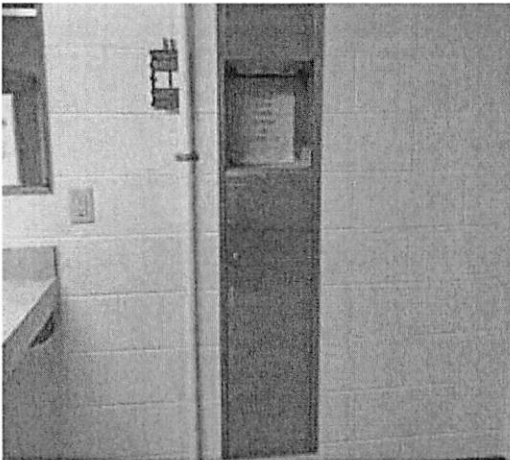
Existing paper towel dispenser and trash  
receptacle

Paper towel dispenser is approximately 60" above floor. This same condition is present at Men's Restroom (116).

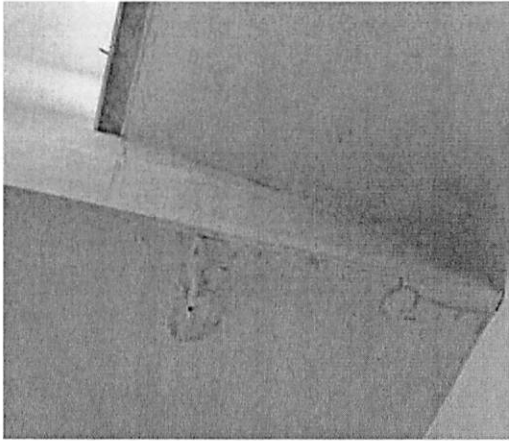
Water damage at ceiling

Water damage at ceiling and soffit.

Investigate cause of water damage, replace areas of damaged ceiling.

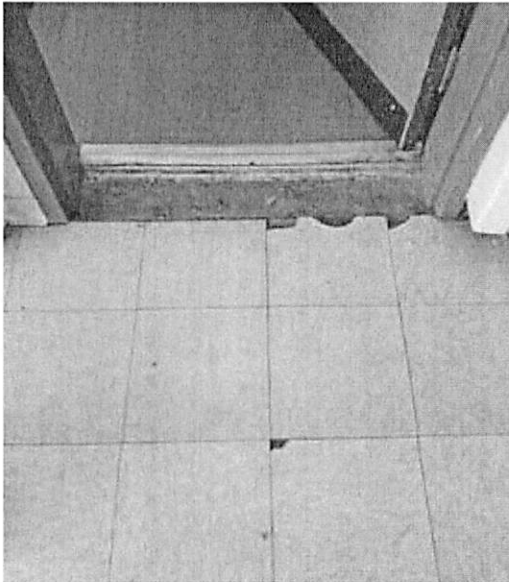
Damaged floor tiles at entry to egress stair

Floor tiles are buckled and lifting from floor. Broken tiles near access to Stair #2.

Replace floor tiles and install new threshold at Stair #2.

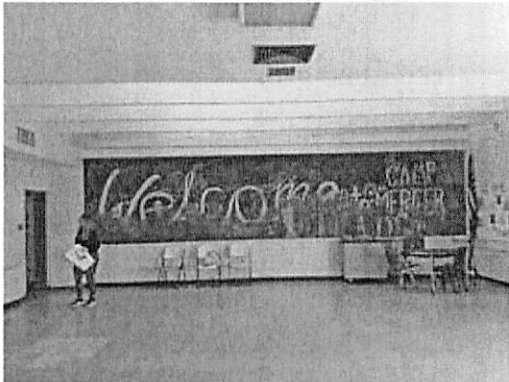
Wall between room 203 and 207

Finishes are worn, floor tiles are damaged.

Replace finishes, window blinds, and repaint. Combine with Classroom 207 to create assembly space. Install new ceiling and light fixtures following installation of fire sprinkler system. Room to be subdivided to provide elevator lobby, storage space, and access hallway to Stair #2.

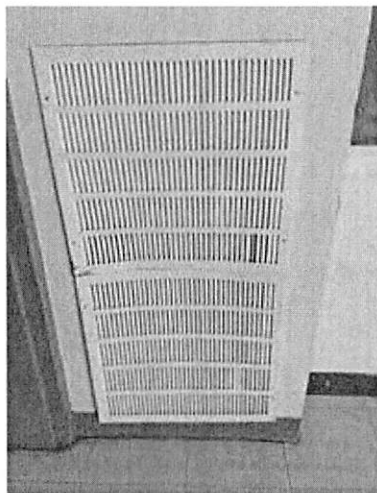
Damaged transfer grille

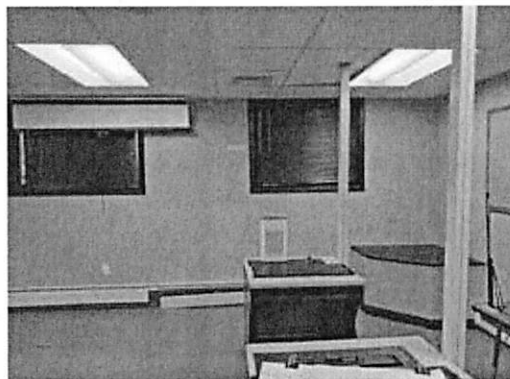
Damaged baseboard cover and ceiling condition.

Ceiling and lighting fixtures are in need of replacement. Existing finishes are worn, and flooring is exposed concrete. Baseboard cover is damaged. Existing projector screen may be reused.

Install flooring, repaint walls, and replace ACT ceiling and upgrade lighting fixtures. Repaint walls. Subdivide space for elevator and elevator lobby, and new partition wall for renovated Classroom 013.

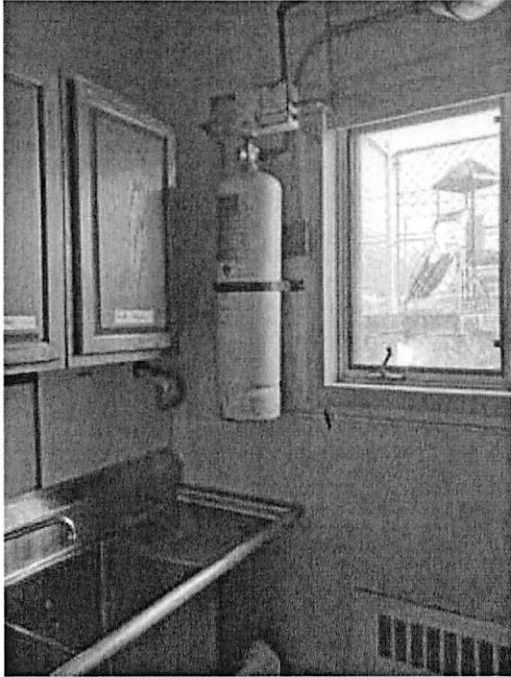
Three-compartment sink, cabinets, and fire suppression system

Existing three-compartment sink and industrial stove with hood and remote fire suppression system. Lighting and emergency lighting in need of upgrade. Flooring and stainless steel wall panels are worn and in need of replacement.

Replace cabinets, flooring, and stainless steel wall panels.

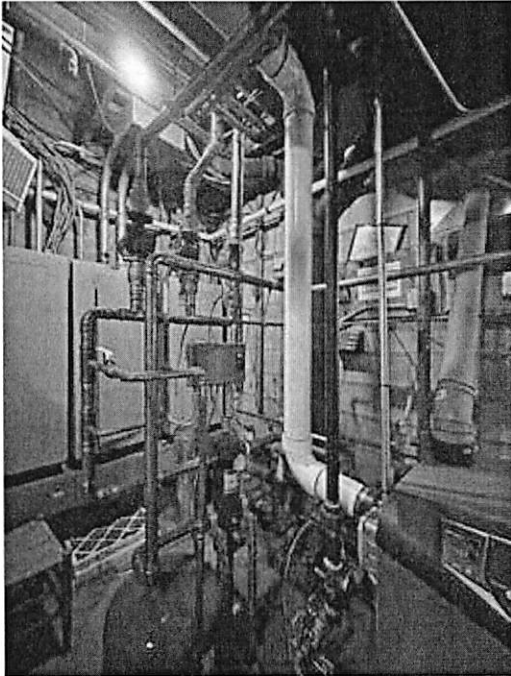
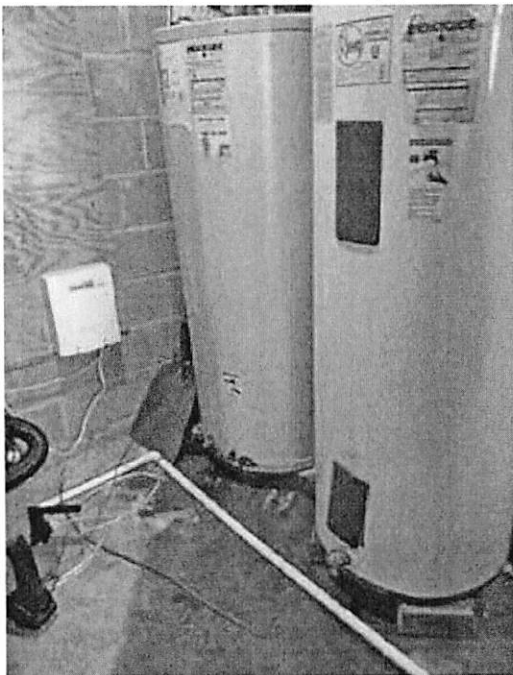
Boiler (lower right of image) and piping

Hot water heaters

Continue to maintain, replace boiler and hot water heaters when they reach end of useful lives
