**LAWRENCE TOWNSHIP, MERCER COUNTY, NEW JERSEY**  
**ADDENDUM NO. 2 (ANSWERS TO QUESTIONS PRESENTED)**  
**REQUEST FOR PROPOSAL (RFP #LT-2026-01)**  
**LEASE OF LAWRENCE NEIGHBORHOOD CENTER**  
**TO A NON-PROFIT ORGANIZATION**

# LAWRENCE COMMUNITY CENTER CONDITIONS ASSESSMENT

295 EGGERT'S CROSSING ROAD

JANUARY 27, 2025

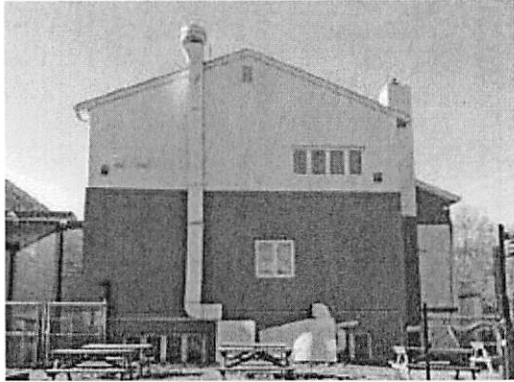
East side of main building

Exterior of main building is in overall good condition. Exhaust ductwork from basement kitchen to roof is rusted in spots. Limited exterior lighting.

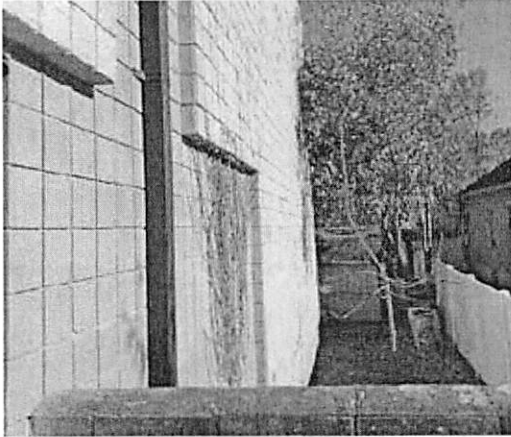
Vines at South side of gymnasium wing

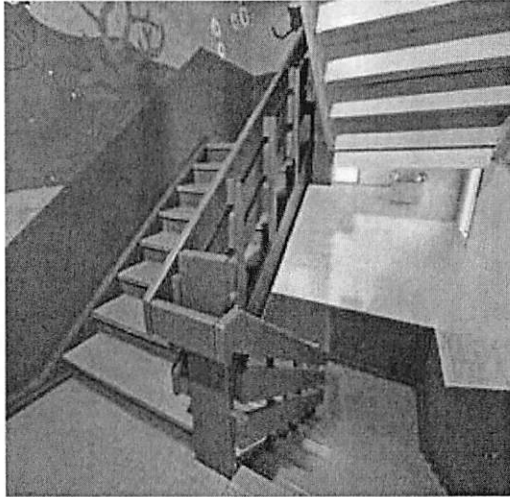
Stair 1

View of stairs

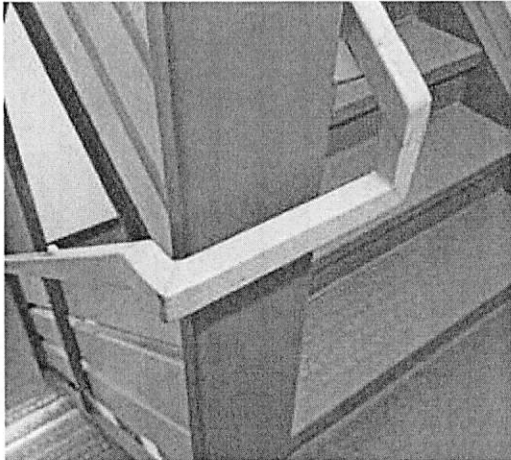
Stair 2

Non-compliant handrail and guardrail

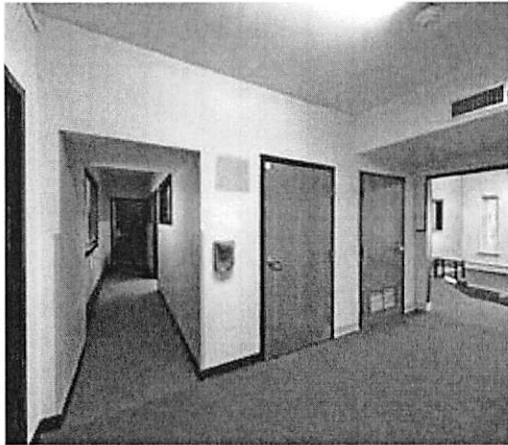
View of corridor to offices 111 and 112

Existing finishes are worn and in need of replacement.

Short-Term: Replace floor, base, and wall finishes.

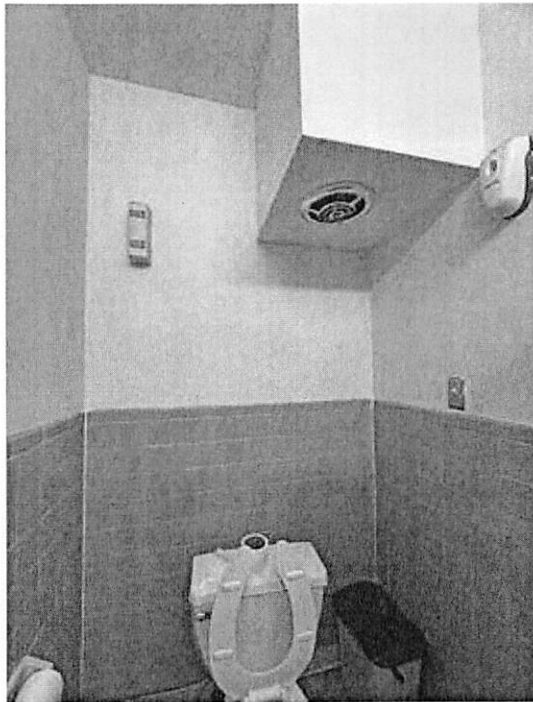
Women's toilet: exhaust fan in soffit above toilet

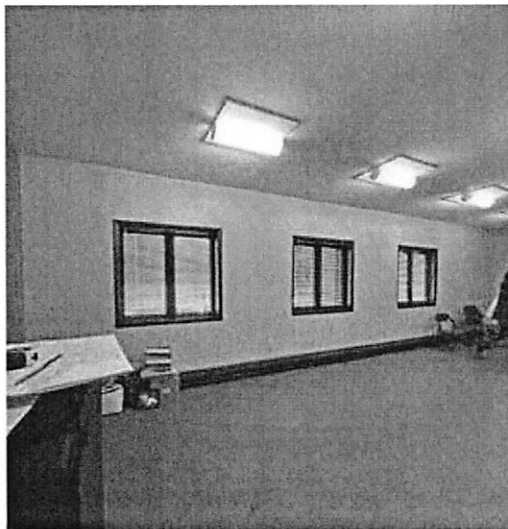
Existing finishes

Existing finishes are worn and in need of replacement.

Replace floor, base, and repaint walls. Room will be divided for elevator, corridor, and offices. Infill window for elevator shaft. Install new ceiling and light fixtures following installation of fire sprinkler system.

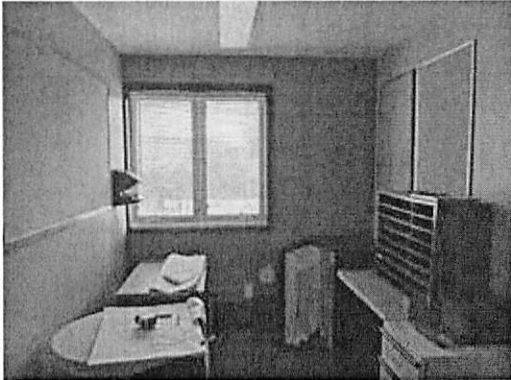
Corridor 107 - Workspace/kitchenette

Finishes are worn.

Replace finishes, window blinds, and repaint. Install new ceiling and light fixtures following installation of fire sprinkler system. Combine with Office 106 and Office 108 to create shared office.

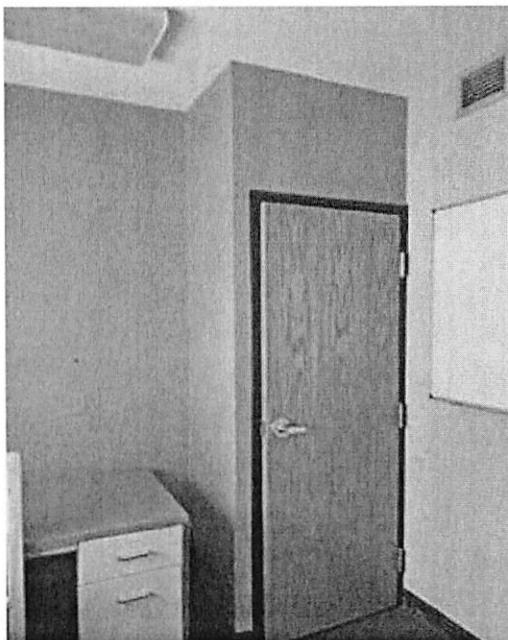
Finishes are worn.

Office 106 - Existing closet

Replace finishes, window blinds, and repaint. Install new ceiling and light fixtures following installation of fire sprinkler system. Combine with Office 106 and Office 108 to create shared office.

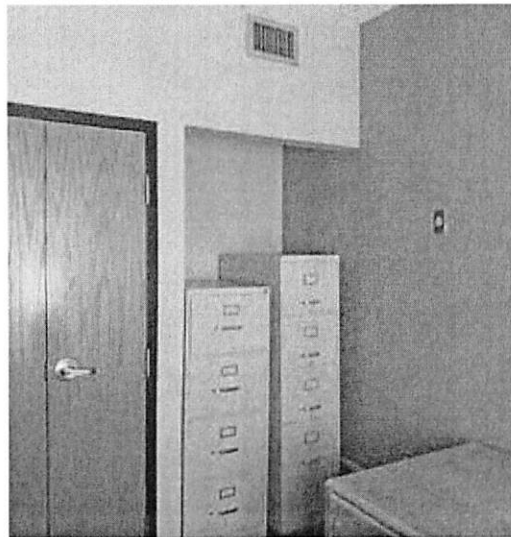
Existing closet and soffited storage area

Finishes are worn.

Replace finishes, window blinds, and repaint. Install new ceiling and light fixtures following installation of fire sprinkler system. Combine with Office 106 and Corridor 107 to create shared office.

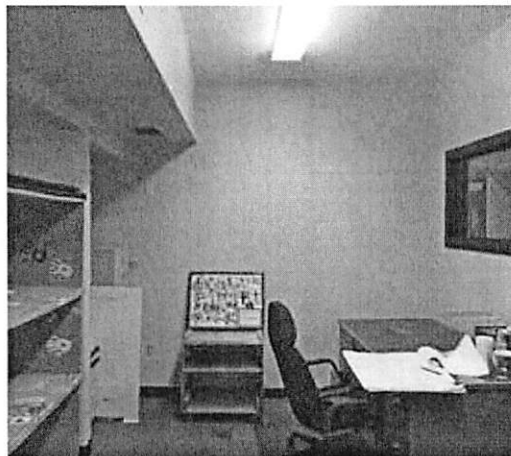
Existing workstation

Existing finishes are worn and in need of replacement.

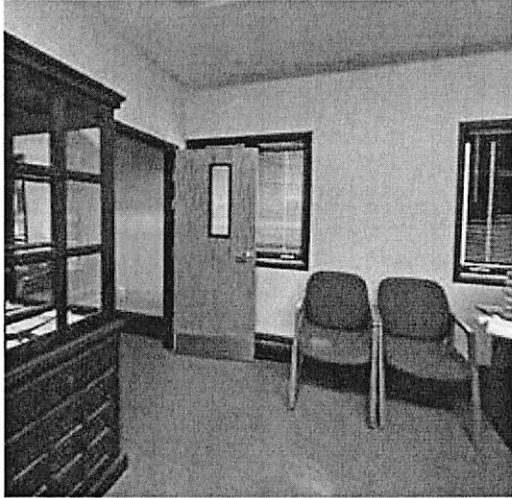
Windows and door

Existing finishes are worn and in need of replacement.

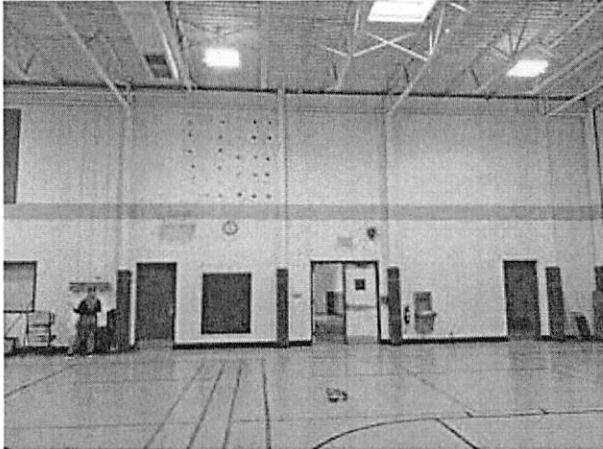
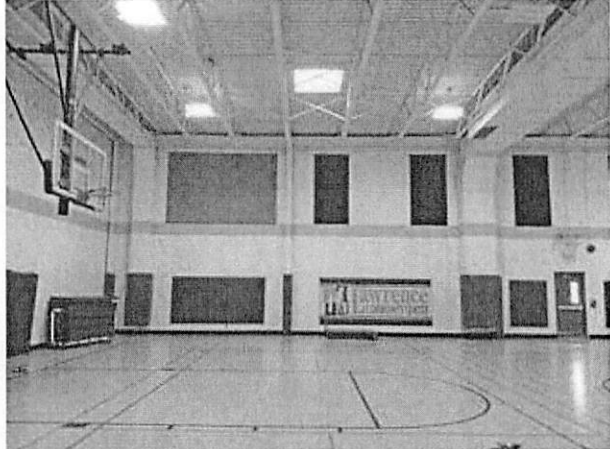
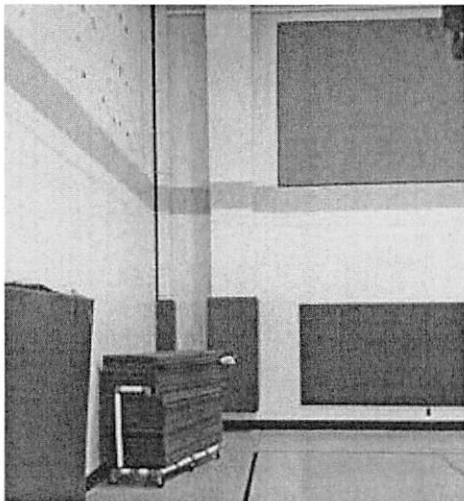
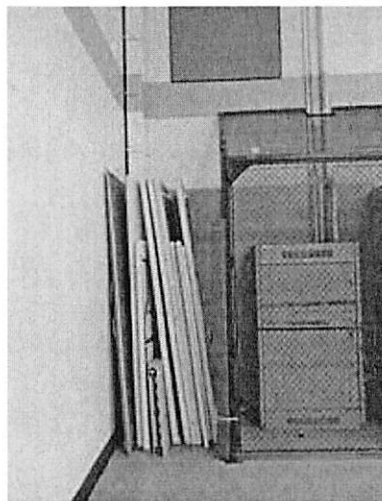
View towards main building and restrooms

Gymnasium wall

Existing wall-mounted ductwork

Makeshift storage between electrical cage and wall

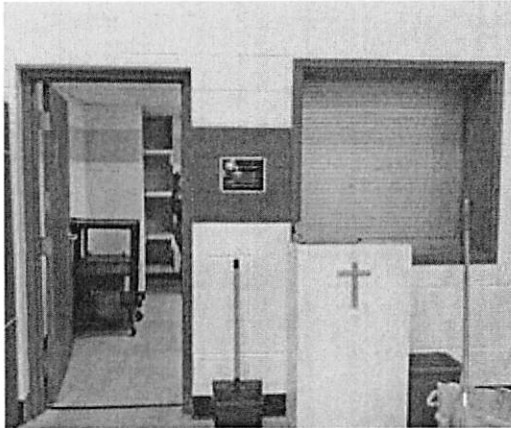
View of kitchen and service window from gymnasium

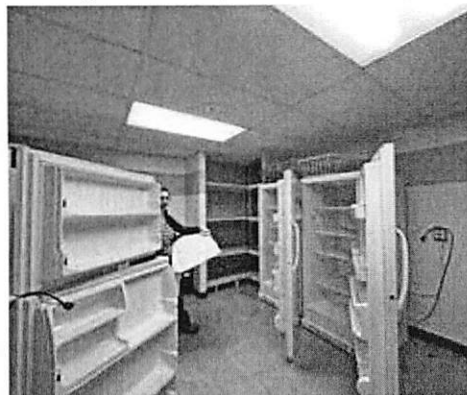
Existing kitchen

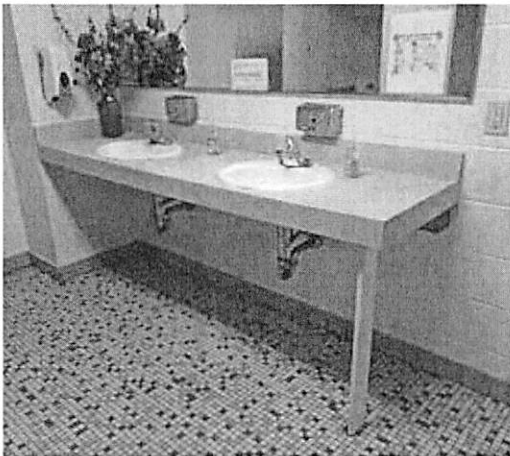
Sink and counter

Counter is worn and in need of replacement. Soap dispensers are in conflict with faucets. Bottom of mirror is approximately 48" above the floor. Similar condition is present at Men's Restroom (116).

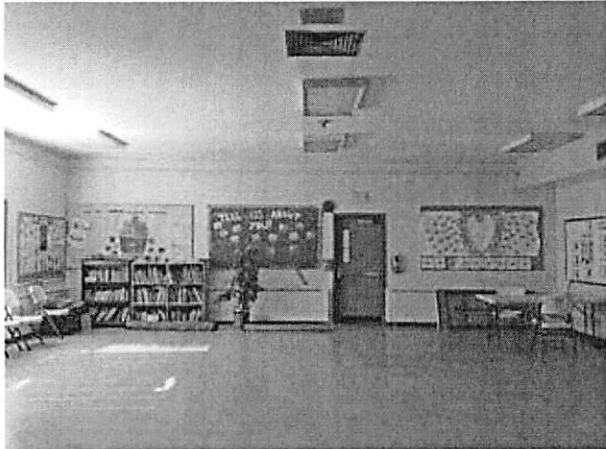
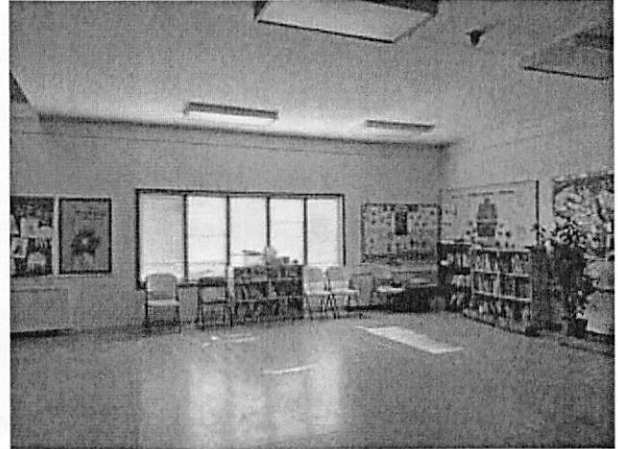
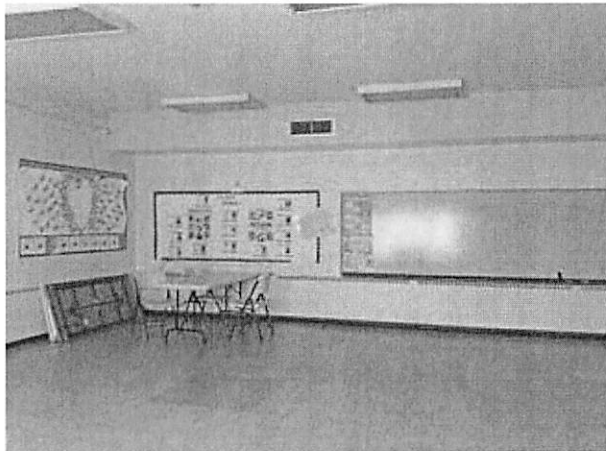
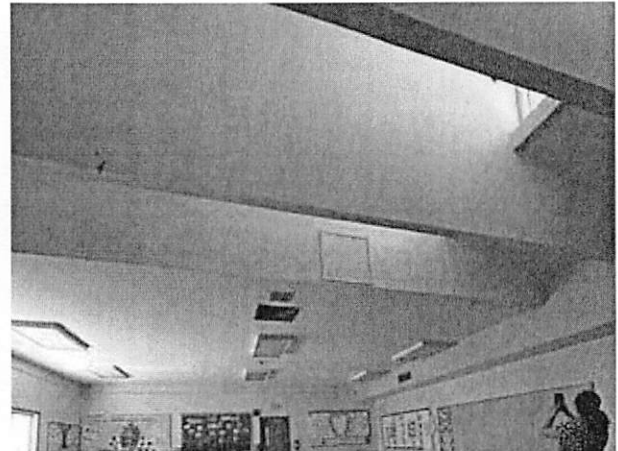
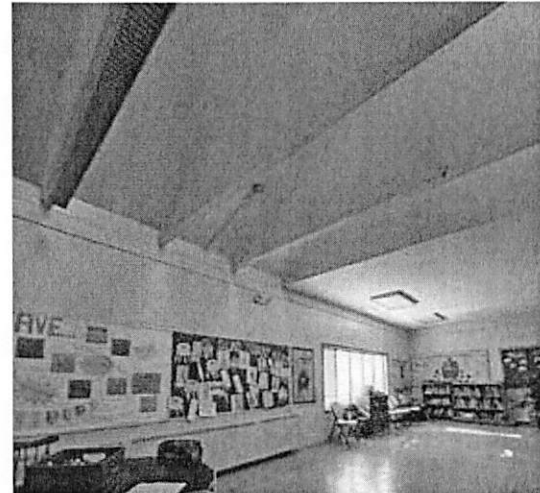
Finishes are worn, floor tiles are damaged.

Replace finishes, window blinds, and repaint. Combine with Classroom 207 to create assembly space. Install new ceiling and light fixtures following installation of fire sprinkler system. Room to be subdivided to provide elevator lobby, storage space, and access hallway to Stair #2.

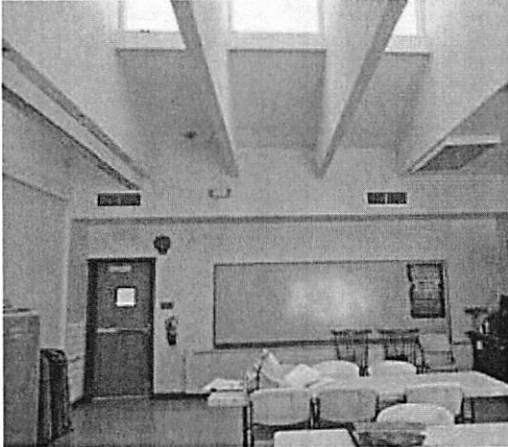
One means of egress from room. Access to Stair #1 from lobby and Stair #2 through room 203.

Existing egress door

Remove wall between rooms 203 and 207 to create one meeting room with two means of egress

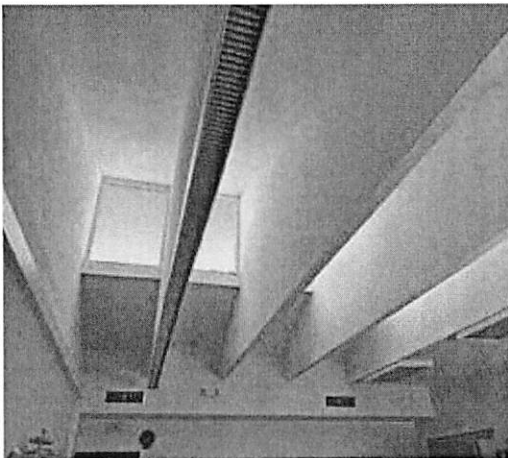
Existing lighting and clerestory lighting

Windows appear to be in good condition. Lighting appears to be insufficient.

Install new lighting to provide adequate light levels for meeting space.

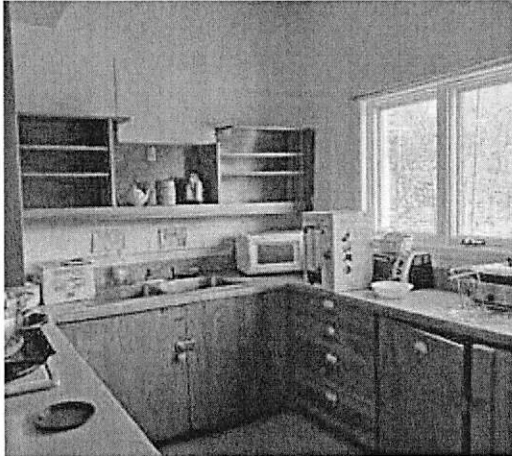
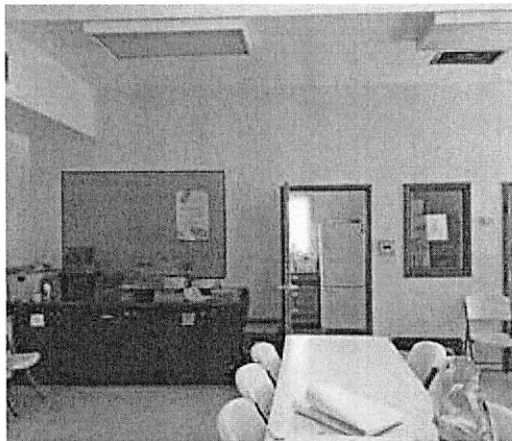
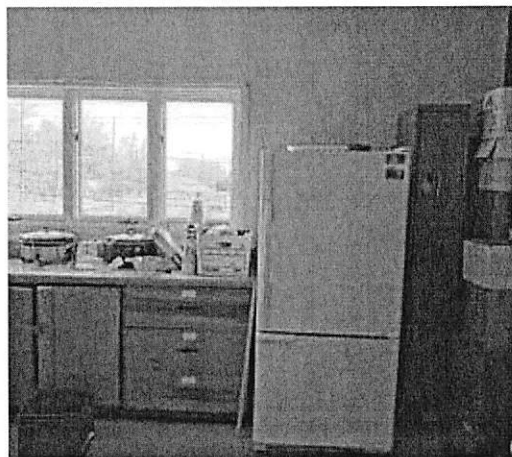
Existing lower cabinets and refrigerator

Existing plywood cabinets and laminated counters are aged and in poor condition.

Renovate as a teaching kitchen. Replace all cabinets, sinks, and install stove, ovens, fire suppression and exhaust systems required by code.

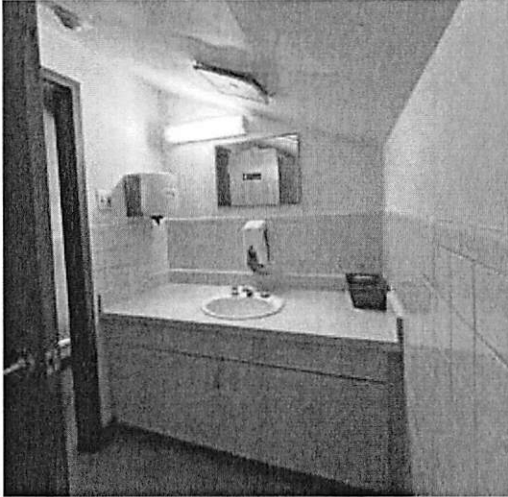
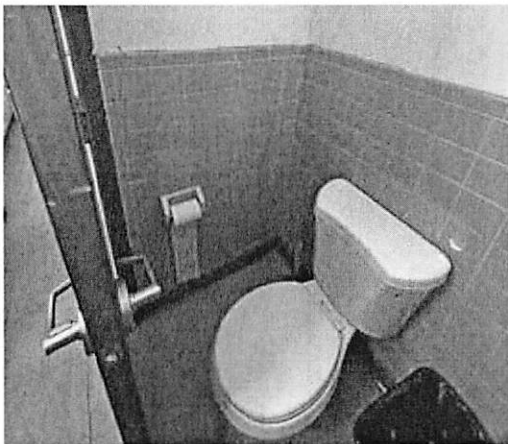
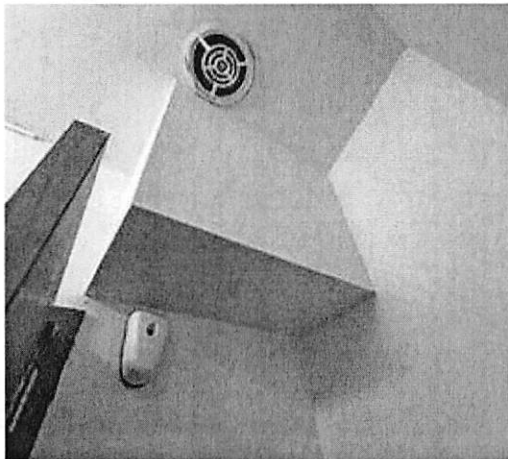
Women's restroom cabinet and sink

Existing toilet and accessories with door open

Existing exhaust fan at men's restroom

Renovate restrooms; create into one single-user restroom with 3'-0" door and adjacent Janitor's Closet. Sinks to be wall-mounted or recessed in a cabinet that meets current code requirements. Install new code-compliant toilets, grab bars, and code-compliant toilet accessories. Remove and replace floor and wall finishes.

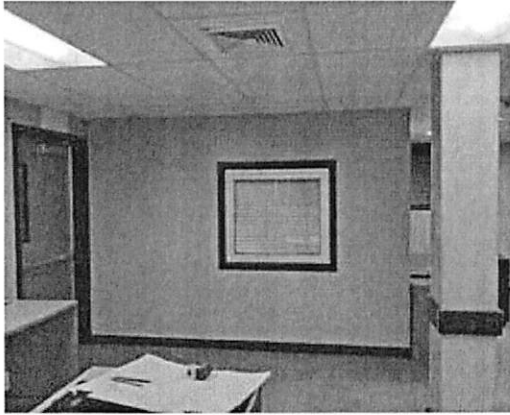
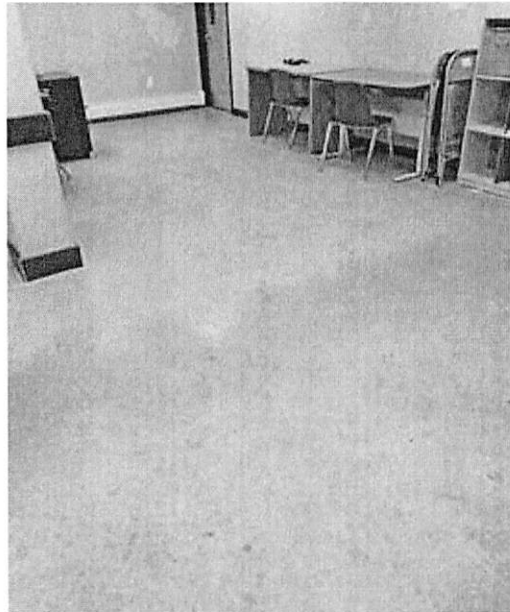
Window to Office 014

Exposed concrete flooring

Ceiling and lighting fixtures are in need of replacement. Existing finishes are worn, and flooring is exposed concrete. Baseboard cover is damaged. Existing projector screen may be reused.

Install flooring, repaint walls, and replace ACT ceiling and upgrade lighting fixtures. Repaint walls. Subdivide space for elevator and elevator lobby, and new partition wall for renovated Classroom 013.

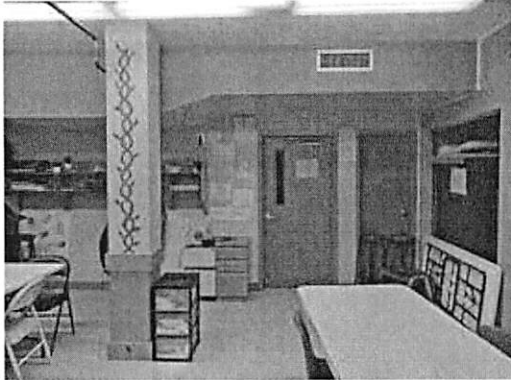
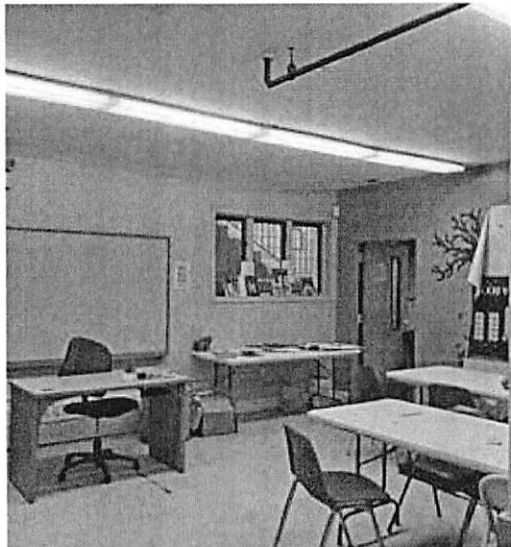
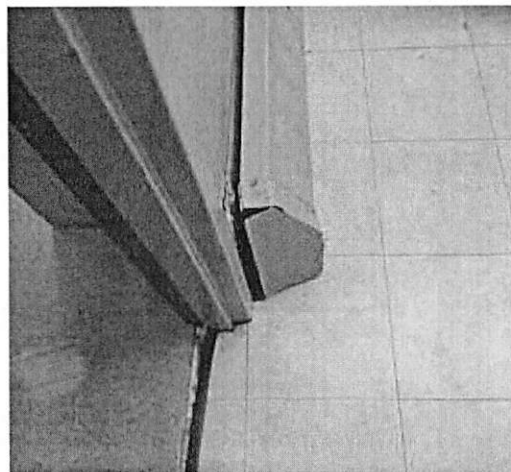
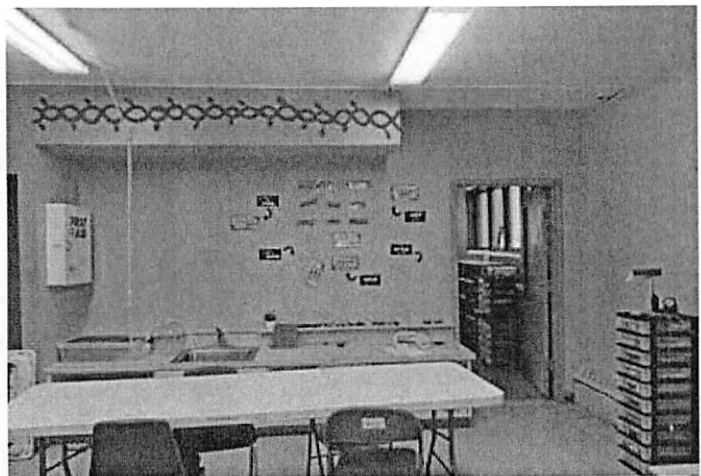
View of classroom towards Corridor 015a

Windows, exposed piping, and light fixtures

Existing baseboards, threshold, and floor

Sink and counter are at child height, existing condensate drain. Exposed piping, ductwork concealed in soffits. Lighting and emergency lighting in need of upgrade. Flooring is worn and in need of replacement. Baseboards are damaged. Door to Classroom 013 and Teen/Game Room 006. Closet is former toilet.

View of classroom showing door to Teen/Game Room 006.

Remove finishes from closet and install shelving for storage. Replace flooring and repaint walls. Upgrade lighting fixtures. Remove sink and cabinets. Install new ceiling and light fixtures following installation of fire sprinkler system.

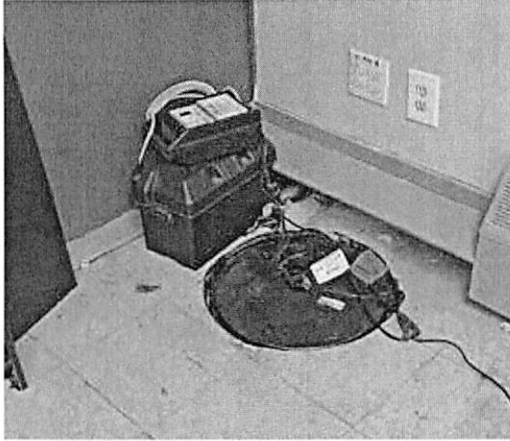
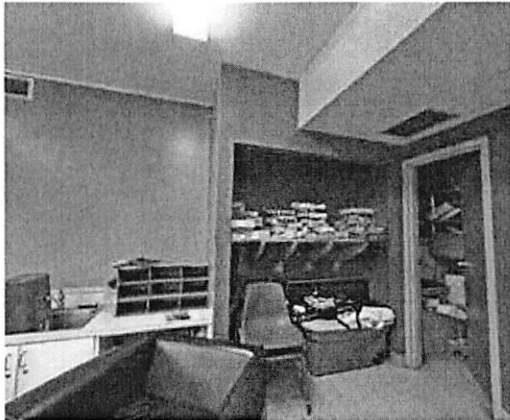
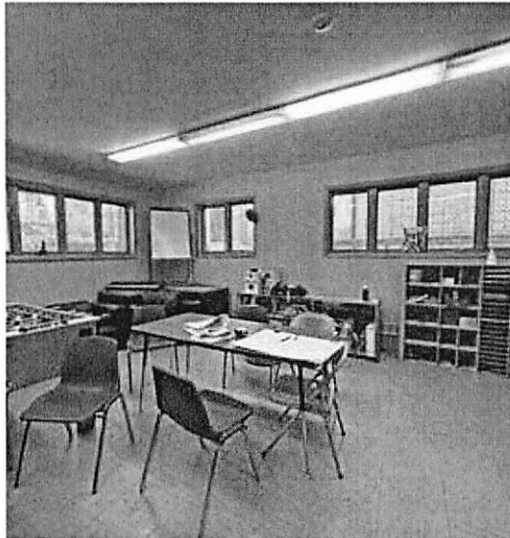
Exposed sump pump

Existing cabinet with sink and storage areas

Flooring, windows, and lighting

Sink and counter are at child height, existing condensate drain. Exposed piping, ductwork concealed in soffits. Lighting and emergency lighting in need of upgrade. Flooring is worn and in need of replacement. Baseboards are damaged. Closet is former toilet with fixtures removed; open storage and shelving throughout room.

Remove finishes from closet and install shelving for storage. Remove sink and cabinets. Replace flooring, repaint walls and ceiling. Remove sink and cabinets. Enclose sump pump in separate room and create closet adjacent to sump pump. Install new ceiling and light fixtures following installation of fire sprinkler system.

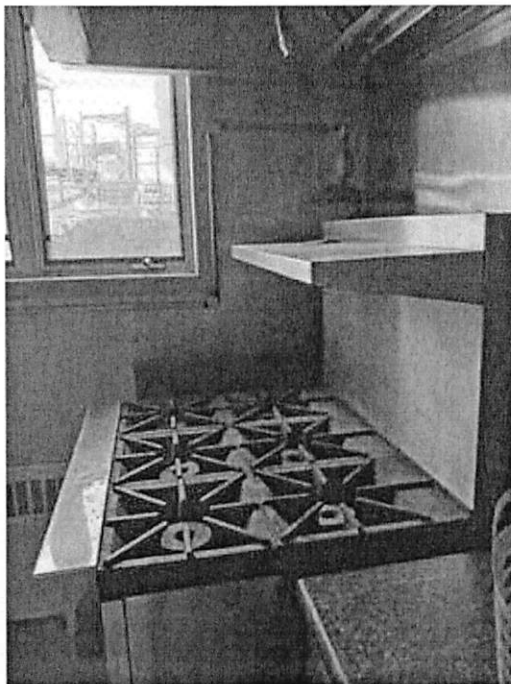
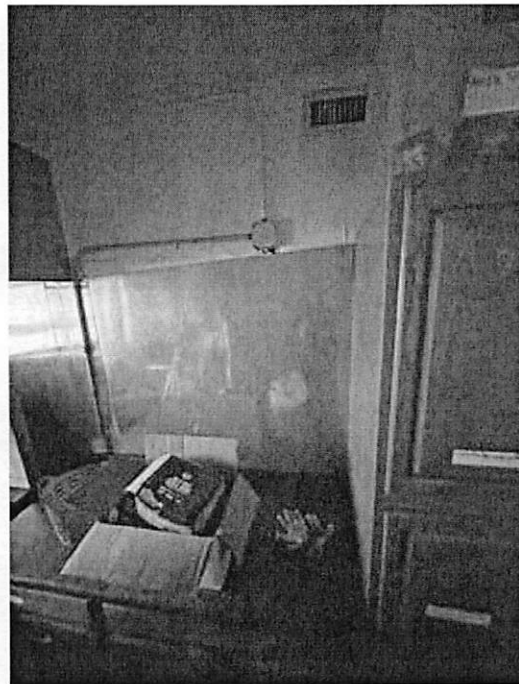
Existing three-compartment sink and industrial stove with hood and remote fire suppression system. Lighting and emergency lighting in need of upgrade. Flooring and stainless steel wall panels are worn and in need of replacement.

Stove and exhaust hood

Flooring, windows, and lighting

Replace cabinets, flooring, and stainless steel wall panels.
